### **BGC Project Memorandum**

<b>To:</b>	<b>Copper Fox Metals Inc.</b>	<b>Date:</b>	<b>February 5, 2008</b>
<b>Attention:</b>	<b>Shane Uren, M.A.Sc., R.P.Bio</b>	<b>CC:</b>	<b>Matthias Jakob</b>
<b>From:</b>	<b>Kris Holm, M.Sc., P.Geo.</b>	<b>Project No:</b>	<b>0530-001</b>
<b>Subject:</b>	<b>Schaft Creek Tailings Options study, Geohazards</b>

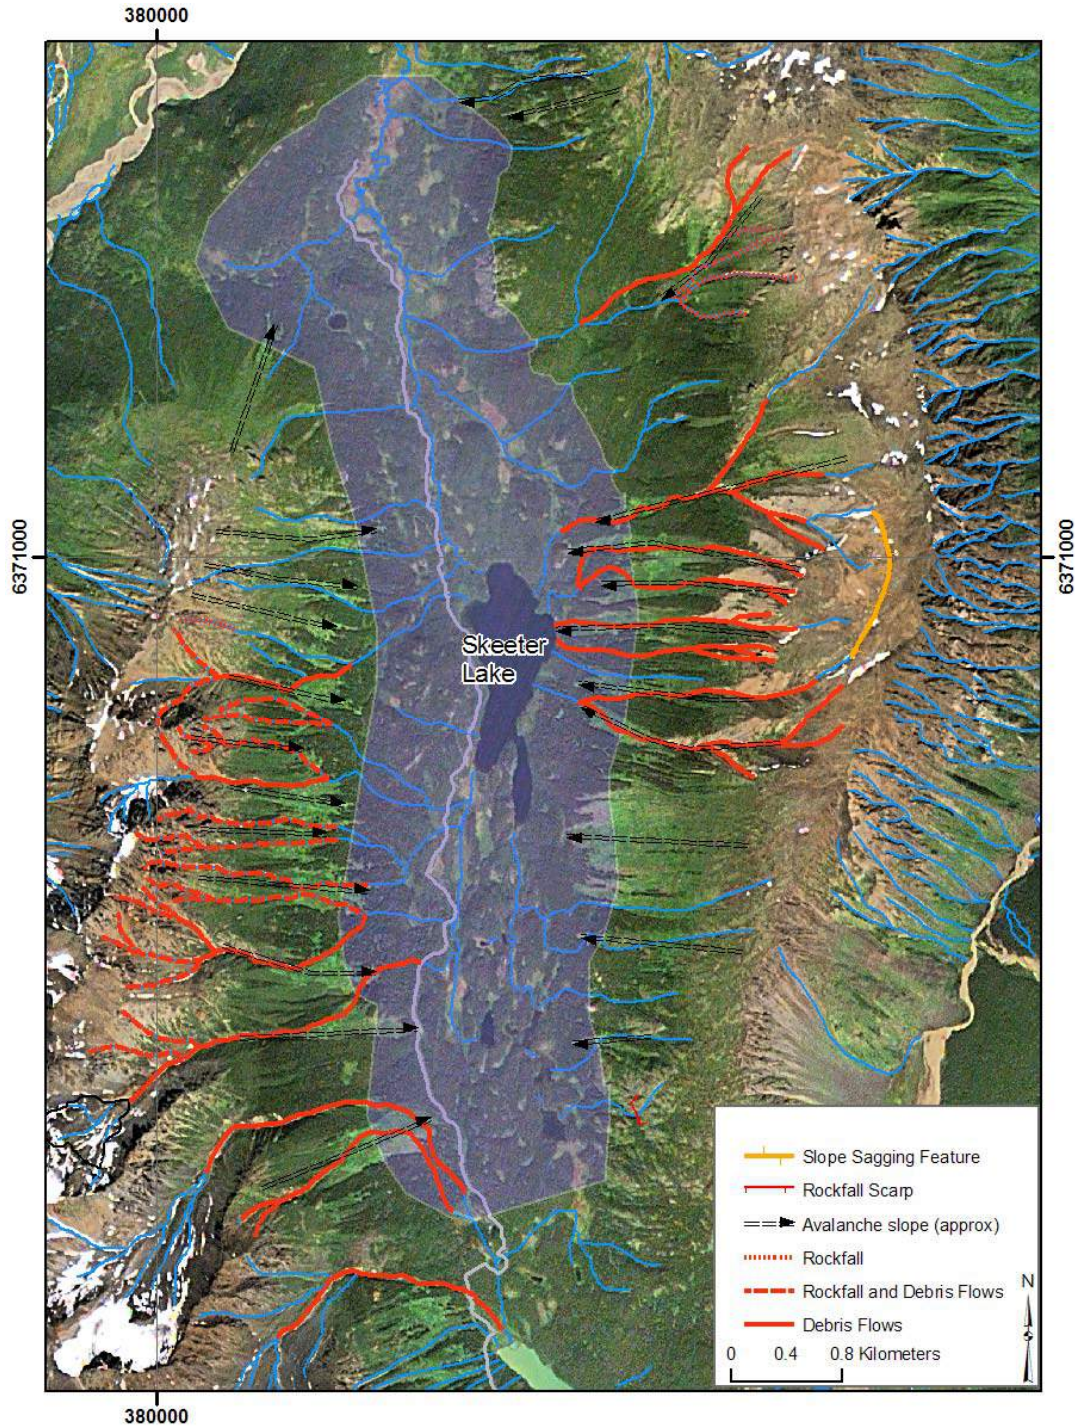
**Figure 2.1 Terrain Hazards, Tailings Option “A”.**

Geohazards with the potential to impact the tailings footprint are shown in Figure 2.1 and primarily include runout zones of snow avalanches and debris flows around the footprint perimeter. Gentle terrain in the middle of the tailings footprint is considered to have very low levels of geohazards.

A ~2000 m wide linear bedrock feature exists on the east side of the valley (orange line in Figure 2.1). Based on the position of the feature with respect to adjacent slopes, it is interpreted to have sagged several tens of metres relative to slopes above. No signs of recent movement are visible on the photos, and it is possible that the feature is very old (on the order of thousands of years and possibly associated with glacial debuttressing). Implications of rapid failure would likely include wave triggering and could be factored into tailings dam design. However, rapid failure of the block is considered very unlikely (less than 1/1,000). Further more detailed geological mapping and monitoring of slope movements (e.g. Interferometric Synthetic Aperture Radar (INSAR) and/or Differential GPS) would be required to test this hypothesis.

Hummocks and numerous disconnected depressions exist in the valley bottom throughout the footprint of the tailings area. Some depressions may be kettles formed from melting of stagnant glacial ice. However, discontinuous bedrock outcrops imply thin till cover and suggest the presence of sinkholes and karst terrain in underlying carboniferous bedrock. These landforms were also noted by Spooner (2007b). Combined with the presence of

extensional faults, this could represent a very significant hydro-geotechnical challenge for tailings design related to groundwater flow.

At Option A, implications of slope failure at the site interpreted as a sagged slope include damage to infrastructure, safety considerations, and the potential for wave generation in the tailings. However, the likelihood of rapid failure is considered very low. More detailed assessment and possibly slope monitoring is recommended at this site. BGC also recommends further investigation of karst landforms noted across the lower valley area of Option A, as their existence could present significant hydro-geotechnical challenge to tailings pond construction.

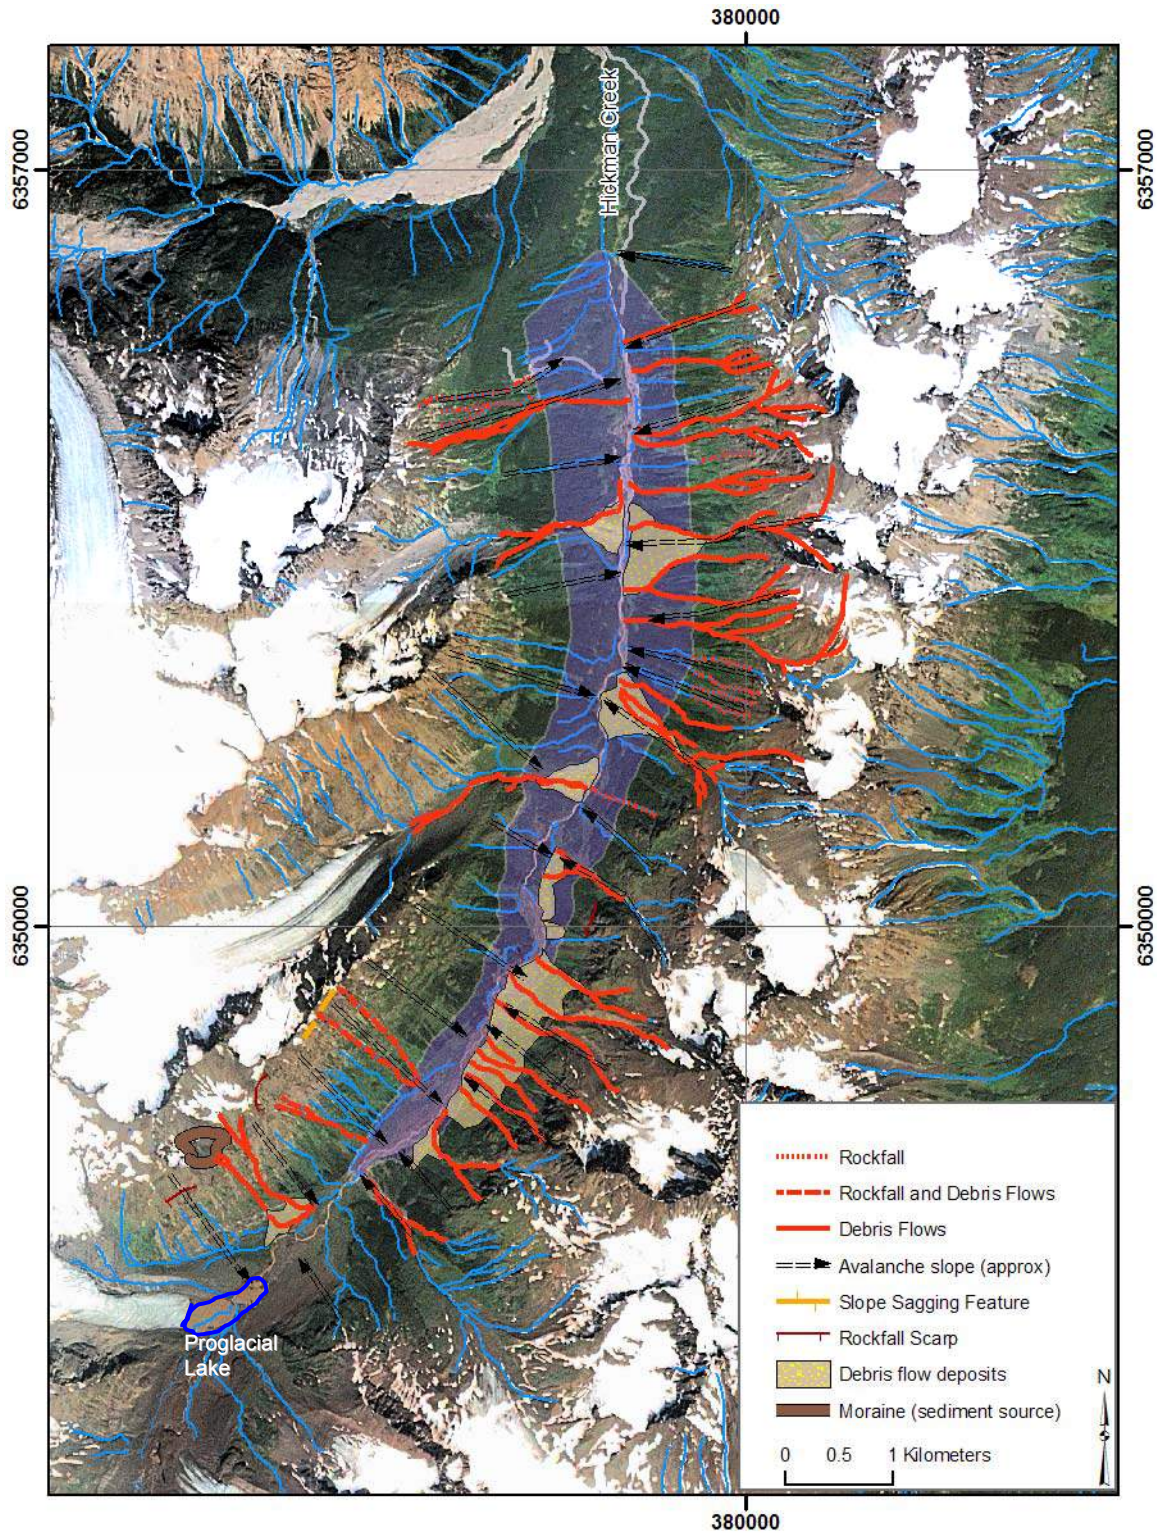
Figure 2.3 Terrain Hazards, Tailings Option B.

Geohazards with the potential to impact the tailings footprint are shown in Figure 2.3. Hazards include debris flows, rockfall, and snow avalanches.

Snow avalanches are the most frequent geohazard and occur on all slopes above the tailings footprint. Maximum avalanche runout zones extend to the middle of the valley and frequent ( $>1/\text{year}$ ) avalanches have the potential to reach the tailings footprint. Fragmental rockfall occurs on most steep rockslopes on both valley sides. Debris flow channels exist on both valley sides and have formed fan deposits at outlets of tributary channels, as shown in Figure 2.1. Based on the freshness of deposits, debris flow frequency is estimated as approximately 1:10 years. Linear features interpreted as slope sagging (sackung) were also identified on the uppermost west slope (orange lines on). These features are common in many glacially scoured valleys and do not show signs of active movement.

A small ( $\sim 0.2 \text{ km}^2$ ) proglacial pond exists below the glacier toe in upper Hickman Creek. This lake has approximately doubled in size since the early 1980's, based on comparison of TRIM and satellite data, and is dammed by a recessional moraine. Spooner (2007) observed that the moraine dam has previously been breached, and that accumulation of subglacial meltwater beneath Hickman glacier is unlikely due to its steep gradient. These factors limit the potential for future moraine dam outbreak floods at this site, and BGC's preliminary estimate is that outbreak flood hazard at this site is very low ( $<1/500$  annual probability). However, this location should be further assessed during summer fieldwork, including investigation of moraine dam stability and potential flood peak discharges, if this location is selected as the preferred tailings option.

At Options B and C, no landslide or snow avalanche geohazards were identified during this overview assessment that would preclude tailings construction or operation. However, snow avalanche and debris flow hazard could represent significant challenge to the design of drainage capture and diversion structures, if constructed around the tailings pond perimeter. In addition, more detailed assessment of the potential for moraine dam outburst floods is recommended at both sites.

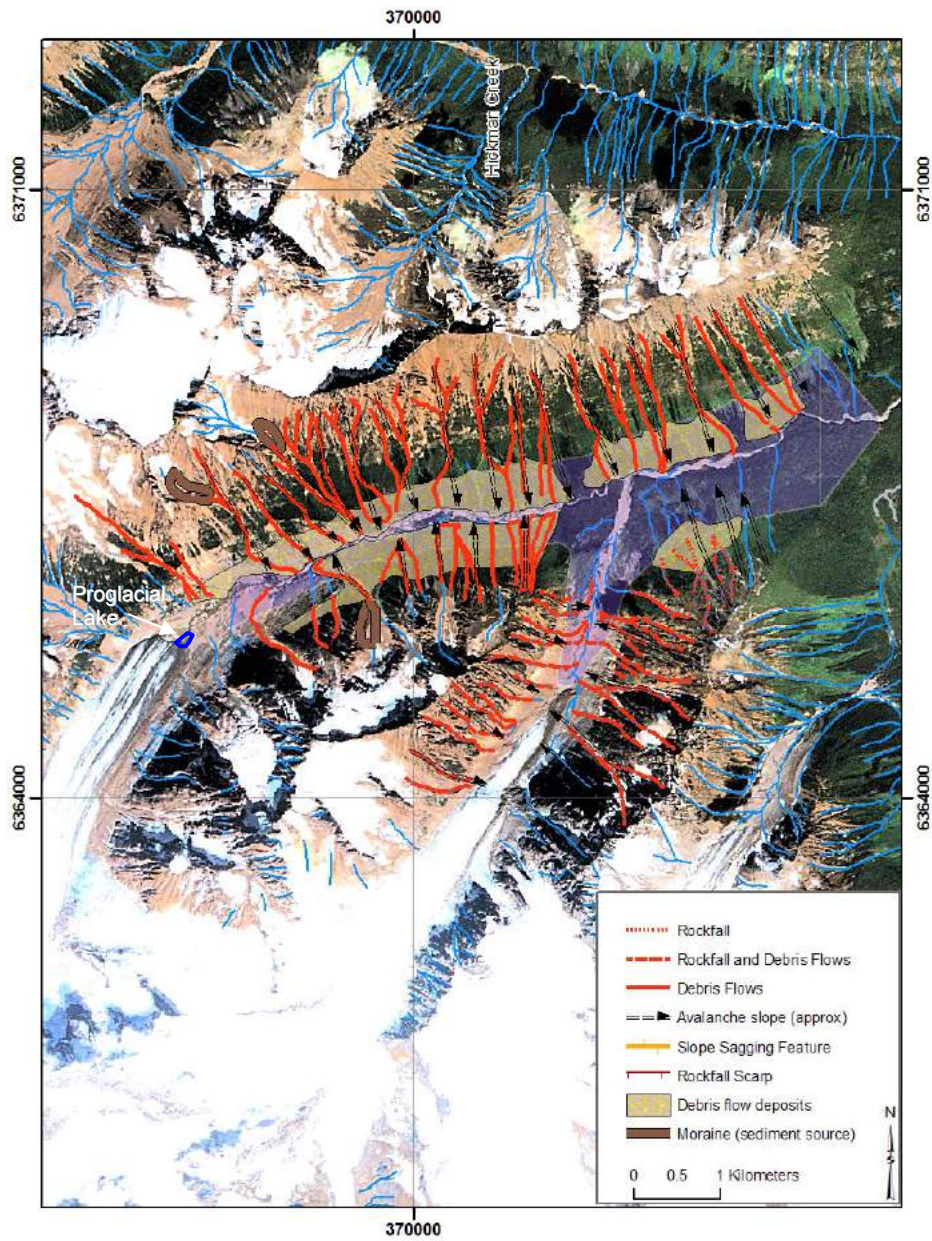
Figure 2.4. Terrain Hazards, Tailings Option C.

Geohazards with the potential to impact the tailings footprint are shown in Figure 2.4. Hazards include debris flows, rockfall, and snow avalanches.

Similarly to Tailings Option B, snow avalanches are the most frequent geohazard and occur on all slopes above the tailings footprint. Maximum avalanche runout zones extend to the middle of the valley and frequent ( $>>1/\text{year}$ ) avalanches have the potential to reach the tailings footprint. Fragmental rockfall exists on most steep rockslopes. Debris flow channels exist on north and south sides of the main valley, and have formed fan deposits that coalesce as a blanket along lower valley slopes. Based on the freshness of vegetation scars and deposits, frequency of debris flows intersecting the tailings footprint is estimated as approximately 1:10 years.

Glacial outburst flood hazard appears to be very low in the main sub-tributary. A very small ( $0.1 \text{ km}^2$ ) pro-glacial lake exists at the toe of the main tributary glacier. No evidence was identified on the airphotos to suggest previous moraine dam outburst floods at this site. However, the lake itself lies west of the available stereo airphoto coverage and would need to be visited in the field for further assessment of this potential hazard.
