Copper Fox Metals Inc.

**Geomorphic Channel Assessment and
Channel Migration Hazard Mapping of
Upper Mess Creek**

**Stephen Bird
Fluvial Systems Research Inc.**

January 2010

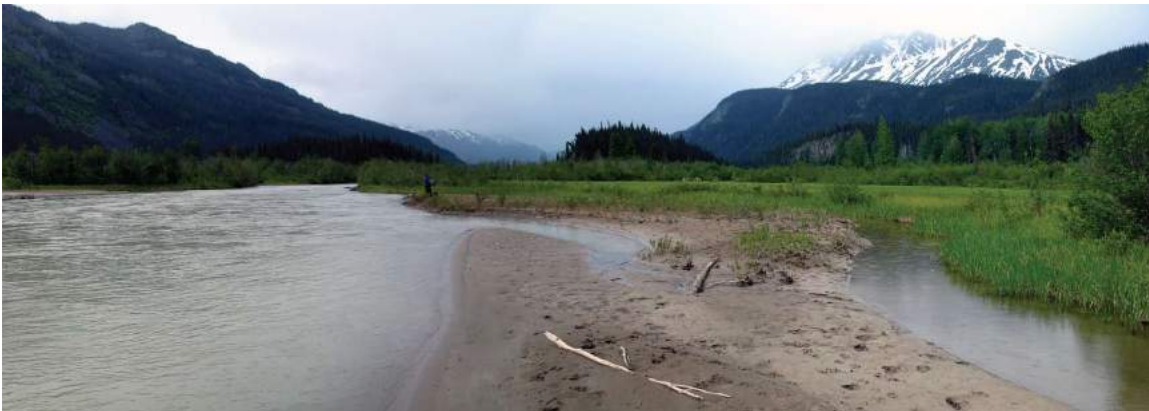
Figure 2. Photomosaic of upper Mess Creek looking upstream along reach M1-D with the Boundary Ranges on the right and the Tahltan Highland on the left. The surface texture of the bar in the foreground is dominated by silty sand. A floodbasin and associated wetland are seen along the right of the image.

Cordilleran ice during Pleistocene glaciations reached elevations in the area of about 2,000 to 2,100 m valley (Holland, 1964). During Fraser Glaciation (ca. 25-10 ka), ice flowed across the region in a southwesterly direction and crossed valleys such as Mess Creek at an oblique angle and did not follow local topography until the ice thinned, sometime after the climax of the glaciation (McCuaig and Roberts, 2002). Once sufficient thinning had occurred, ice was channeled along Mess Creek valley where terrain features were further modified and straightened (Holland, 1964). In general, peaks and ridges below the ice level are rounded, slopes are oversteepened, and the main valleys are U-shaped (Figure 2). There were two advances of

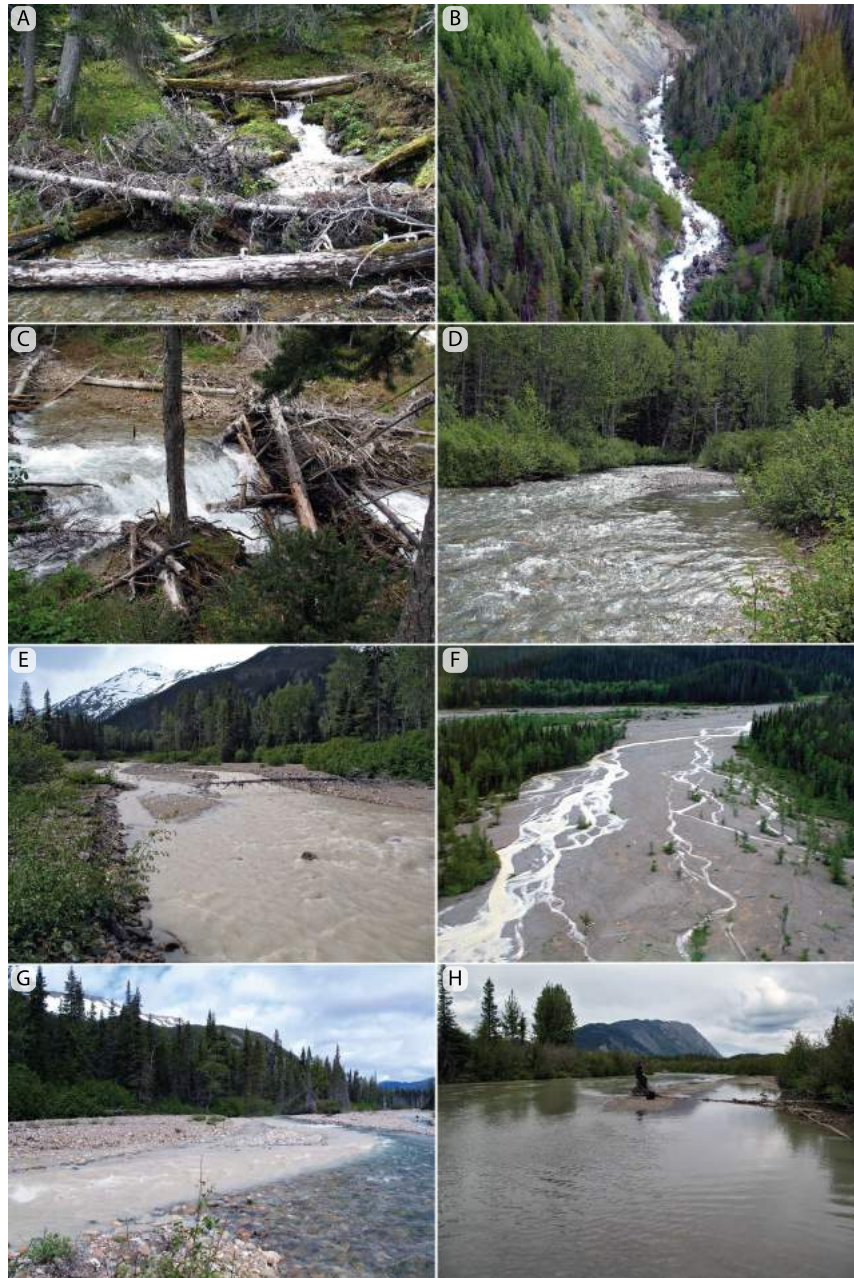
Figure 6. Photographic examples of channels that form part of the drainage network. a and b) Step-pool channels in sub-basins D and A, respectively. c) Large woody debris jam in a riffle-pool channel in sub-basin D. d) Riffle-pool channel near outlet of sub-basin C. e and f) Aggraded channels on fans of sub-basins E and F, respectively. g) Looking downstream at reach M-6 at the confluence of tributaries E and C (on left and right of the frame, respectively). h) Large, low gradient channel near the outlet of study basin (reach M-1).

The general morphometric properties of each sub-basin are given in Table 3 and discussed below. Examples of channels along the drainage network are given in Figure 6. Sub-basins A through C drain the Tahltan Highland, while sub-basins D through F drain the Boundary Ranges. Generally, the potential sediment yield to the mainstem of Mess Creek is greatest in sub-basins E and F. Both sub-basins contain relatively high proportions of ice, and recent glacial retreat has exposed large areas of morainal sediments. Glacial outwash and slope processes transfer sediment directly to the respective channels (i.e., the hillslopes are coupled to the channel network), while unvegetated, proximal sediments may be readily mobilized by the channels during high streamflow events (see section 2). In addition, both sub-basins contain relatively high amounts of steeppland and a steep main channel, and these provide a route for sediment transfer from distill portions of the sub-basins and leading to the mainstem channel. Both sub-basins have built relatively large fans that prograde onto the Mess Creek floodplain.

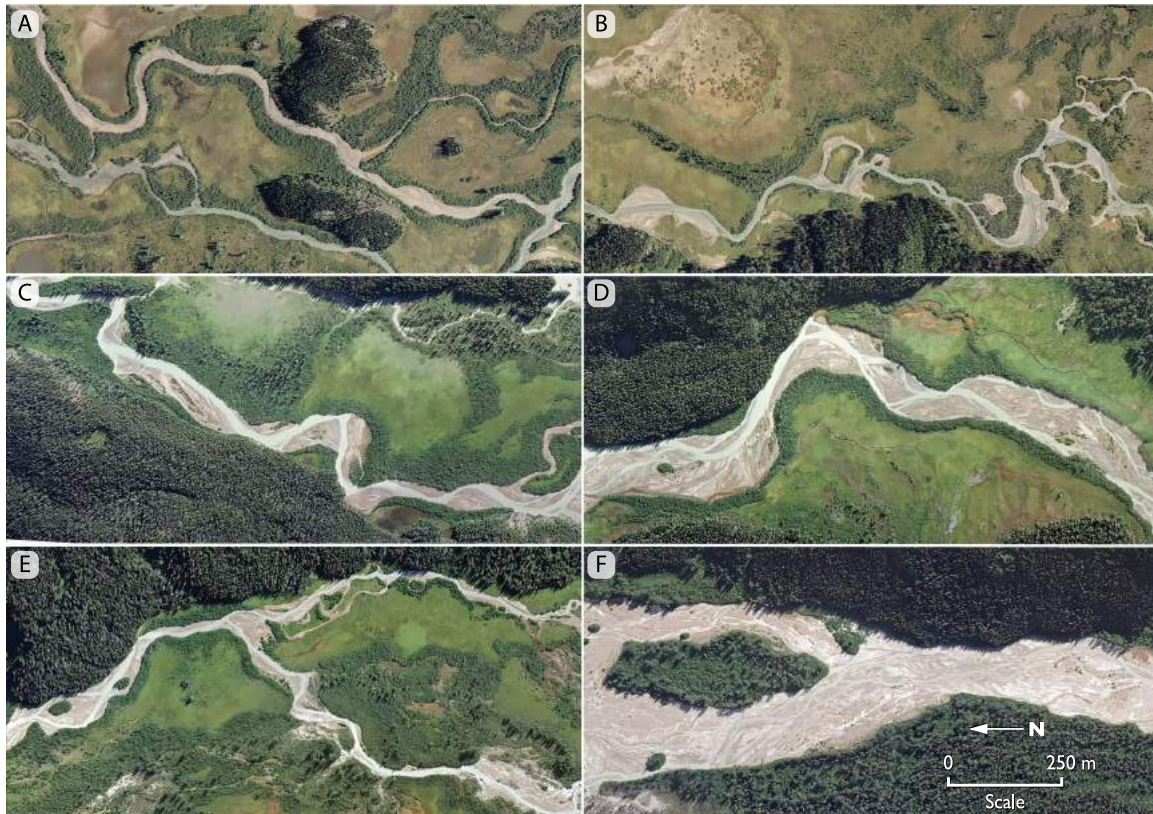
Figure 8. Pictorial illustration of channel reaches along the mainstem channel of Mess Creek, including a) M1, b) M2, c) M3, d) M4, e) M5, and f) M6. Flow is from right to left. Imagery was subset from orthoimages acquired in 2006 by Copper Fox. Note that the images do not show the entire reach but highlight differences in channel morphology that characterize each reach (refer to text for discussion).

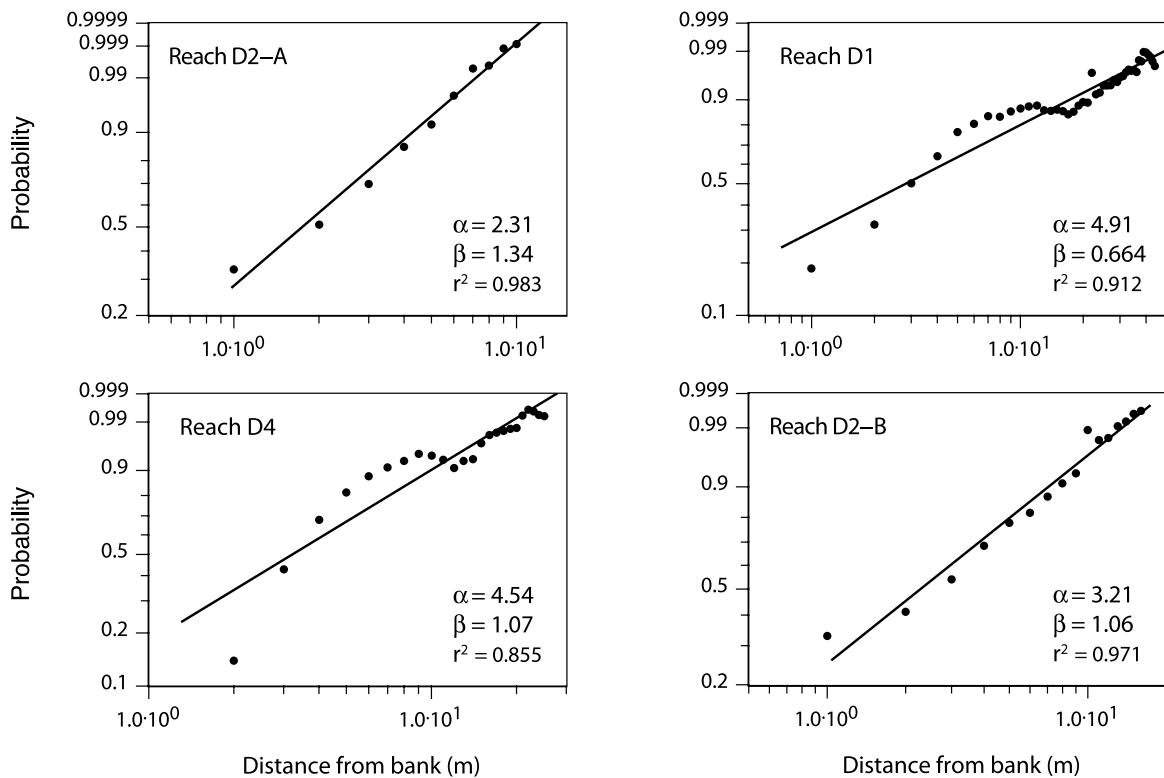
Figure 16. Weibull probability plots describing floodplain stability for select reaches in sub-basin D over the next 50 years.

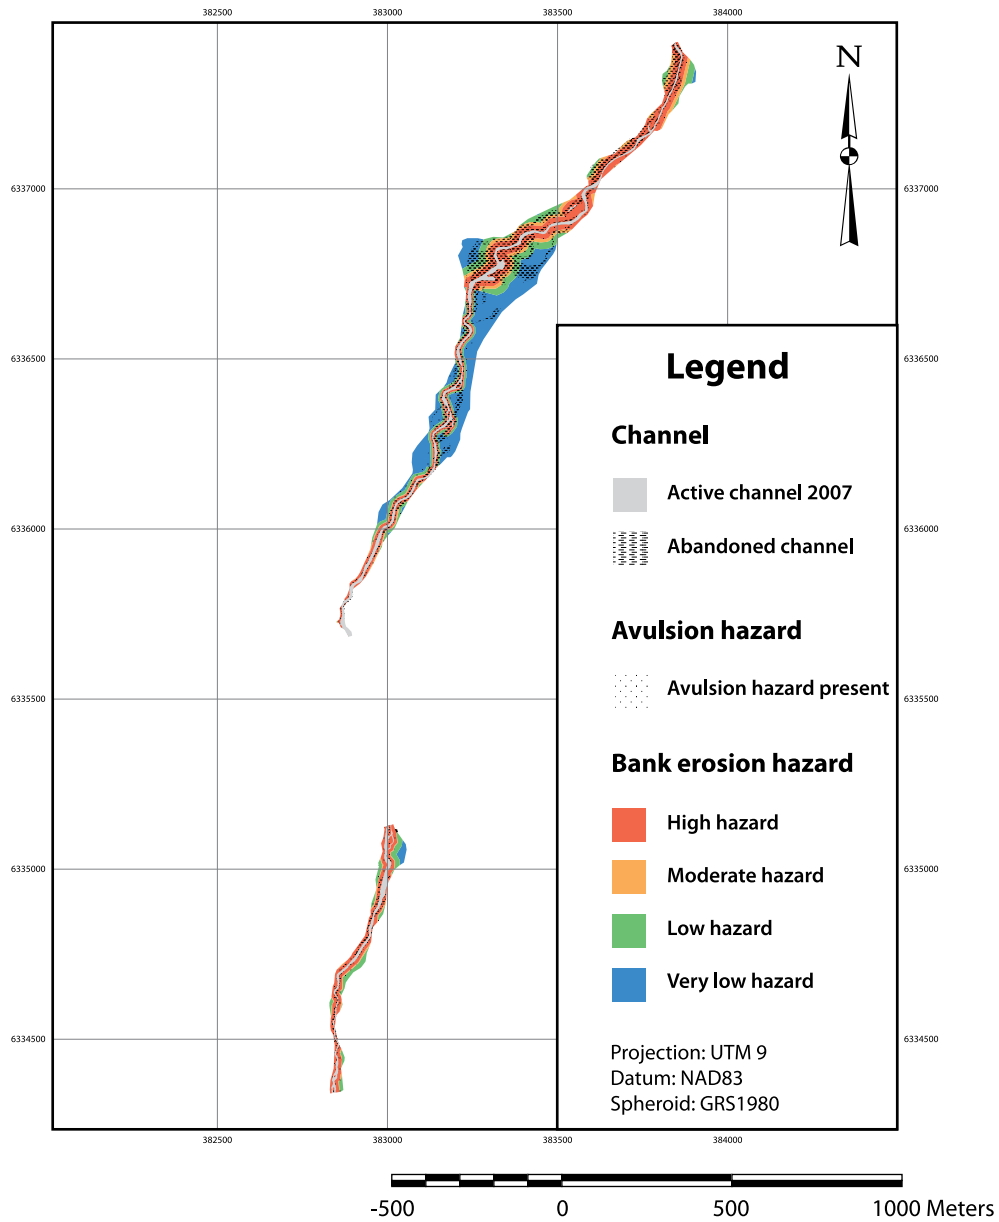
Figure 18. Channel migration hazard map for sub-basin D (location of the reach breaks is given in Appendix A). Refer to the pocket for a large-scale version of this figure.

Bank erosion and avulsion hazards were combined into a single channel migration hazard map that illustrates areas of the floodplain along a portion of reach M1 and areas of the valley bottom along reaches D1, D2, and D4 susceptible to erosion over the next 50 years (relative to the relevant imagery acquired in either 2006 or 2007). Small-scale versions of the maps are presented in Figures 17 and 18, while large-scale

versions are included in the pocket. The channel migration zone is bound by the projected extent of bank erosion and/or the avulsion hazard zone and is relative to the current location of the channel banks and meander belt axis (again, as depicted in the relevant imagery acquired in either 2006 or 2007). The bank erosion hazard is ranked as very low, low, moderate, or high based on a quantitative assessment of bank erosion rates (see section 5.3), while the avulsion hazard is identified as a singular zone where avulsions are most likely to occur based a qualitative assessment of channel geometry and past locations of the channel on the floodplain or valley bottom (see section 5.4). The avulsion hazard is otherwise not ranked (e.g., low, moderate, high, etc.) given our inherent inability to predict the occurrence and characteristics of avulsions (Slingerland and Smith, 2004).

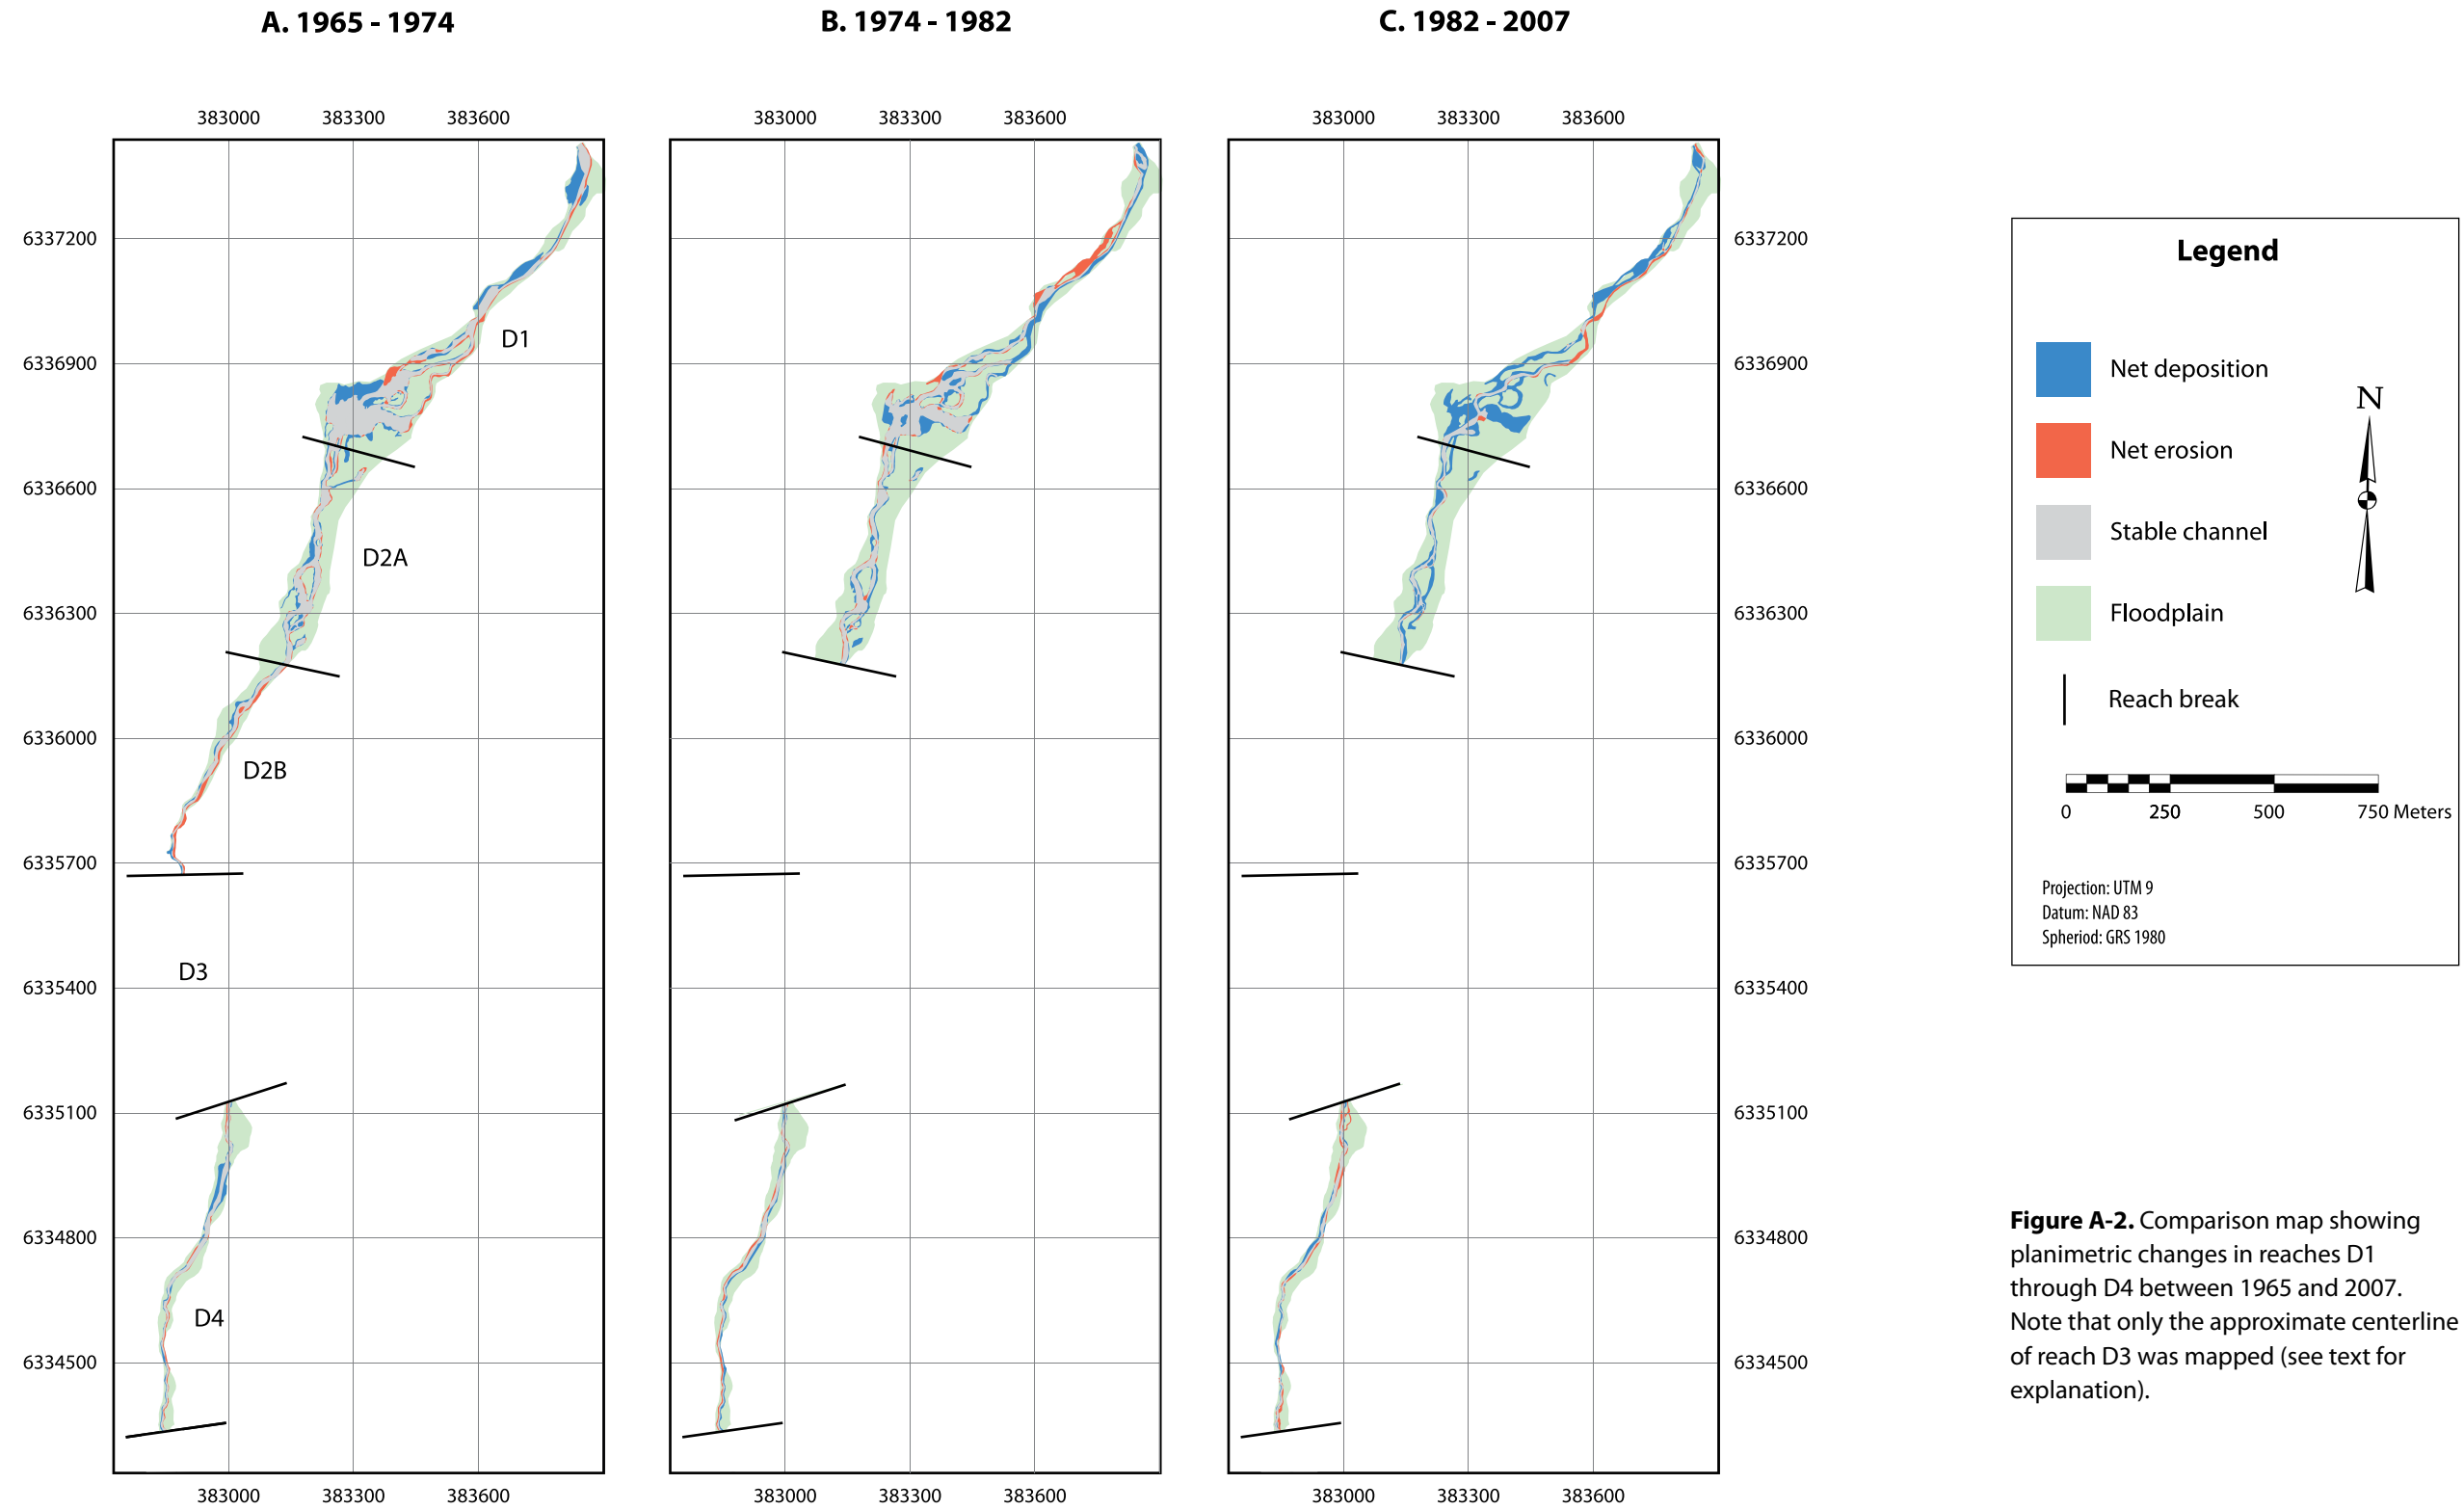
Figure A-2. Comparison map showing planimetric changes in reaches D1 through D4 between 1965 and 2007. Note that only the approximate centerline of reach D3 was mapped (see text for explanation).
