Schaft Creek Fisheries Baseline 2007

Rescan Tahltan Environmental Consultants
Vancouver, British Columbia

March 2008

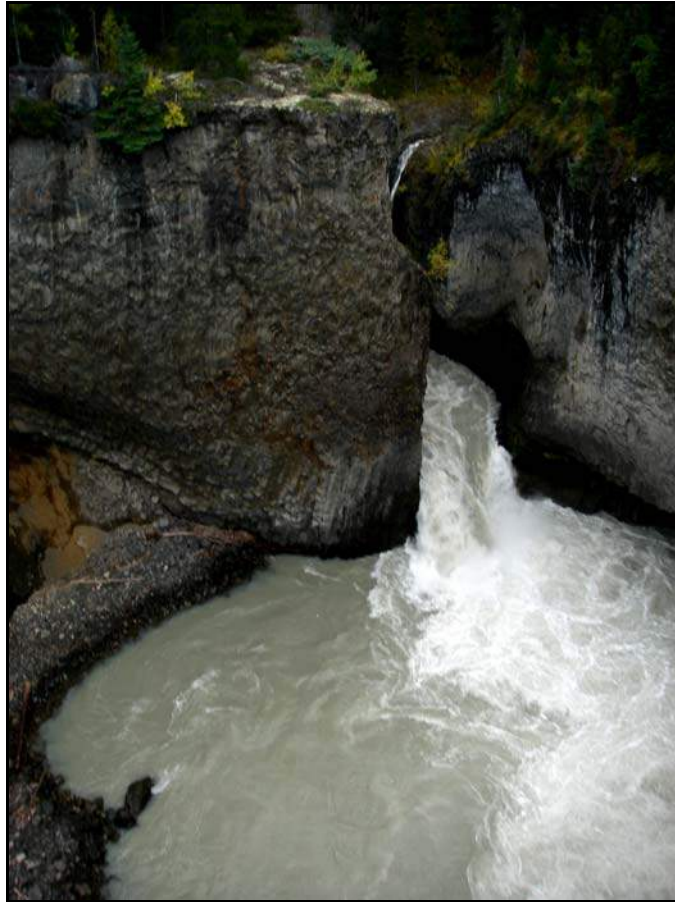
Plate 3.2-1. 6 m waterfall on Mess Creek, looking upstream.

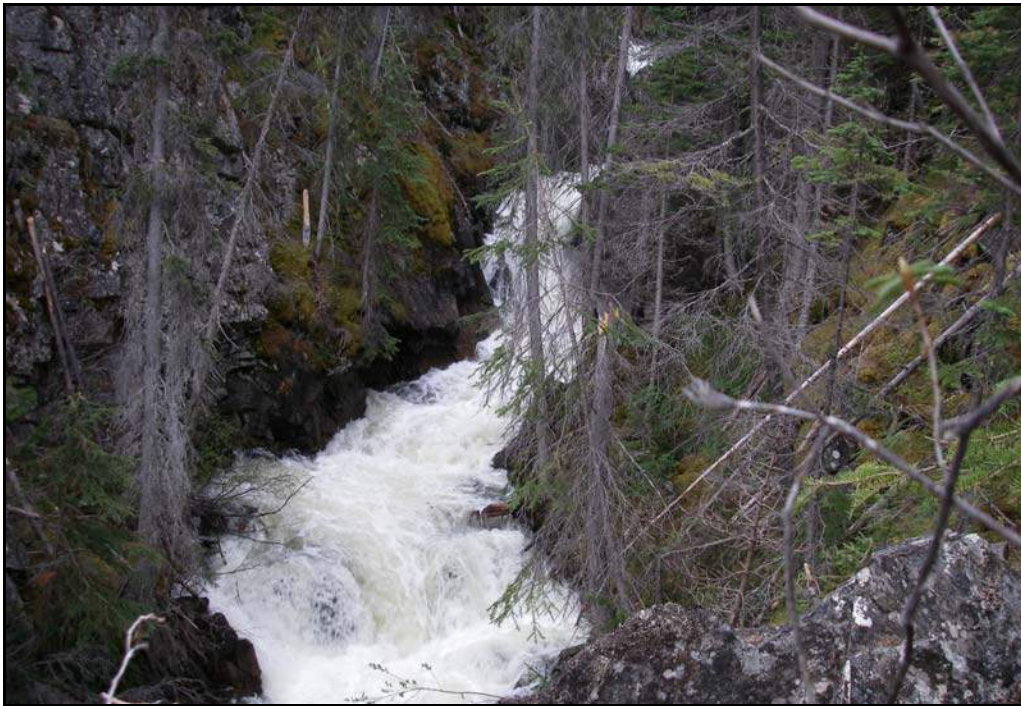
Plate 3.2-3. 30 m waterfall on Skeeter Creek near the outlet to Schaft Creek.

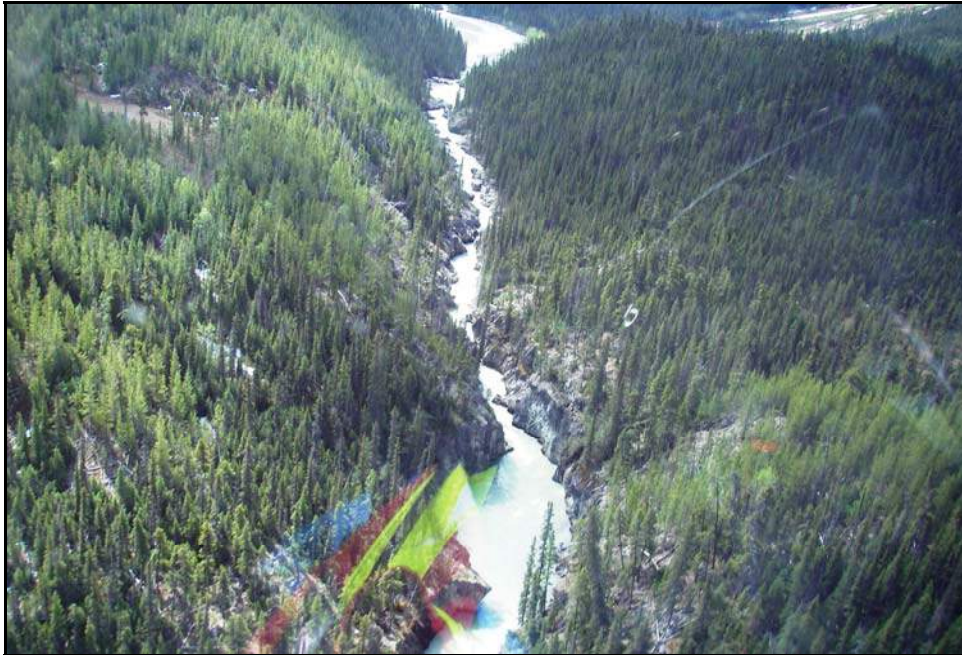
Plate 3.2-4. Cascade barrier on Schaft Creek, near the confluence with Tailings C Creek.

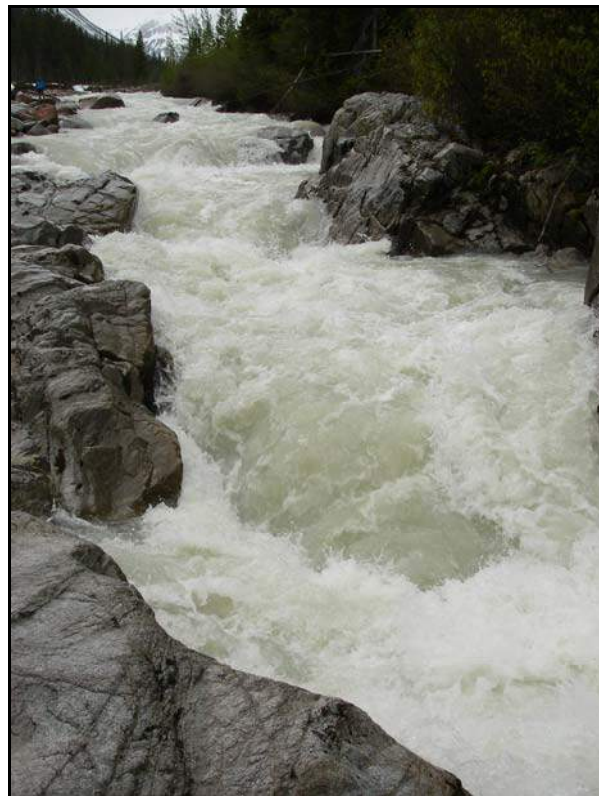
A potential fish barrier was located on Tailings C Creek in 2007. This barrier consists of a bedrock chute, approximately 80 m long, with numerous 1 to 2 m drops (Plate 3.2-5). Flow is fast and turbulent through this stream section. The bankfull width of this area was much wider

than the wetted width at the time of the survey, and it was obvious that water occasionally flows around this chute. Fish density on this stream, even below the barrier, is low due to poor habitat and cold water temperature, and fish sampling has only been conducted at two locations above this reach twice in 2007. Therefore, it is not possible at this time to confirm that this chute acts as a true barrier to fish migration. Other factors, which include habitat quality and water temperature, may also play a role in limiting fish distribution in this watershed. Continued sampling in 2008 will aid in confirming the fish-bearing status of the upper reaches of Tailings C Creek.

Plate 3.2-5. Possible cascade barrier on Tailings C Creek.

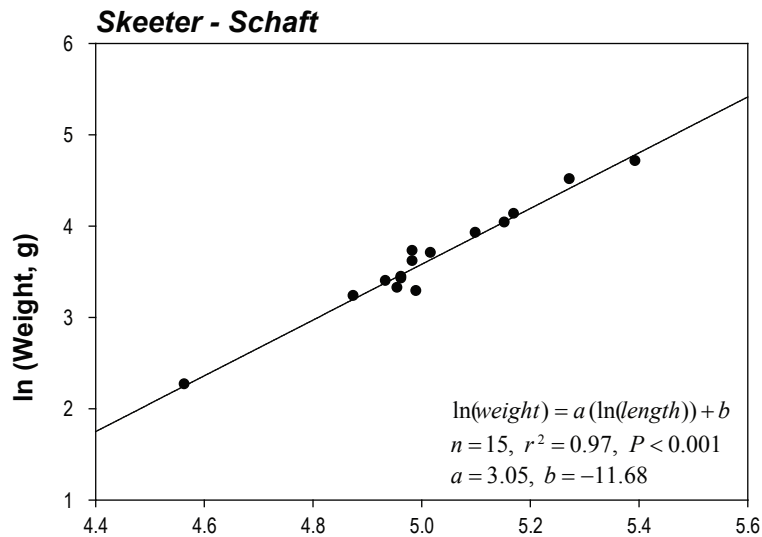
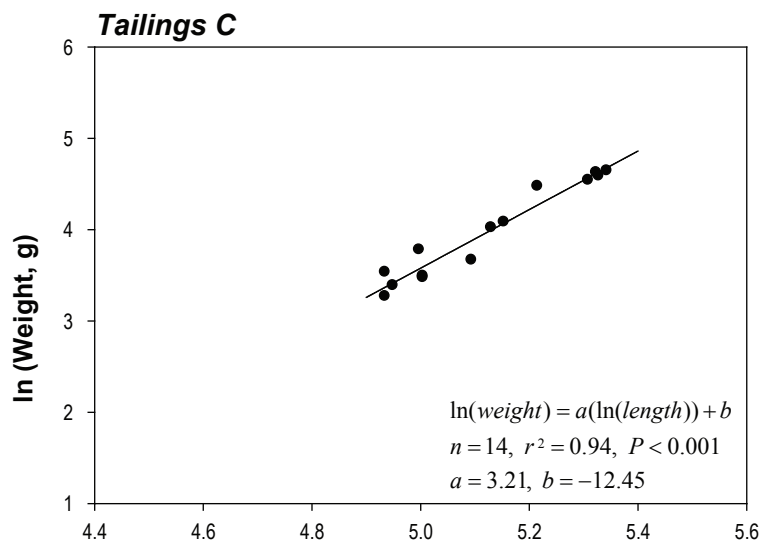
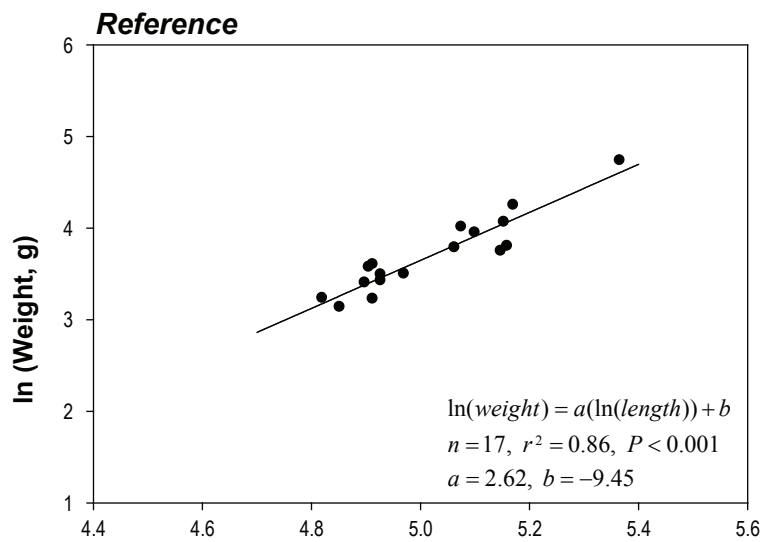
Energy storage was assessed using measures of fish condition. Figure 3.2-33 presents weight-length regressions for rainbow trout captured from the three MMER watersheds. The slopes of the weight-length regressions for fish sampled from the MMER watersheds were not significantly different among sites (GLM, $F_{2,44} = 1.81$, $P = 0.18$), and weight-at-length did not differ significantly (ANCOVA, $F_{2,42} = 0.72$, $P = 0.50$). Similarly, mean rainbow trout condition did not differ significantly among the three groups (ANOVA, $F_{2,43} = 0.75$, $P = 0.48$) (Figure 3.2-34).

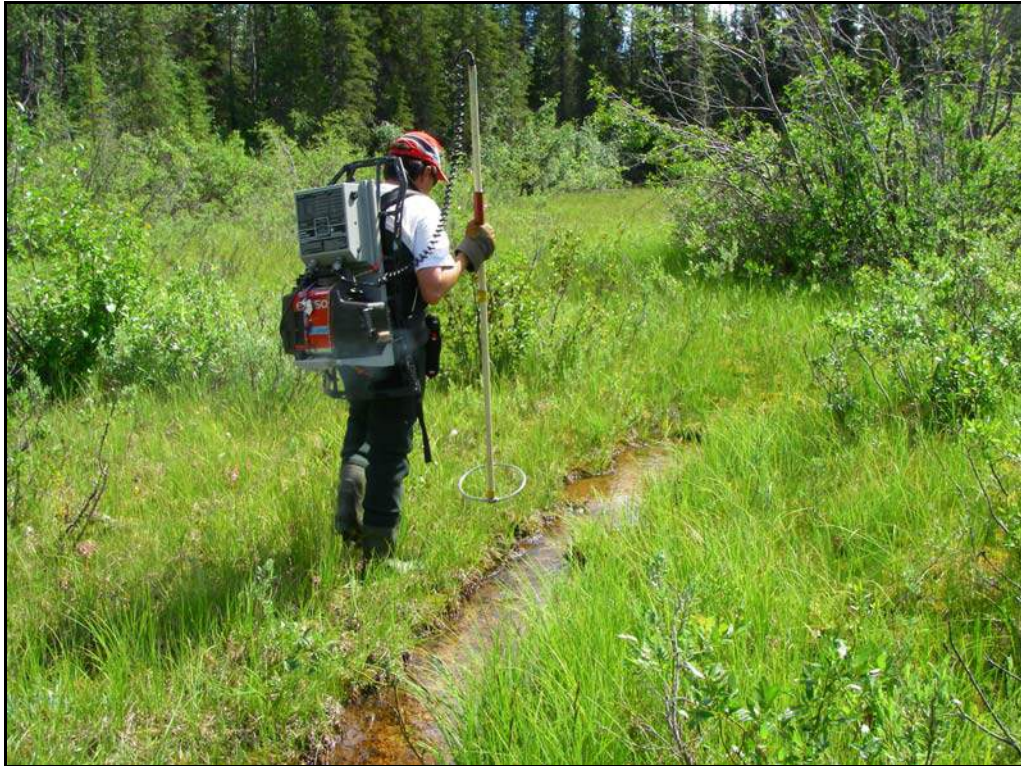
Plate 3.2-6. Electrofishing one of the poorly defined stream channels in wetland 10.

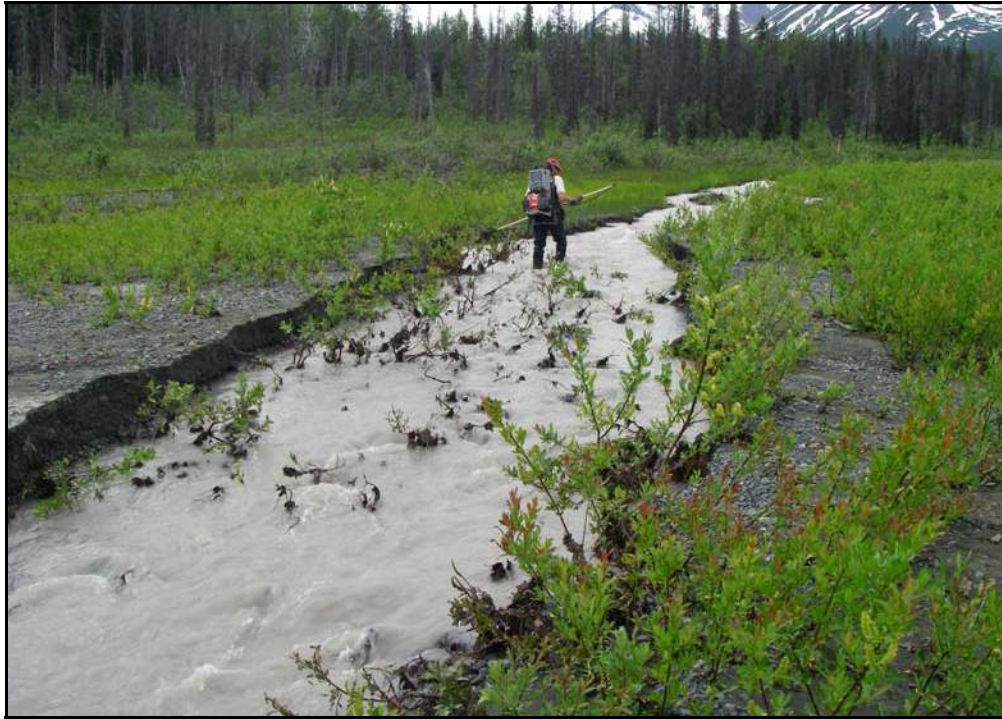
Plate 3.2-8. Stream channel running through wetland 8.

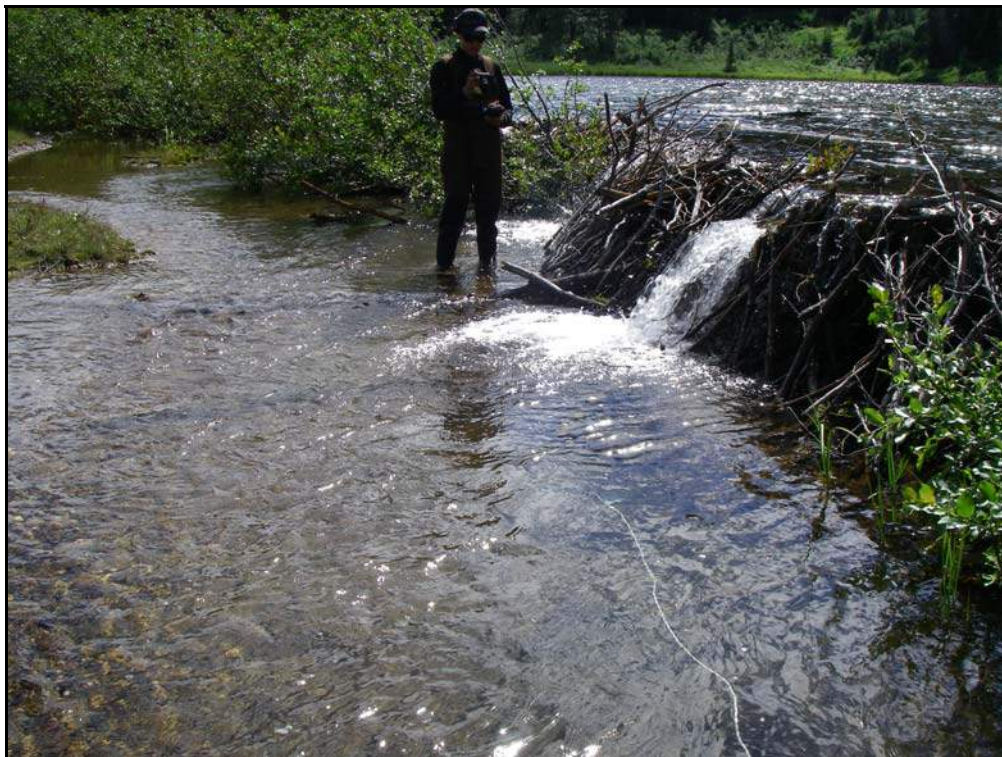
Plate 3.2-9. Example of good rearing habitat (abundant cover, good flow and depth) at wetland 9.

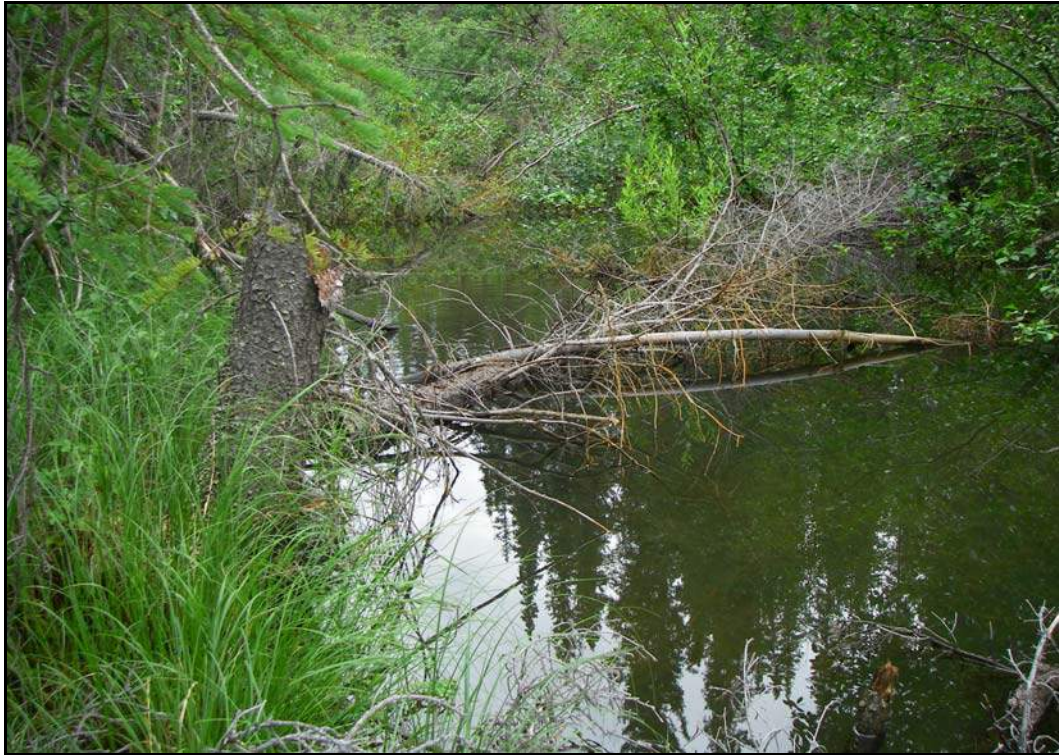
Plate 3.2-10. Deep overwintering habitat at wetland 2.

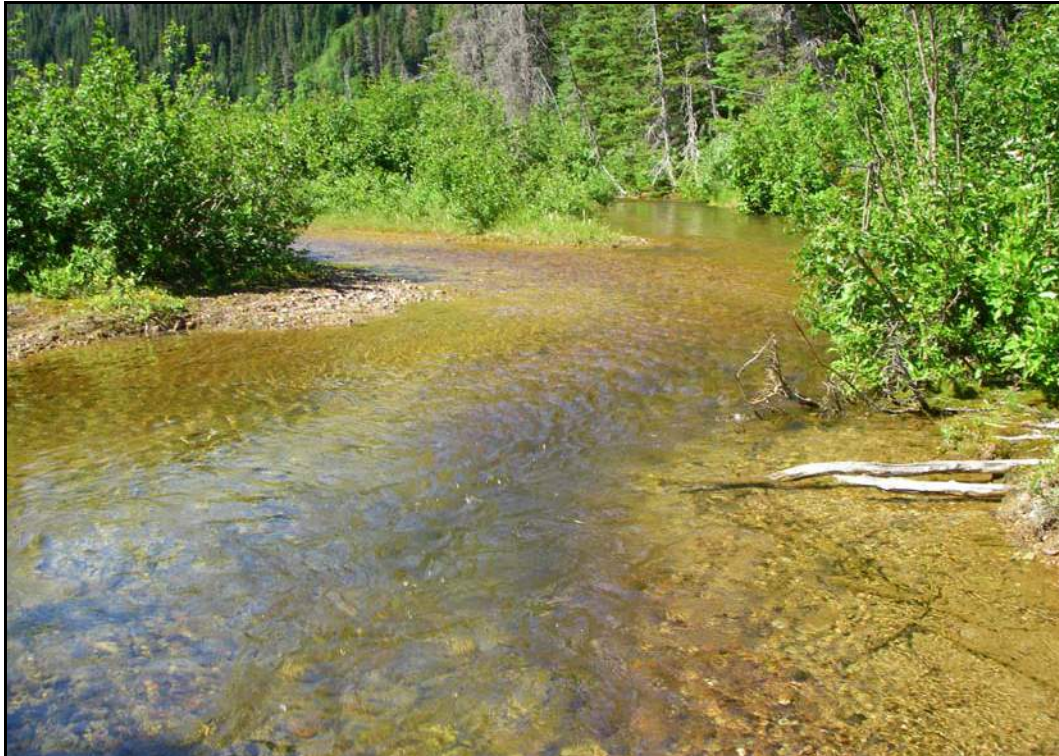
Plate 3.2-11. Excellent spawning habitat at the outlet of wetland 9.

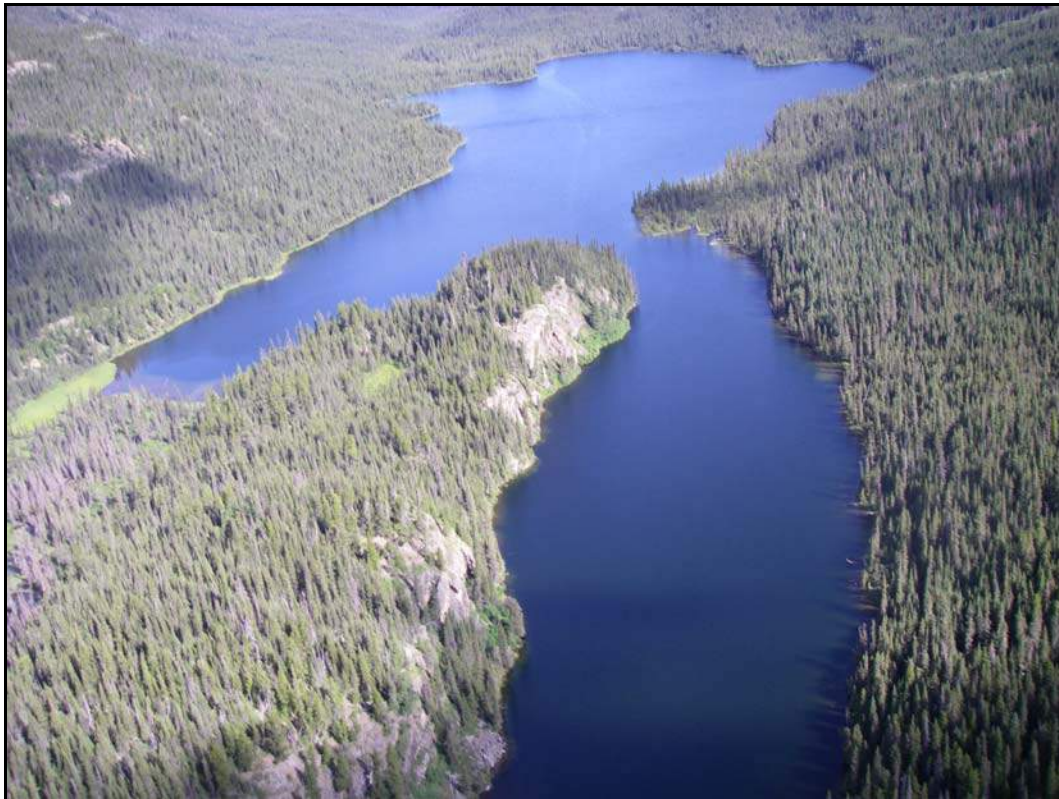
Skeeter Lake is a relatively deep, clear lake located on Skeeter Creek in a valley between Schaft Creek and Mess Creek (Plate 3.2-13). It falls within the footprint of one of the proposed tailings facility options. The maximum depth of the lake was measured at 40 m in July 2007. The surface temperature at the time of sampling was 12°C, the conductivity was 160 µS/cm and the pH was measured as 9.8. This is a very high value for pH and may have resulted from a malfunctioning meter. Fine substrates dominate the shoreline around most of the lake, with sporadic patches of gravel-dominated shoreline (Figure 3.2-48). A total of eight inlet streams were identified around Skeeter Lake, five of which contain habitat suitable for spawning and/or rearing salmonids. The main inlet and outlet is the mainstem of Skeeter Creek, which has been sampled as part of the receiving environment and contains excellent spawning, rearing and overwintering habitat. The outlet stream in particular flows at a low gradient through a wetland with abundant deep pools, gravel substrate and cover.

Cover in the lake is provided by large woody debris along the shoreline, as well as deep water and occasional boulders (Figure 3.2-49). Some aquatic vegetation is present near the inlet and outlet streams. Habitat quality in Skeeter Lake is good, with good cover and abundant spawning and rearing habitat in adjacent streams.

Plate 3.2-13. Aerial view of Skeeter Lake facing north.

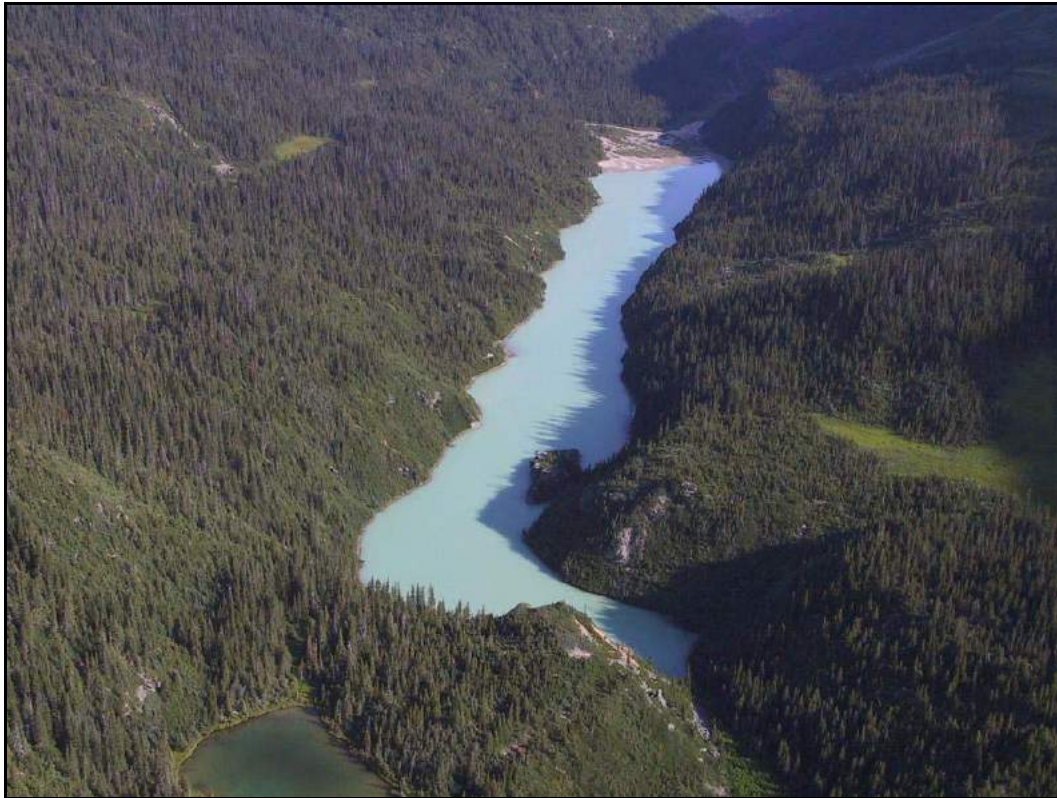
Lake 3 is a long, narrow lake at the headwaters of Mess Creek. It is located in the sub-alpine zone and is clouded by glacial sediment (Plate 3.2-14). The maximum depth measured in July 2007 was 12 m, the surface temperature was 6.5°C and the conductivity and pH were not recorded. Because of the steep shore and high turbidity, the amount of the littoral zone that was visible was very narrow. Shoreline substrates, where visible, were dominated by cobble substrate, followed by gravel and fine sediments (Figure 3.2-50). Some sections of the shoreline had a high abundance of bedrock substrate. Nine tributaries to Lake 3 were identified during the shoreline survey, three of which contained suitable spawning habitat for salmonids. The rest of the tributary streams were steep and rocky, containing no suitable habitat for any salmonid life stage.

The shoreline of the lake provides little cover due to the steeply sloping banks and low LWD abundance (Figure 3.2-51). Habitat quality in the lake is poor to fair due to the absence of cover and high turbidity; however, the presence of adjacent spawning habitat make it a possibility for fish rearing and overwintering.

Plate 3.2-14. Aerial view of Lake 3 looking north.

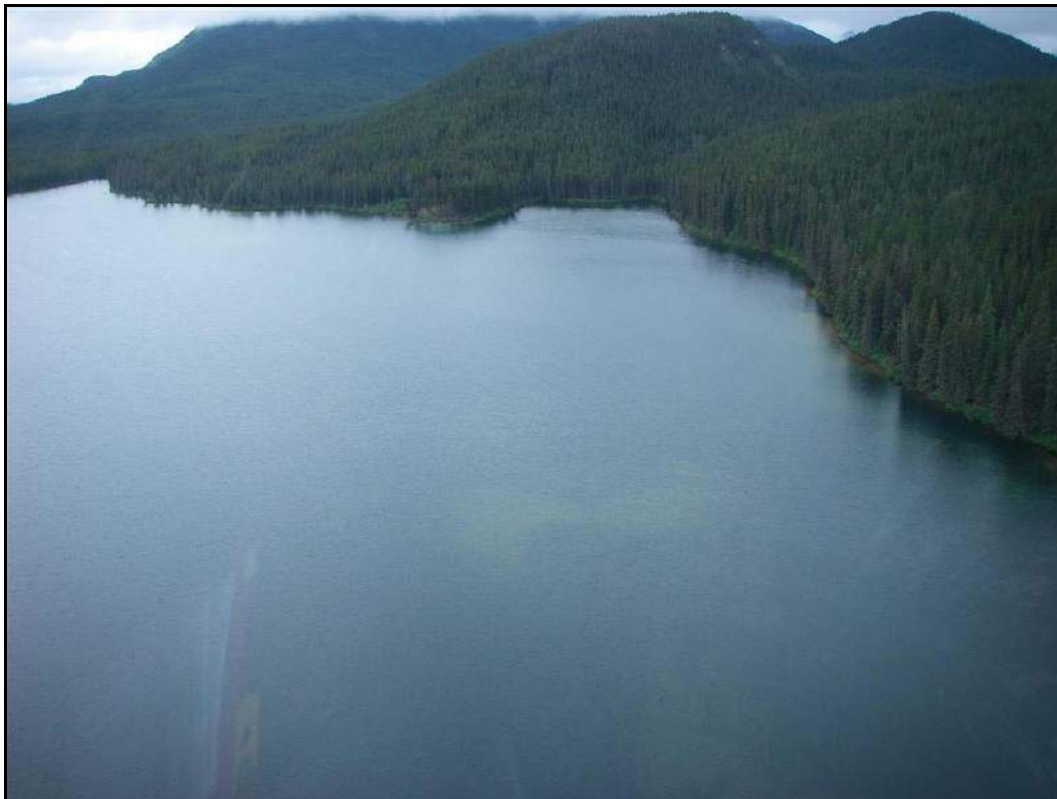
Lake 4 is a large, clear, relatively shallow lake that is located on the plateau between Schaft Creek and Mess Creek, approximately 22 km north of the Project site (Plate 3.2-15). It was surveyed as a reference lake in 2006 and 2007. The maximum depth of the lake was measured as 5.5 m in July 2007, the surface temperature was 15°C, the surface conductivity was 170 µS/cm and the pH was 9.1. The pH may have been overestimated due to a malfunctioning meter. The shoreline substrate of the lake varies widely. The eastern shore is dominated primarily by fine sediments, with smaller proportions of gravel and cobble (Figure 3.2-52). The northwestern section of the lake has cobble and gravel shoals that extend far from the shoreline. Cobble and gravel dominate the southwestern shoreline. Two inlet streams were identified during the shoreline survey. These were small streams with low flow, and may provide fair rearing habitat; however, no spawning habitat was observed. The outlet stream flows from the southeast corner of the lake and is dominated by cobble and fine sediment. It may provide fair to good rearing habitat, but poor spawning habitat.

Cover in the lake is provided by a small amount of aquatic vegetation, large woody debris and occasional boulders along the shoreline (Figure 3.2-53). Habitat quality is generally fair to good due to the size and depth of the lake; however, the lack of nearby spawning habitat may be limiting.

Plate 3.2-15. Aerial view of the northeast section of Lake 4.

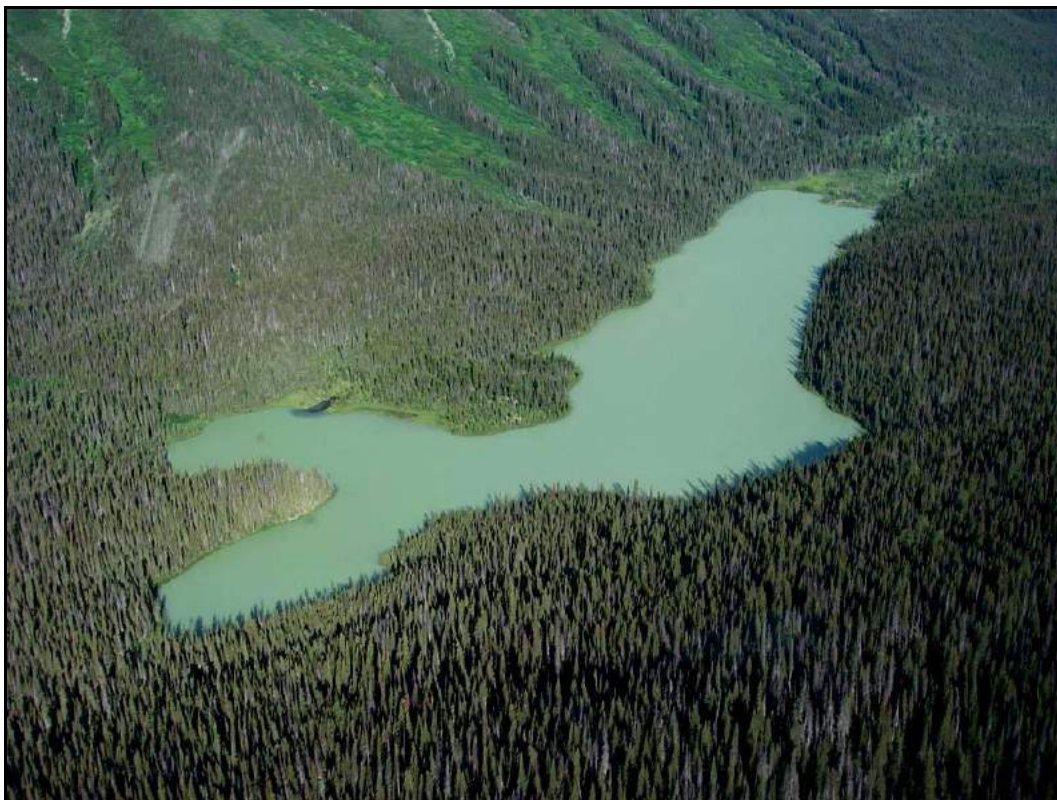
Start Lake is a moderately sized, deep, turbid lake located in the southern part of the Skeeter Valley, between Schaft Creek and Mess Creek (Plate 3.2-16). It empties to the south, eventually draining into Mess Creek. The maximum depth measured in July 2007 was 35 m, the surface temperature was 9°C, the conductivity was 140 µS/cm and the pH was not recorded. The shoreline substrate of the lake varied widely and included sections dominated by cobble, gravel and fine sediment (Figure 3.2-54). Most of the northeastern shore of the lake is dominated by cobble and gravel substrates. The southwestern shore of the lake is dominated by cobble and fine sediment, with patches of boulder substrate. Eight inlet streams were identified, three of which contain habitat suitable for salmonid spawning. Some of the other inlets also have fair to good rearing habitat. The main inlet to the stream at the north end is turbid, and likely supplies most of the glacial sediments that cloud the lake; however, most of the other tributaries are clear.

Cover is provided by the high turbidity and depth, as well as by large woody debris and boulders along the shoreline (Figure 3.2-55). Some aquatic vegetation is present near the inlet streams. Habitat quality in the lake is fair to good due to the depth, abundant cover and presence of suitable spawning habitat in the tributary streams.

Plate 3.2-16. Aerial view of Start Lake looking towards the northwest.

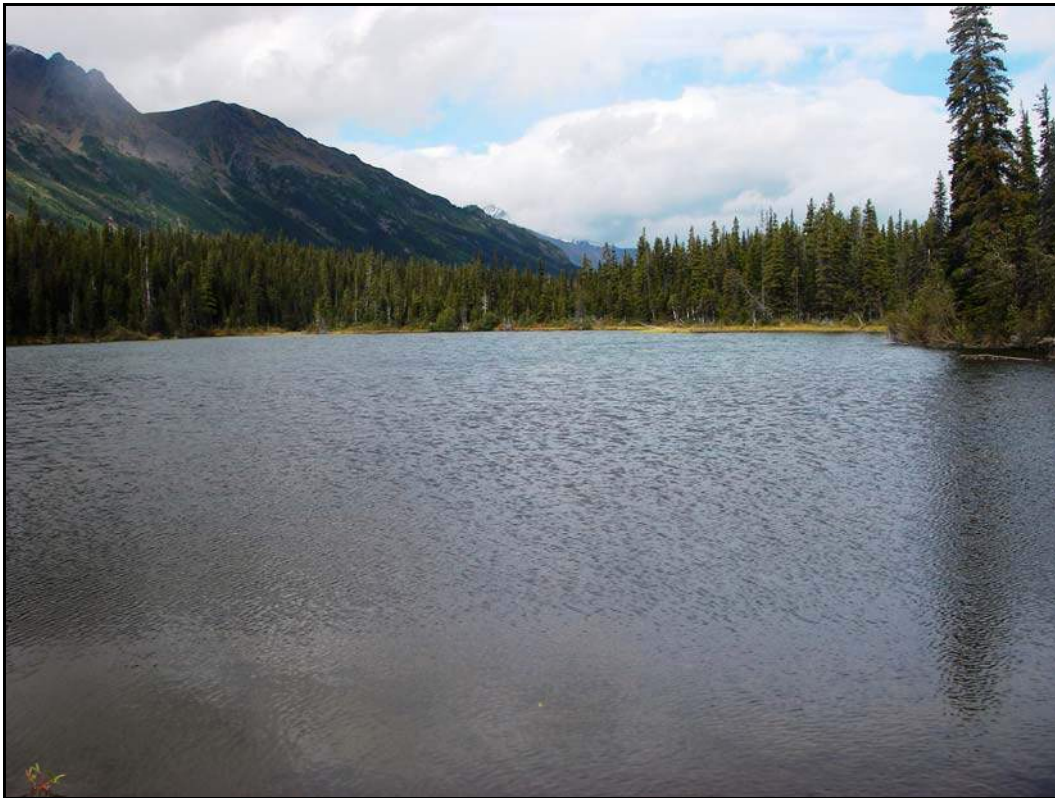
Plate 3.2-17. Lake 6 looking towards the northwest.

Lake 6 is a small, shallow, tannin-stained lake in the Skeeter Valley, located near the height of land that separates the northward-flowing waters from the southward-flowing waters (Plate 3.2-17). This lake drains south, eventually flowing into Start Lake, then into Mess Creek. The maximum depth measured in this lake was 1.7 m in 2007. The surface temperature in July 2007 was 16°C, the conductivity was 130 µS/cm and the pH was 9.1. The pH may have been overestimated due to a malfunctioning meter. The lakeshore is dominated by fine substrates, as is the lake bottom. A small patch of cobble substrate is present on the west shore near the constriction (Figure 3.2-56). Only one inlet and one outlet stream was recorded during the shoreline survey. Both streams are dominated by fine sediment and low flow, and may provide poor to fair rearing habitat for salmonids.

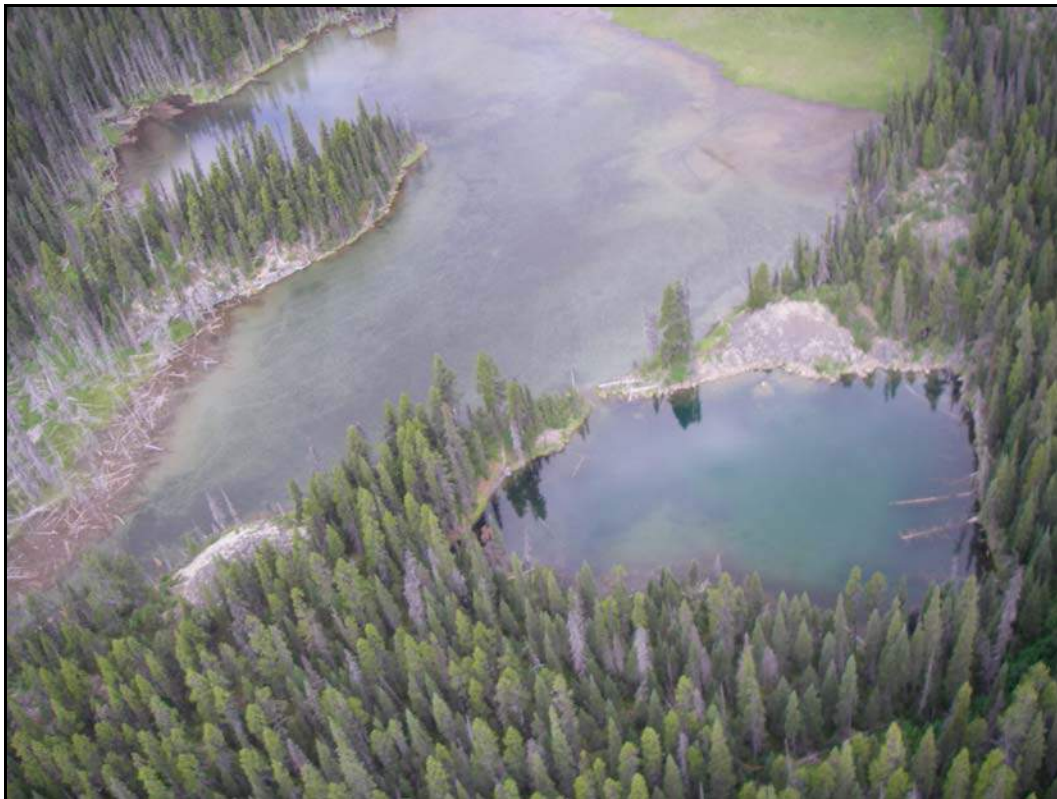
Lake 7 is a small, shallow pond located close to Start Lake (Plate 3.2-18). It drains south, flowing into Start Lake, then eventually into Mess Creek. The maximum depth of the lake was measured as 1.3 m in July 2007. The surface temperature at the times of sampling was 9°C, the conductivity was 130 $\mu\text{S}/\text{cm}$ and the pH was 8.9. The pH may have been overestimated due to a malfunctioning meter. Most of the lakeshore and bottom are dominated by fine substrates, with exceptions near the small lagoon at the east side of the lake, where cobble substrate was common (Figure 3.2-58). A sedge wetland occupies the north shore of the lake. Four tributaries were identified around the small lake, including one that contained suitable habitat for spawning.

The shallow depth and clarity of this lake do not provide much cover. Shelter is mainly provided by large woody debris along the shoreline (Figure 3.2-59). Habitat quality is fair to good along the margins where cover is abundant, but poor in the middle due to the shallow depth and lack of shelter.

Plate 3.2-18. Aerial view of Lake 7 looking towards the northwest.

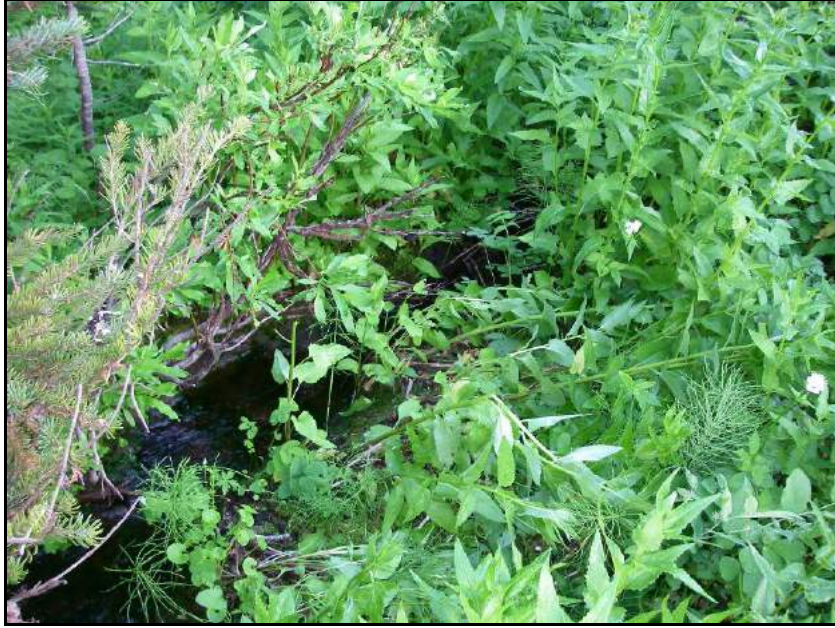
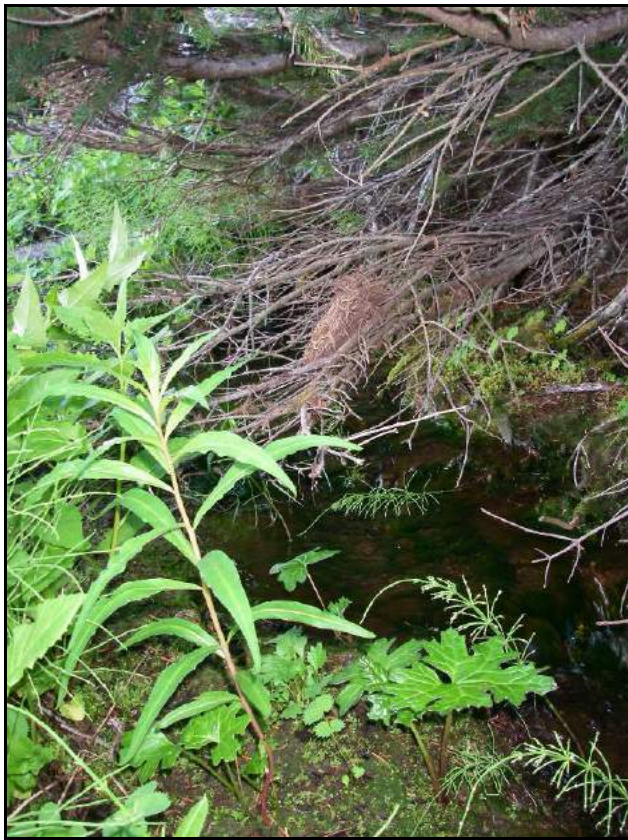
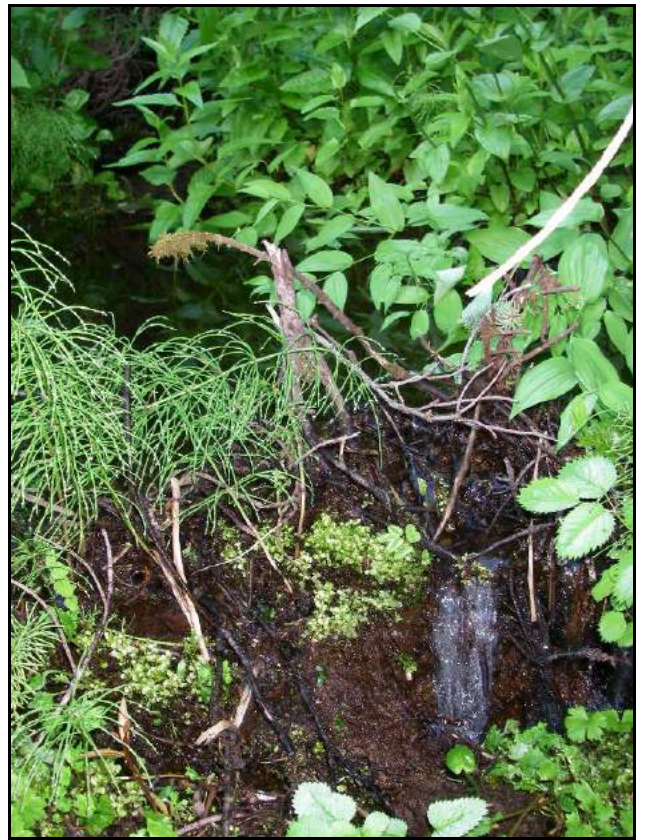
PHOTOS				
Photo		Foc Lg	Dir	Comments
R: 107	F: 3909	STD	D	looking ds to wetland
R: 107	F: 3910	STD	U	
R: 107	F: 3911	STD	U	step pool at us end of reach
WILDLIFE				
Group		Observations		
MAM		bear scat		
COMMENTS				
Section		Comments		
CHANNEL		S6 - small channel with a gradient of 7% leading into a wetland. Gravel and step pool morph then unconfined, fines before wetland.

Site 100 – Downstream view, looking to wetland

Site 100 – Upstream view

Site 100 – Upstream step pool at end of reach

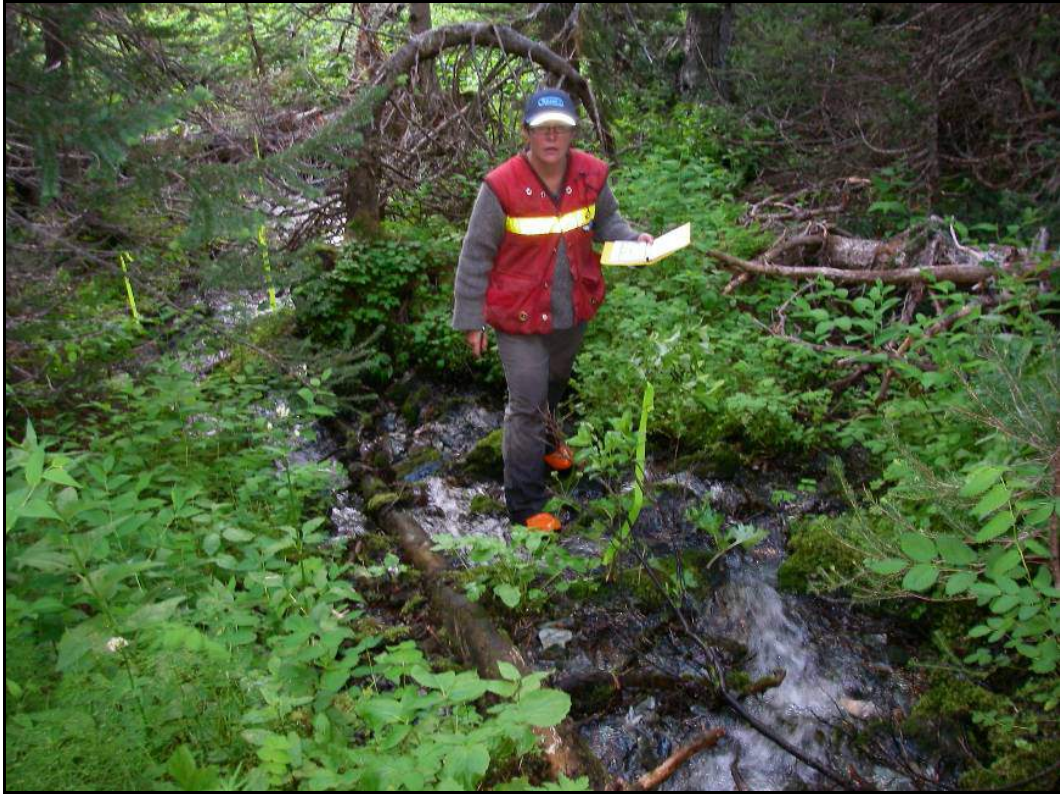
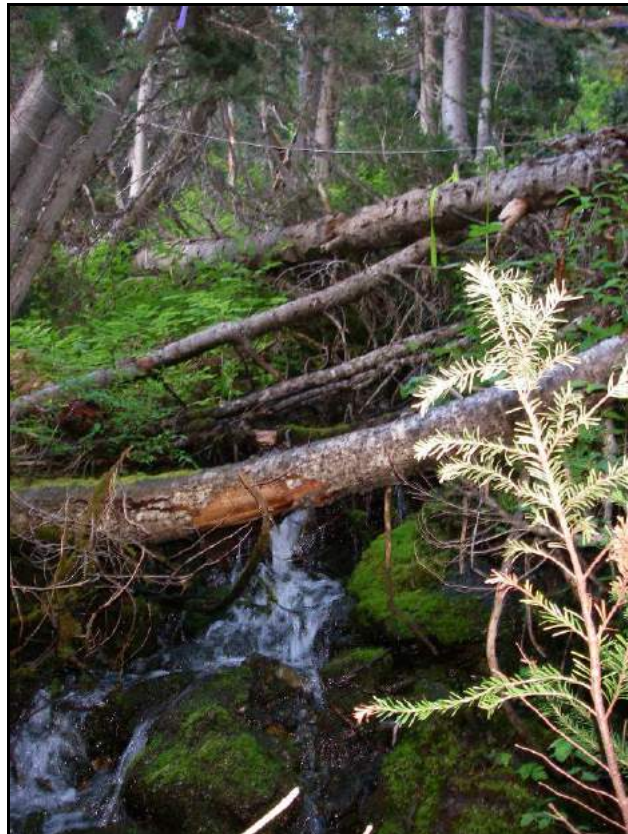
COMMENTS	
Section	Comments
CHANNEL	S6 - high gradient stream leading into a wetland

Site 101 – Downstream view

Site 101 – Upstream view

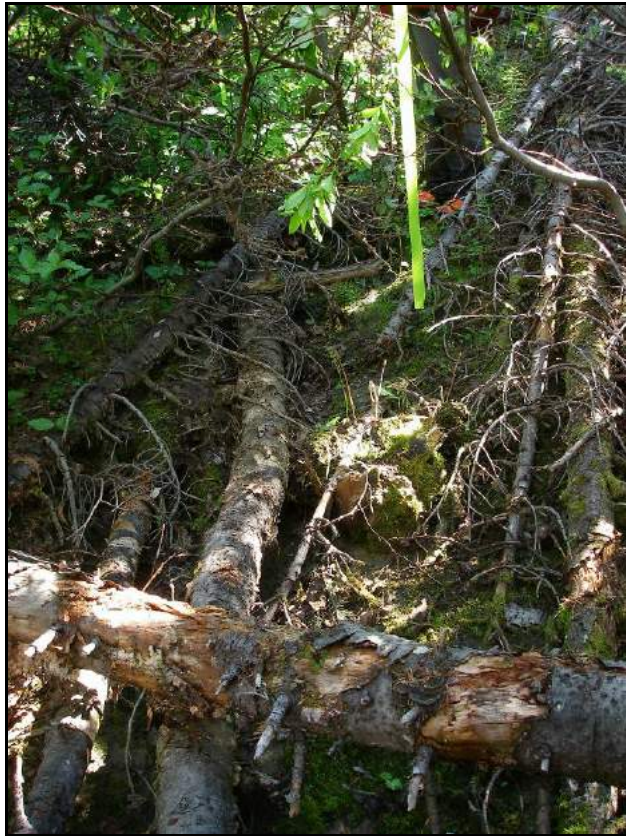
Site 102 – Downstream dry channel

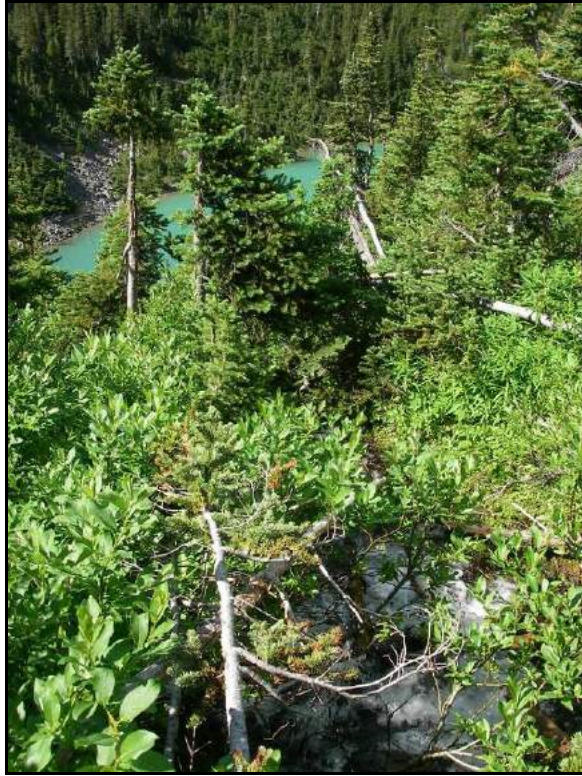
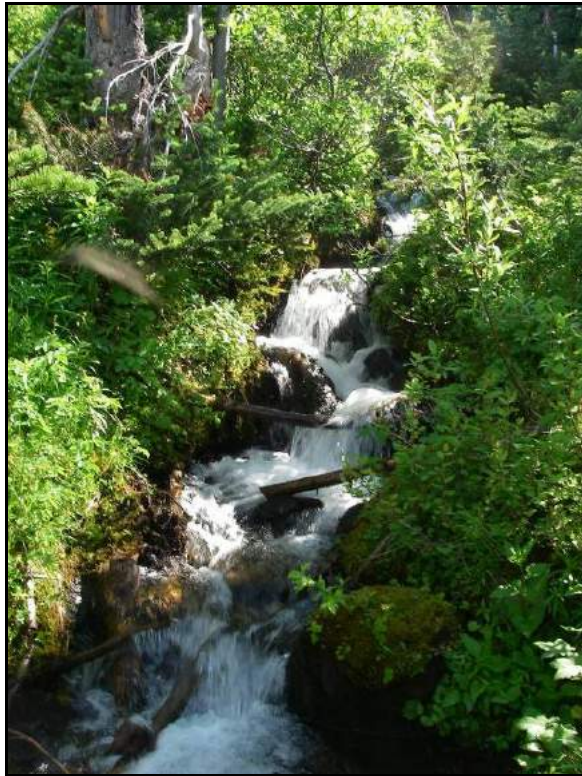
PHOTOS					
Photo		Foc Lg	Dir	Comments	
R:	107	F: 3924	STD	NS	feature - cascade
R:	107	F: 3925	STD	U	sp morph ds of rc
R:	107	F: 3926	STD	D	
COMMENTS					
Section		Comments			
CHANNEL		S6 - sp channel through av chute. Mod gradient at rc but plunges off mountain ~50m ds of road.

Site 103 – Feature cascade

Site 103 – Upstream step-pool morphology

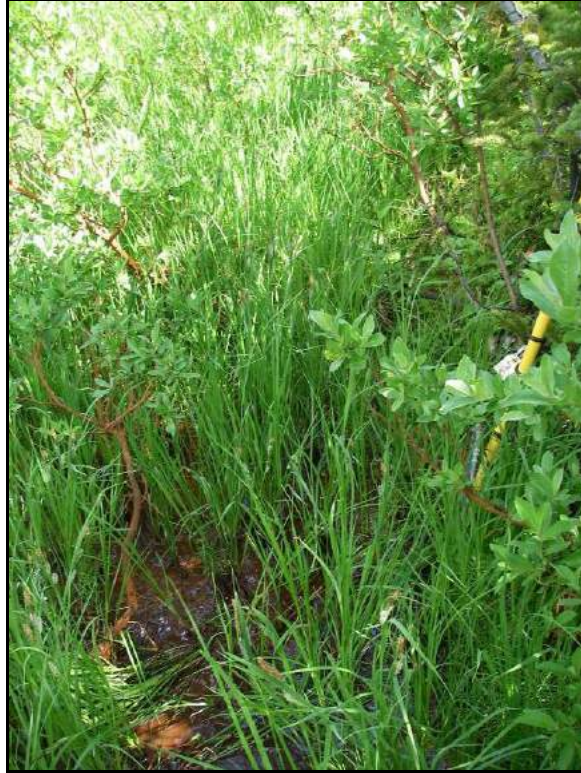
Site 104 – South view showing seepage wetland

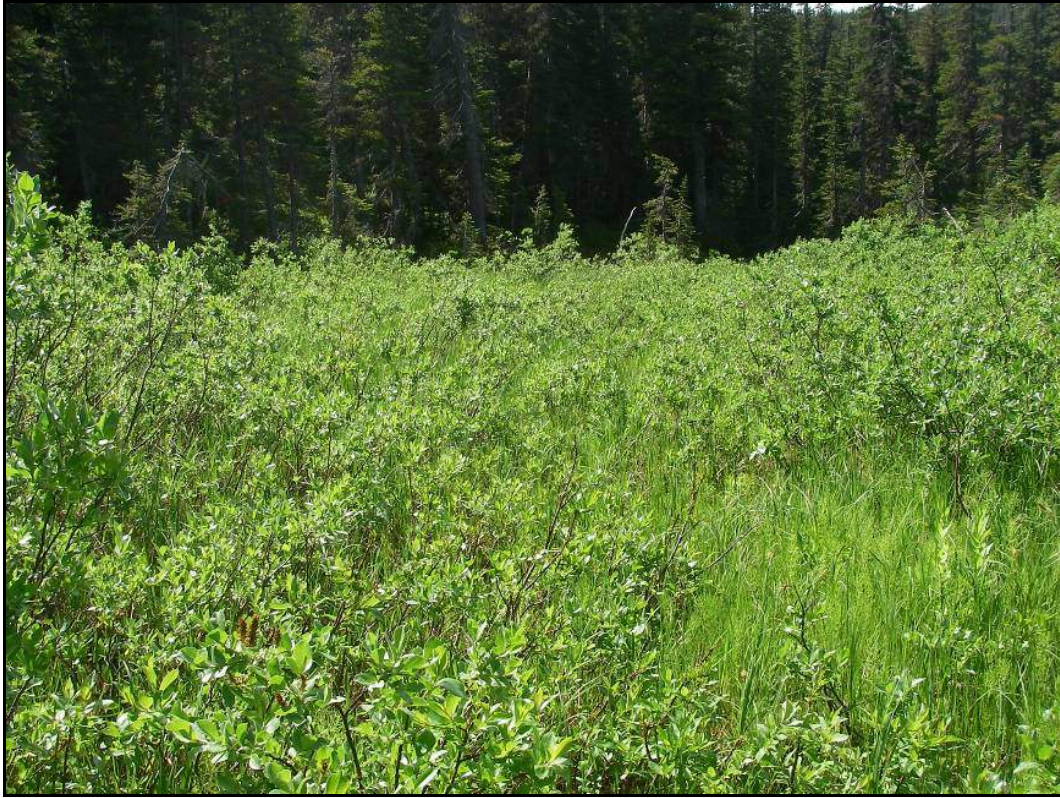
Section	Comments
CHANNEL	NCD - seepage
SITE CARD	NCD

Site 106 – Across view, showing seepage

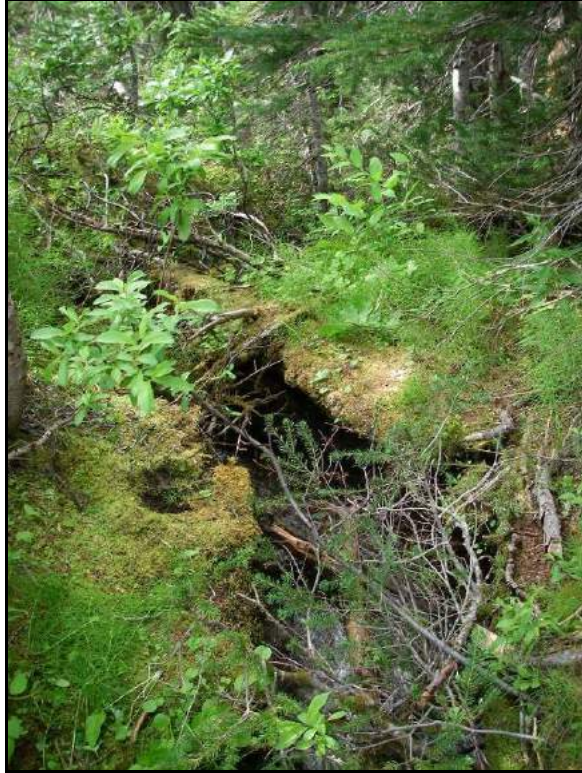
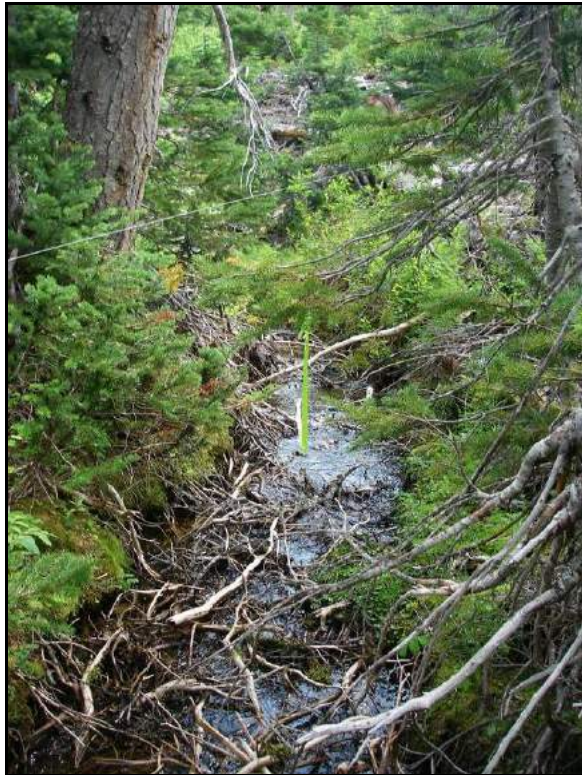
COMMENTS	
Section	Comments
CHANNEL	S6 - 30% gradient ~30m ds of road. Small clear stream through av chute and off.

Site 107 – Downstream view, steep section

Site 107 – Upstream view showing SWD
