Schaft Creek Fisheries Baseline 2007

Rescan Tahltan Environmental Consultants
Vancouver, British Columbia

March 2008

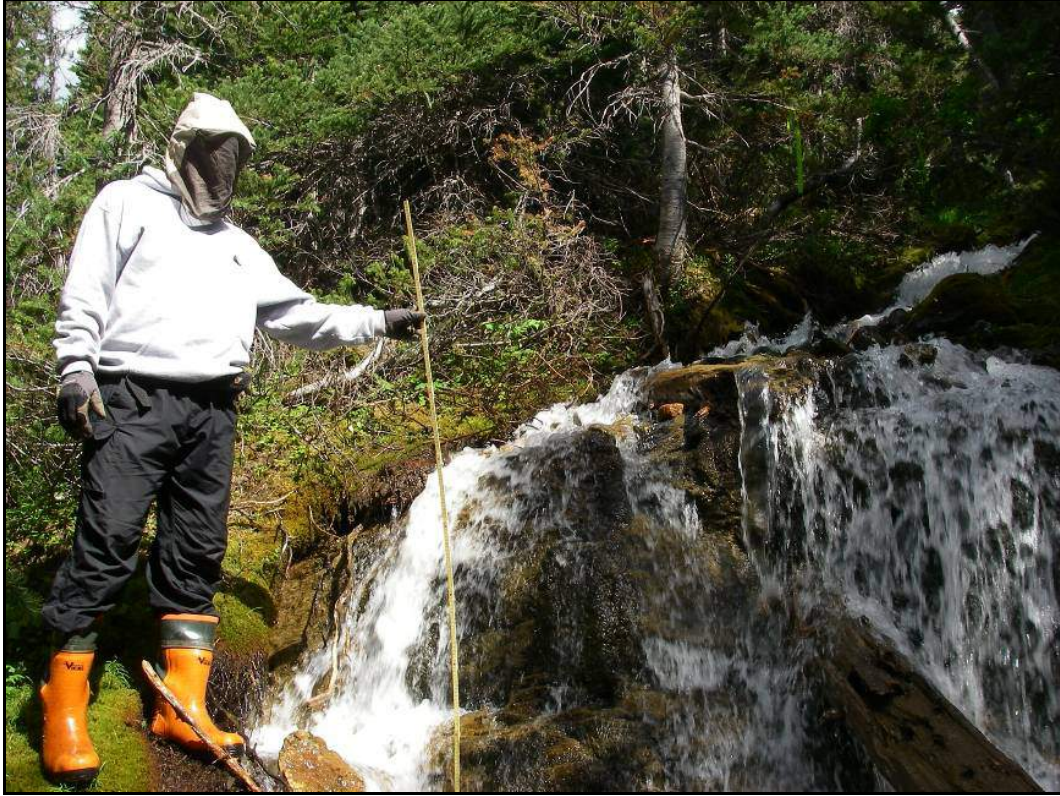
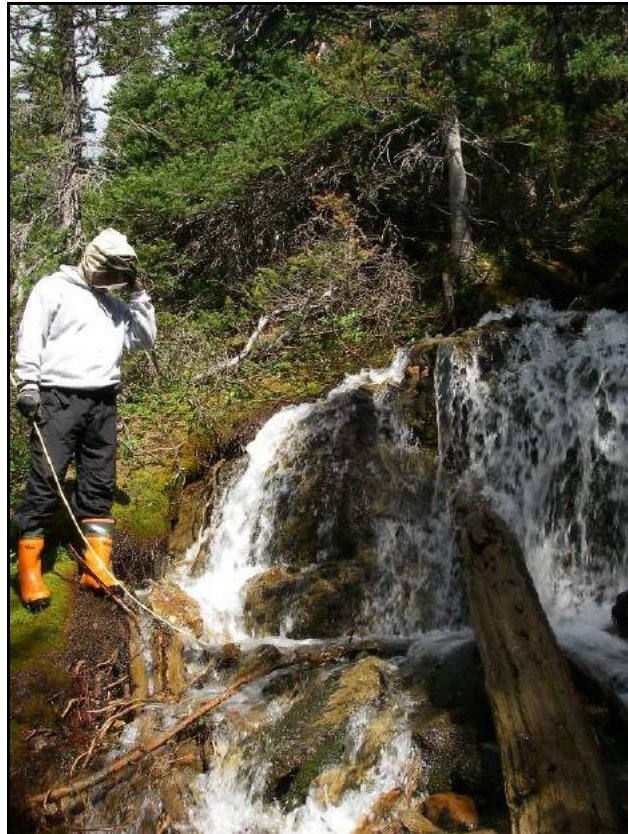
PHOTOS					
Photo		Foc Lg	Dir	Comments	
R:	107	F: 3936	STD	NS	feature - falls
R:	107	F: 3937	STD	NS	feature - falls
COMMENTS					
Section		Comments			
CHANNEL		S6 - steep cascade (40%) at rc. No pools, no habitat.

Site 108 – Feature falls

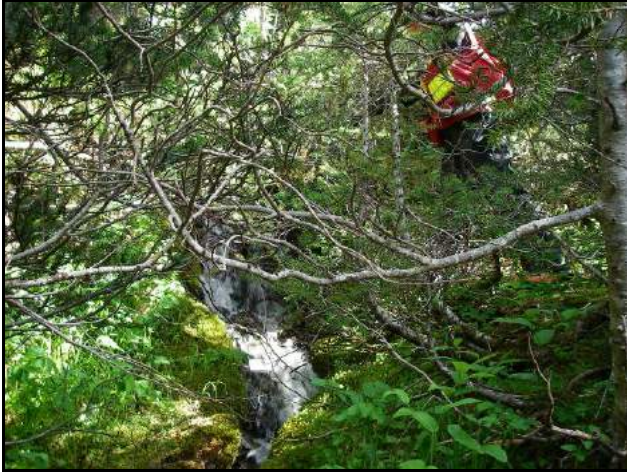
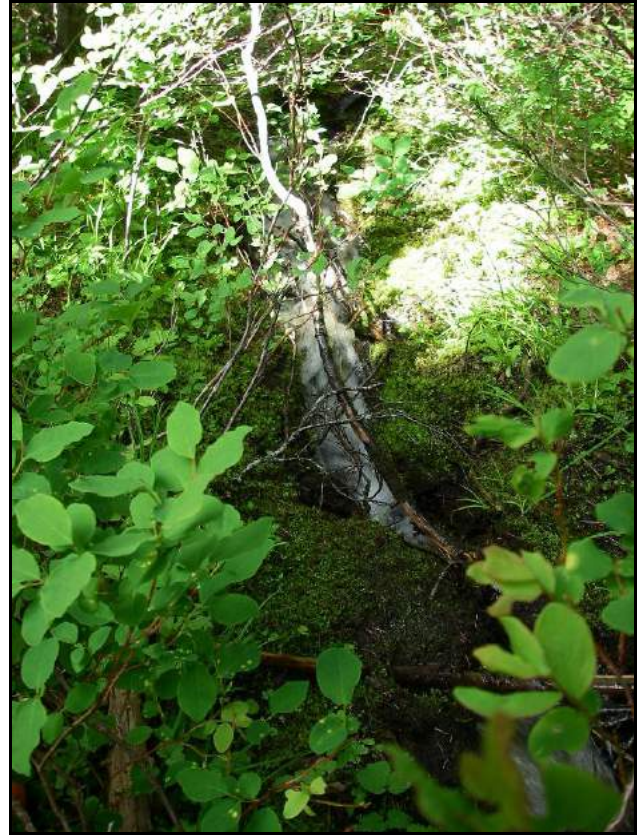
PHOTOS				
Photo		Foc Lg	Dir	Comments
R:	107	F: 3938	STD	U
R:	107	F: 3939	STD	D
R:	107	F: 3940	STD	U
R:	107	F: 3948	STD	U
fish barrier, cascade				
showing unconfined area				
COMMENTS				
Section		Comments		
CHANNEL		S6 - high gradient small stream cascading down the mountain primarily undercut with extensive over veg and often covering stream. Almost flowing underground at parts.

Site 109 – Upstream view

Site 109 – Downstream view

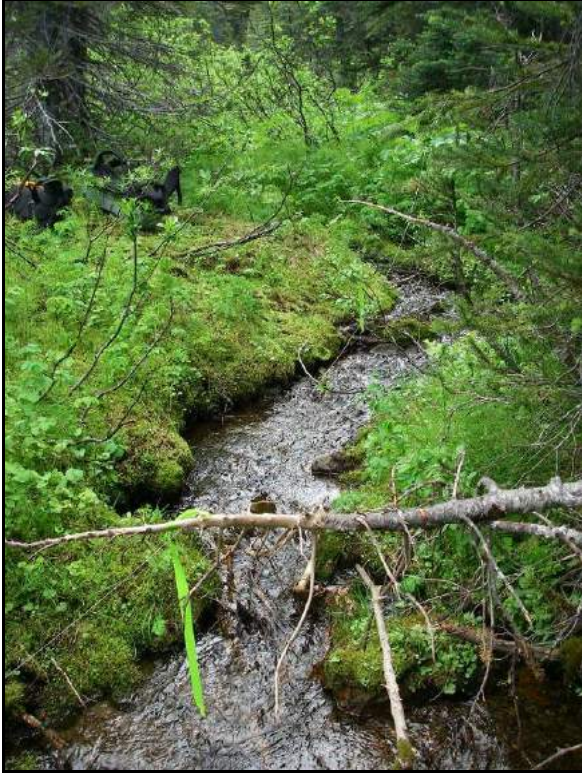
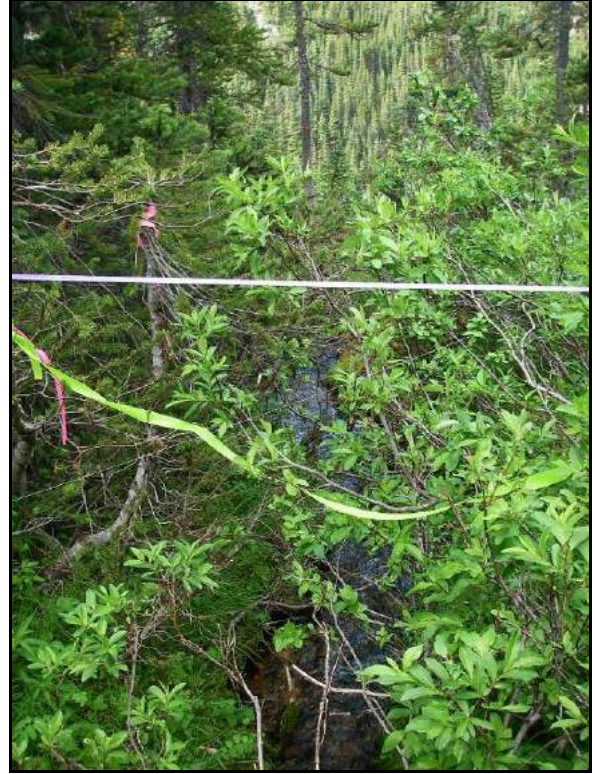
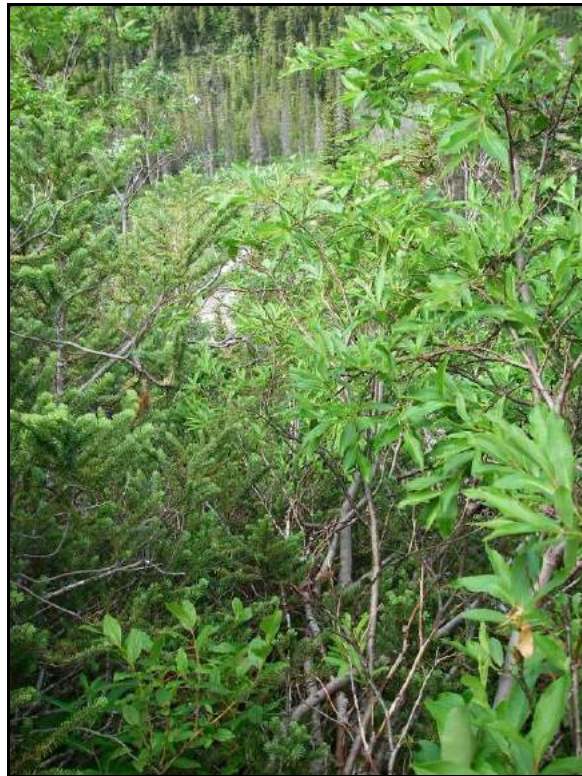
PHOTOS					
Photo		Foc Lg	Dir	Comments	
R:	107	F: 3949	STD	U	good habitat at rc
R:	107	F: 3950	STD	D	
R:	107	F: 3951	STD	D	cascade to lake
COMMENTS					
Section		Comments			
CHANNEL		S6 - nice stream with low gradient at rc. Drops off ~10m ds of rc to upper mess lake. Stream parallels road for ~100m us of rc. Recommend moving crossing us 100m to where it comes off of hillslope to avoid possible encroachment of road into stream.

Site 110 – Upstream view

Site 110 – Downstream view

Site 110 – Downstream cascade to lake

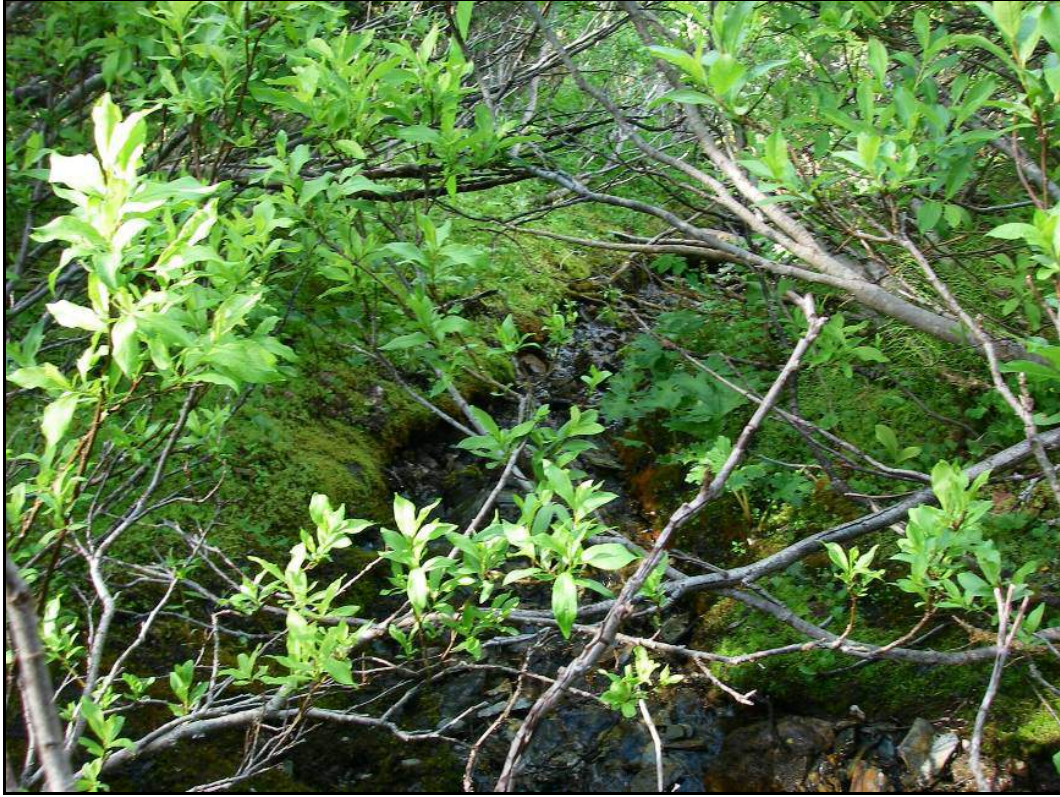
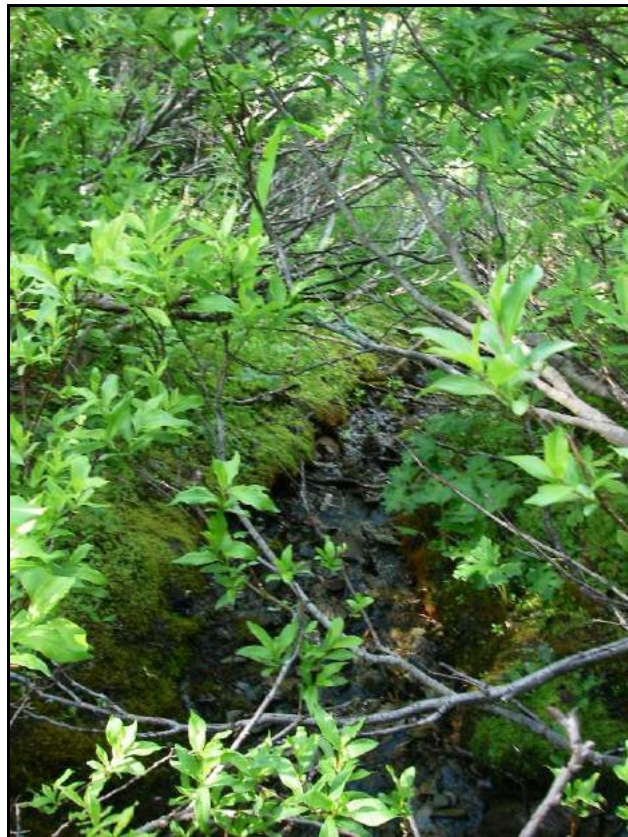
COMMENTS	
Section	Comments
CHANNEL	S6 - very steep drainage through av chute. No fish habitat and not enough water.

Site 111 – Downstream view

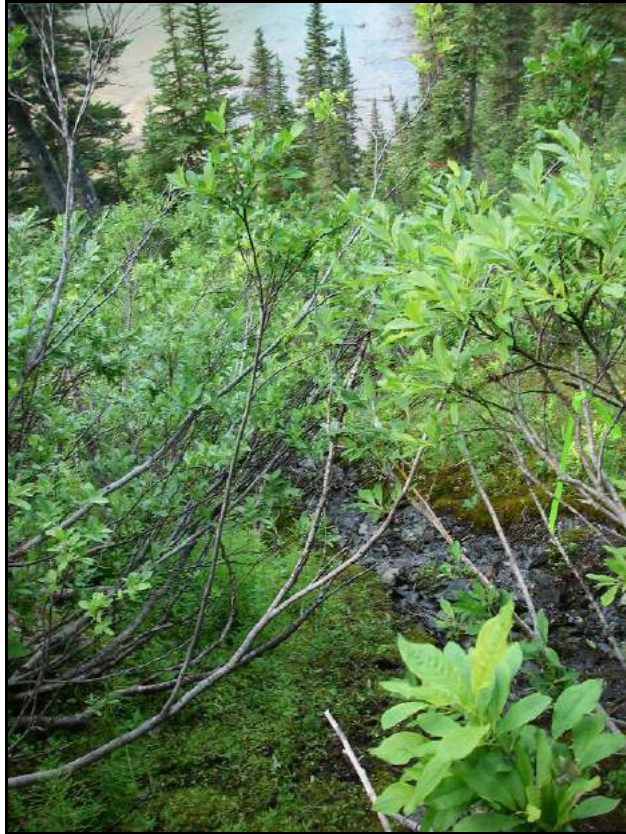
Site 112 – Downstream view

CHANNEL	S6 - no fish habitat, very steep.
---------	-----------------------------------

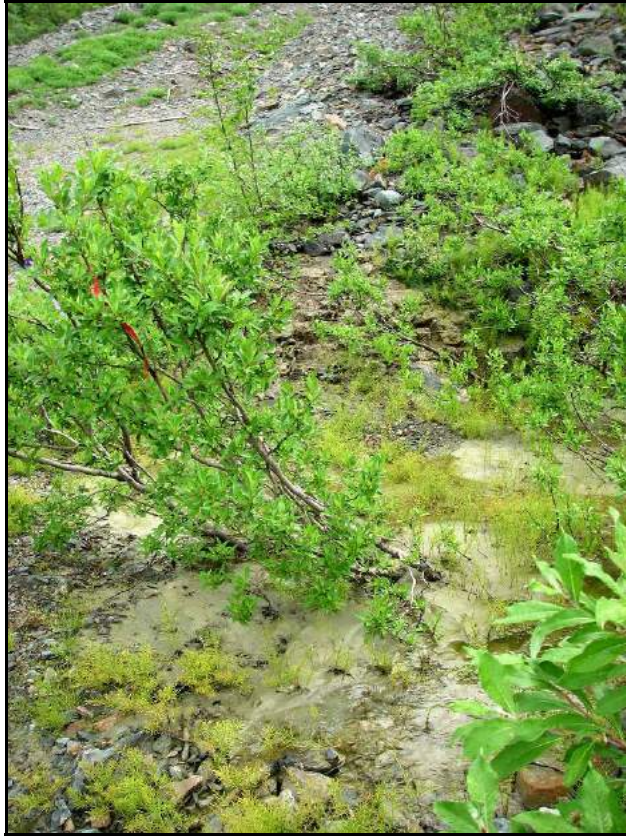
Section	Comments
CHANNEL	NCD - alluvial fan - water emerges and flows ~5m before seeping back into ground.
SITE CARD	NCD

Site 113 – Upstream, showing alluvial fan

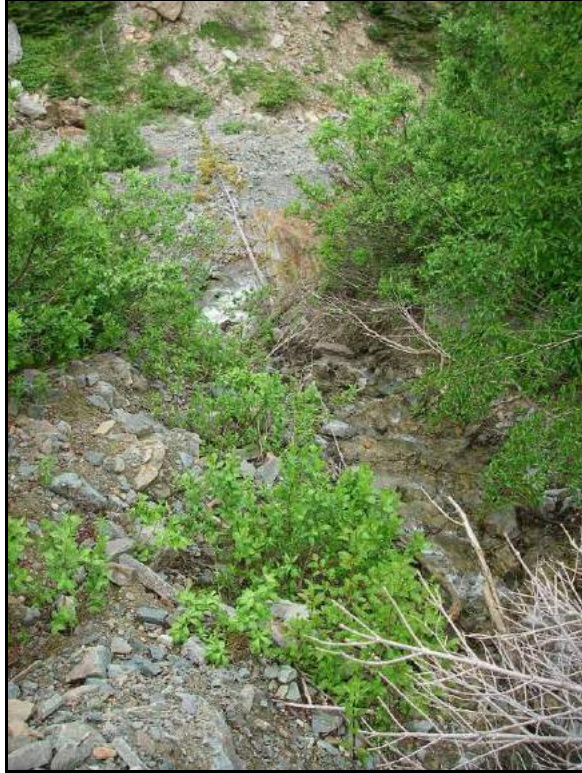
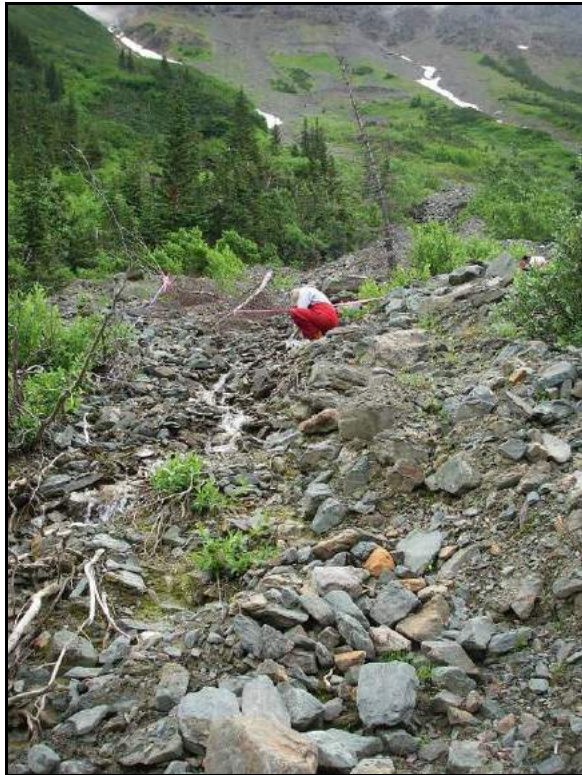
Photo	Foc Lg	Dir	Comments
R: 108 F: 3962	STD	D	cascade (80%) to main channel
R: 108 F: 3963	STD	U	looking towards rc

Site 114 – Downstream 80% cascade to main channel

Site 114 – Upstream view, towards proposed road

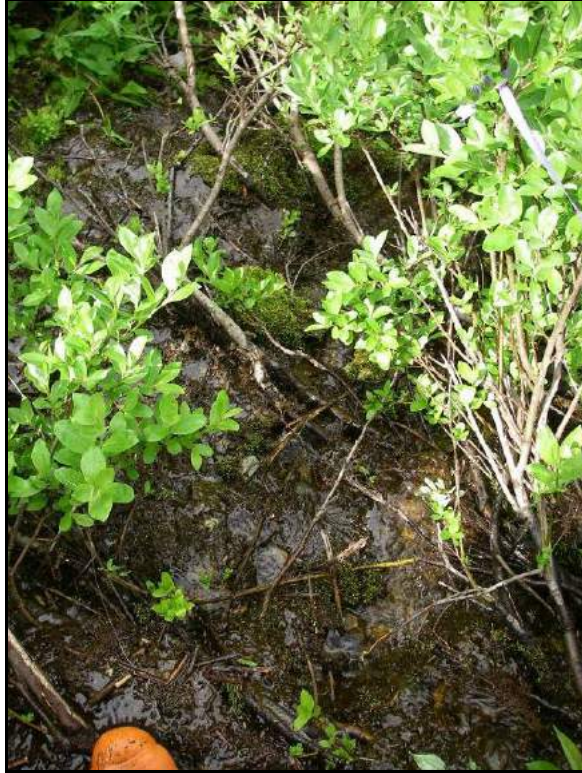
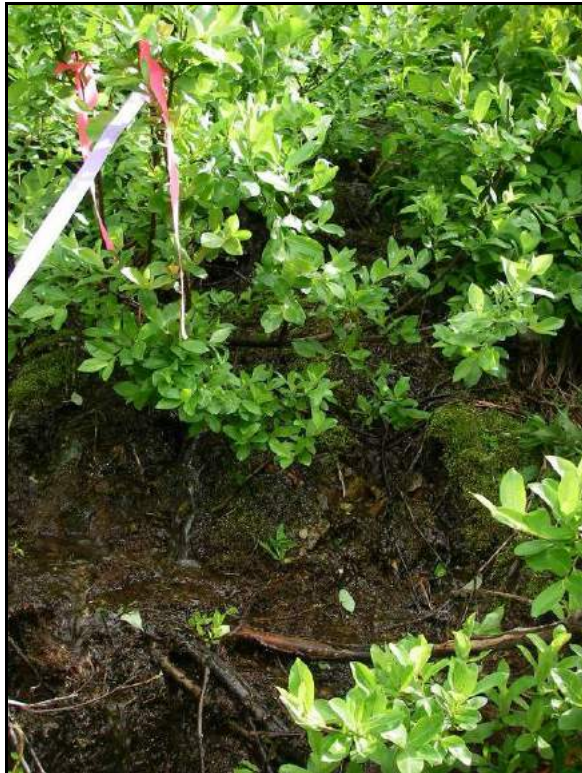
COMMENTS	
Section	Comments
CHANNEL	S6 - very steep, unconfined drainage through av chute. Very shallow, not really any defined banks. Marginal habitat.

Site 115 – Downstream view

Site 115 – Upstream view

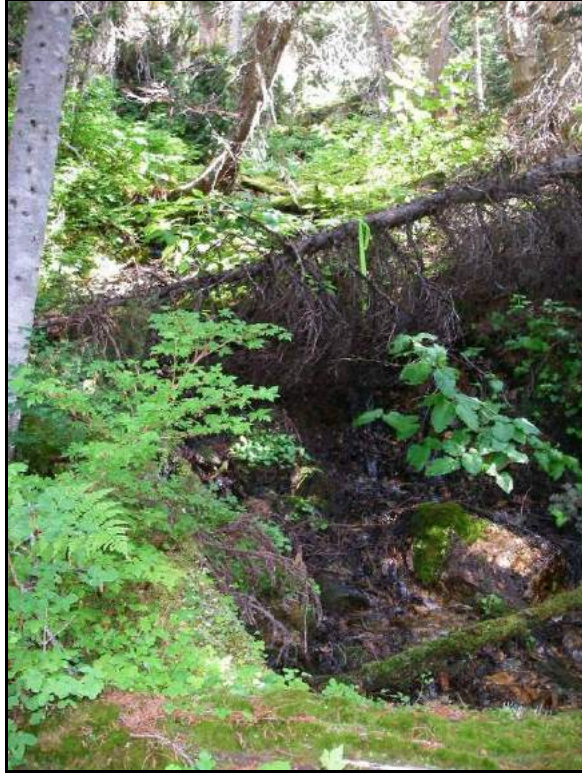
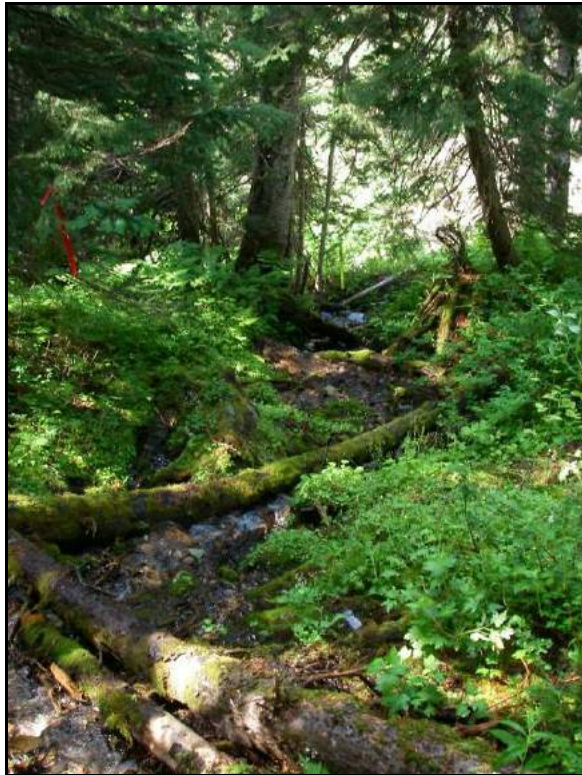
COMMENTS	
Section	Comments
CHANNEL	S6 - small steep forested stream shallow, low banks. Unconfined

Site 116 – Upstream view

Site 116 – Downstream view

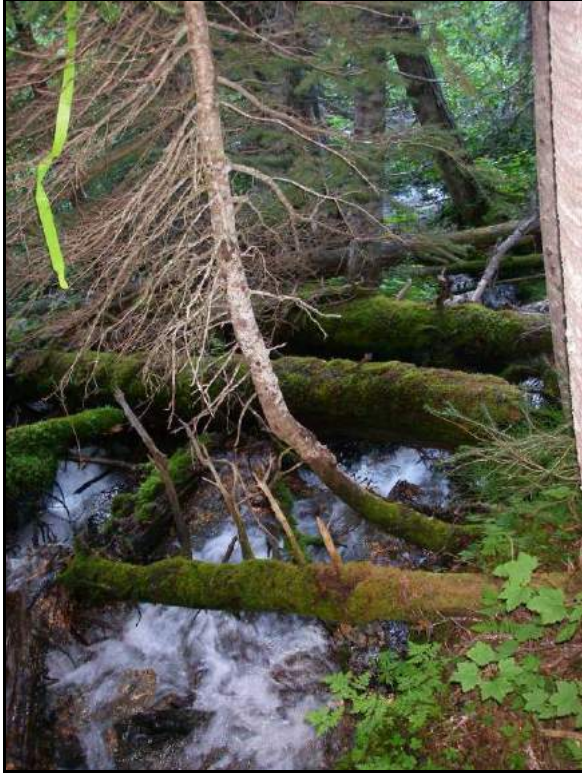
Site 131 – Downstream 39% cascade

HABITAT QUALITY					
Name		Comments			
Spawning Habitat		poor - few patches of gravel but no connectivity			
OverWinter Habitat		none			
Rearing Habitat		fair - decent pools, cover, sp morph			
PHOTOS					
Photo		Foc Lg	Dir	Comments	
R:	100	F: 3675	STD	D	39% cascade ds of rc (~10m)
R:	100	F: 3976	STD	D	cascade
R:	100	F: 3977	STD	U	off channel hab of mess cr at outlet of M33
R:	100	F: 3978	STD	U	29%sp morph at rc.
COMMENTS					
Section		Comments			
CHANNEL		S6 - road through this section is only 20m upslope from Mess cr. And associated side channels. Recommend moving road upslope 20m to avoid HADD in Mess cr during falling and blasting. Small sp stream with good hab. Potential . 39% grade at outlet to Mess

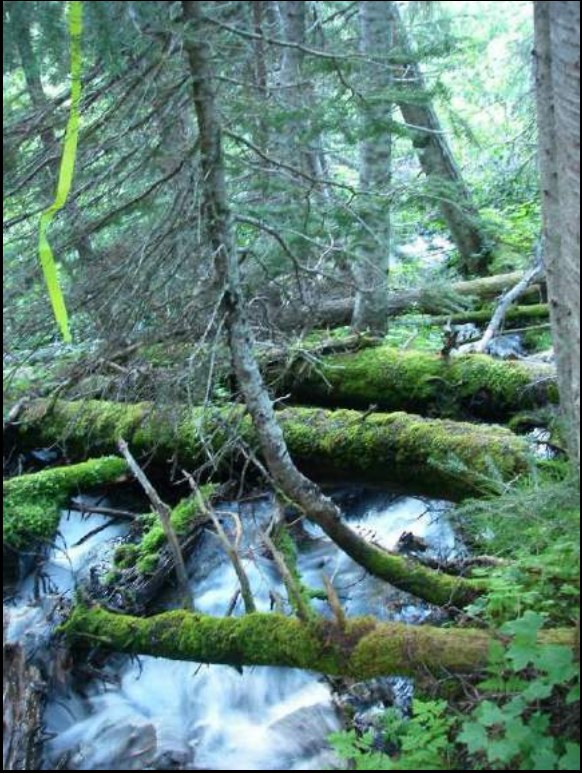
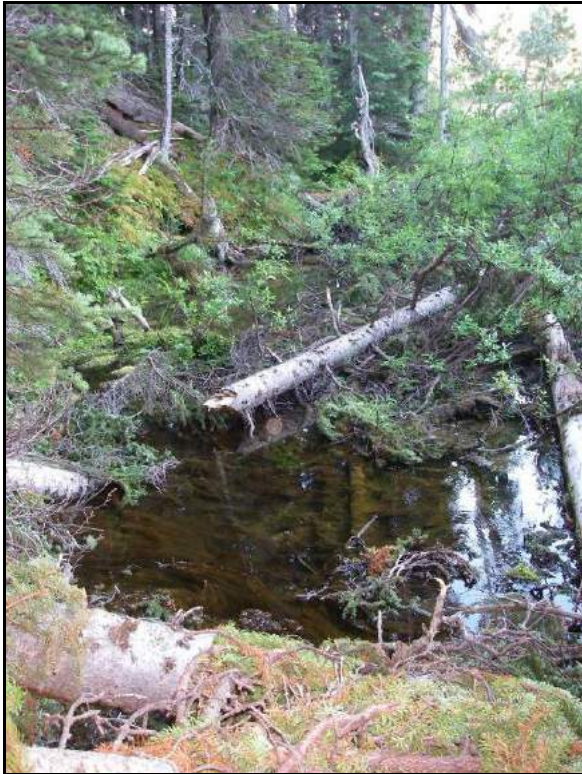
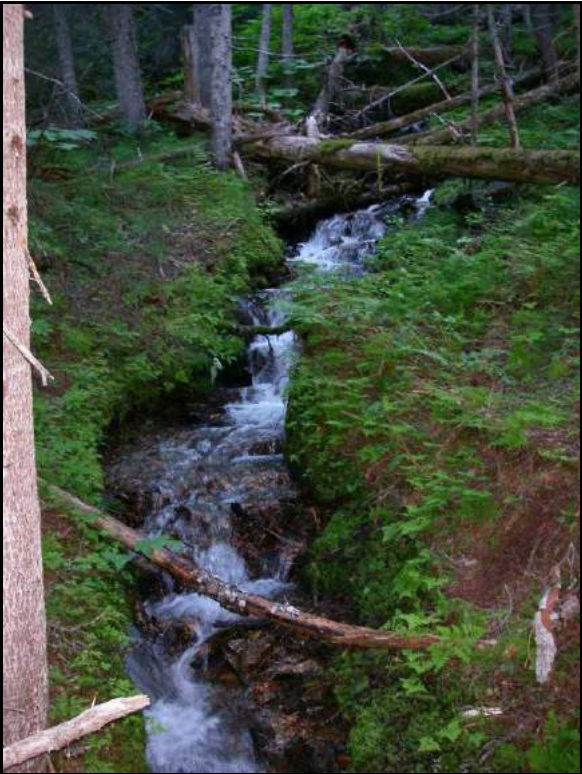
Site 131 – Downstream cascade

Site 131 – Upstream off channel habitat

Site 131 – Upstream 29% step-pool morphology

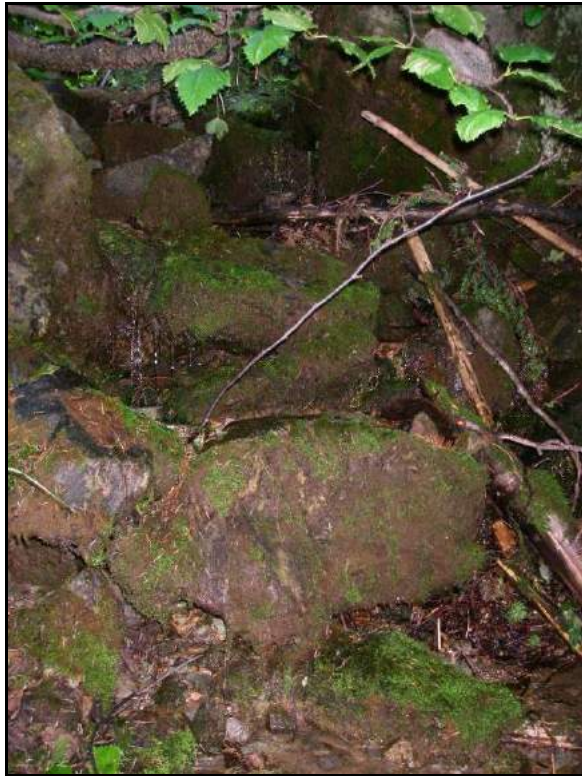
Site 132 – Upstream boulder cascade

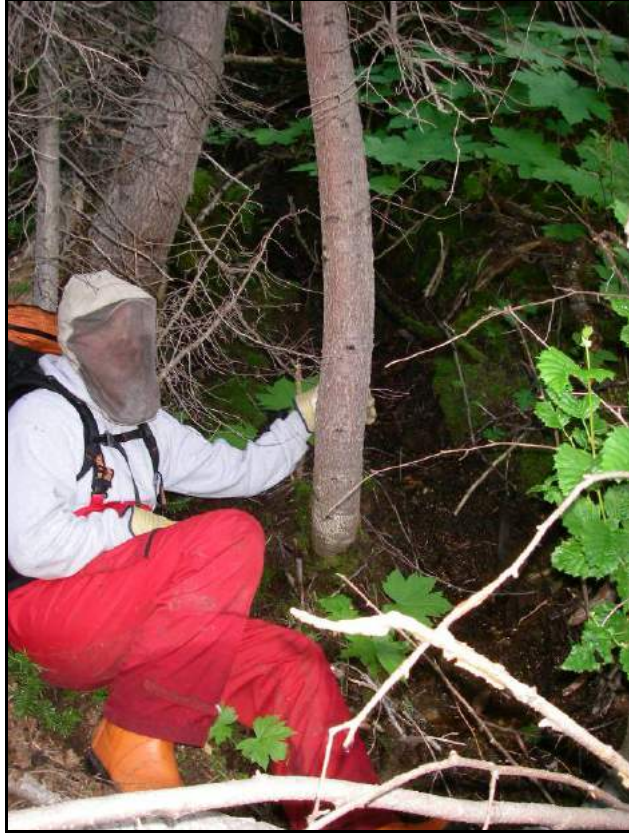
Section	Comments
CHANNEL	NCD
SITE CARD	NCD

Site 133 – Upstream, seepage beside road

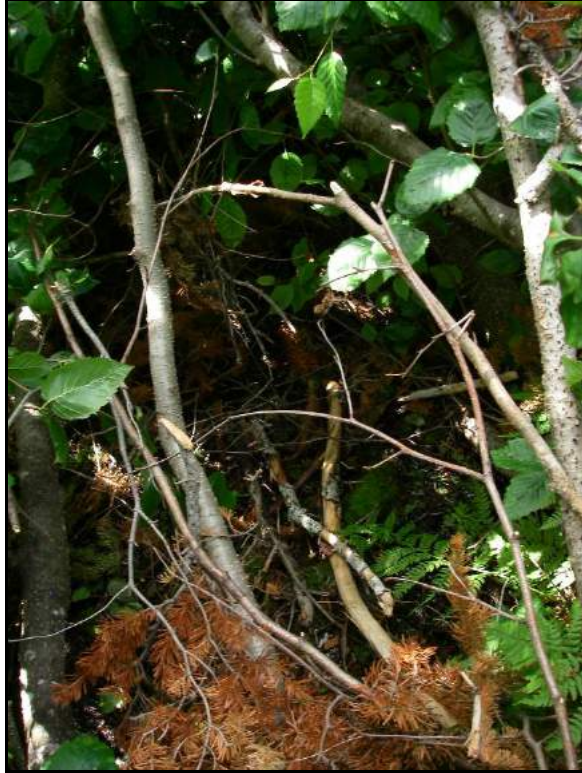
Section	Comments
CHANNEL	NCD - seepage at edge of av chute. Alder and dc.
SITE CARD	NCD

Site 135 – Downstream, barely a seepage

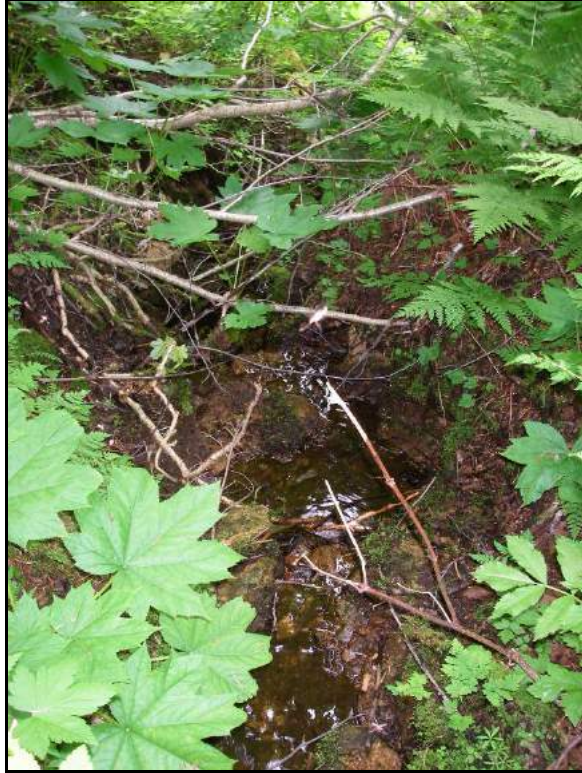
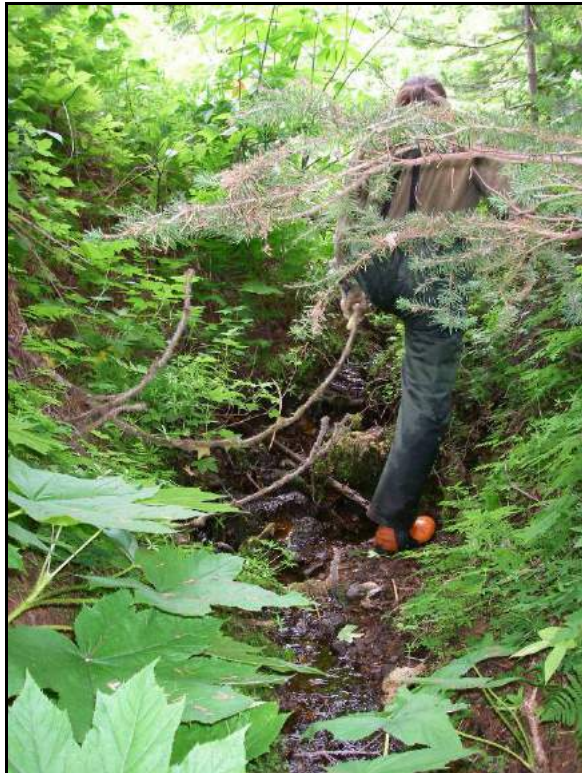
COMMENTS	
Section	Comments
CHANNEL	S6 - very small stream through dc alder spruce. Low flow. Marginal habitat.

Site 136 – Downstream view

Site 136 – Upstream view

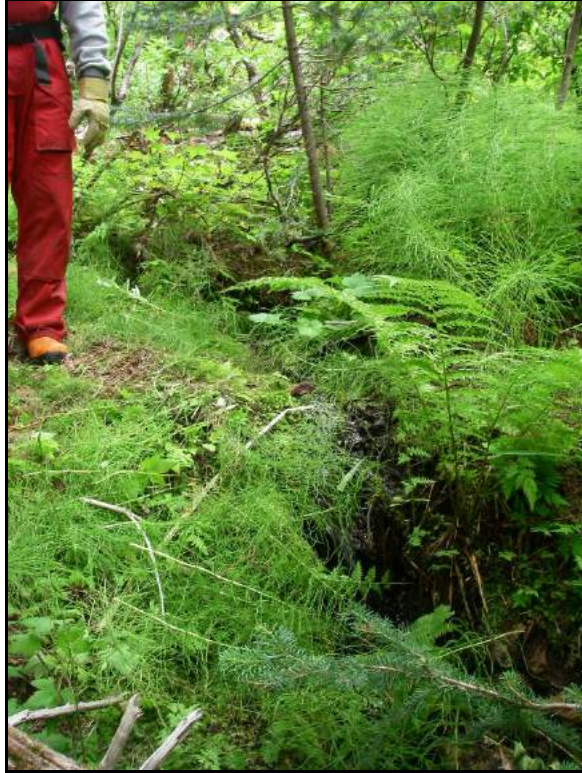
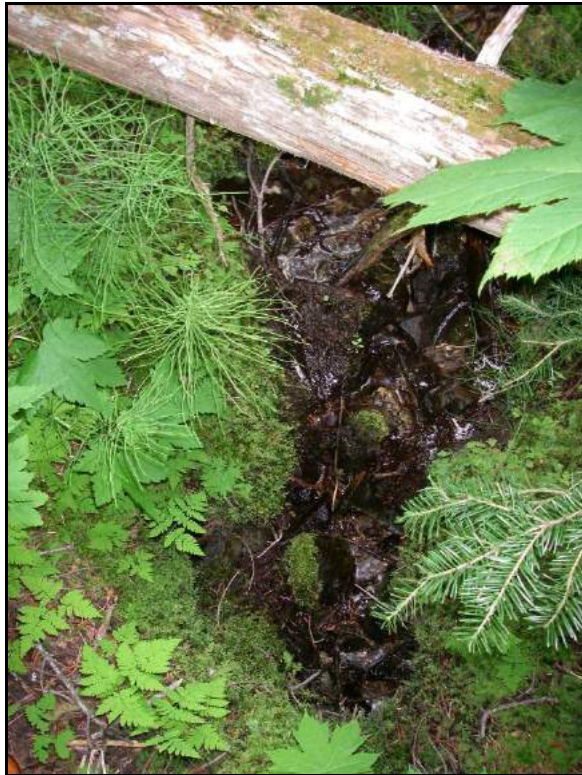
Section	Comments
CHANNEL	NCD - somewhat channelized at rc but overland flow us and ds and seepage.
SITE CARD	NCD

Site 137 – Upstream view, overland flow

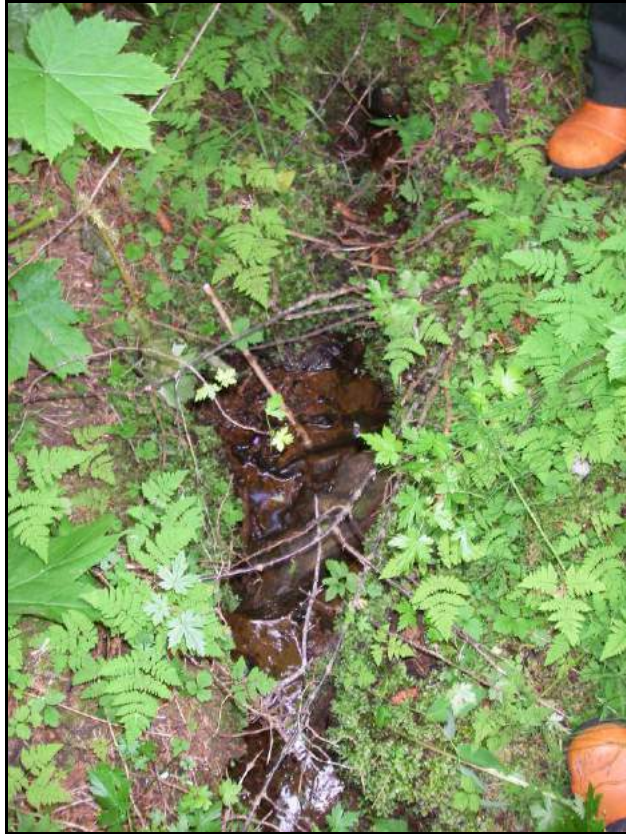
Section	Comments
SITE CARD	NCD
CHANNEL	NCD - small channelized a bit at rc. Lots of underground flow.

Site 138 – Upstream view, seepage

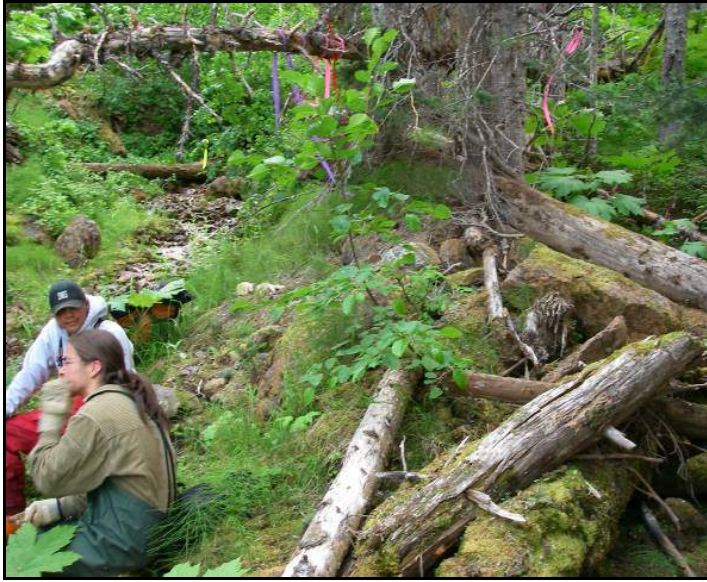
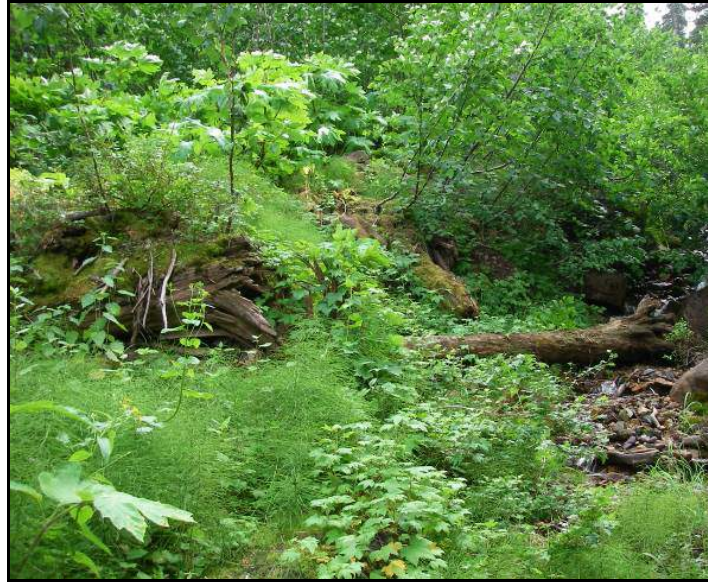
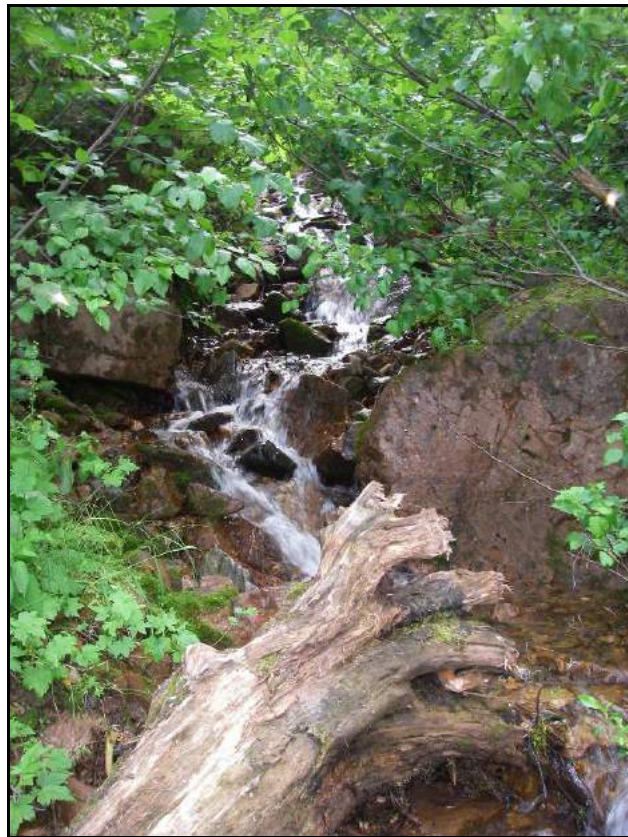
PHOTOS					
Photo		Foc Lg	Dir	Comments	
R:	100	F: 4011	STD	NS	8 angles for TC. Starting us and working clockwise
R:	100	F: 4012	STD	NS	TC
R:	100	F: 4013	STD	NS	TC
R:	100	F: 4014	STD	NS	TC
R:	100	F: 4015	STD	NS	TC
R:	100	F: 4016	STD	NS	TC
R:	100	F: 4017	STD	NS	TC
R:	100	F: 4018	STD	NS	TC
R:	100	F: 4019	STD	U	boulders and logs on lb from debris flow.
R:	100	F: 4020	STD	U	boulders and debris from debris flow on rb
R:	100	F: 4021	STD	U	33% cascade us of rc
COMMENTS					
Section		Comments			
CHANNEL		S3 - 33% ~10m us of rc, 15% at rc. Evidence of old debris flow/rock avalanche on both banks. Could move rc 30m us and avoid fish bearing area. 2 seepages ~5 and 10m from rb of stream, all could be avoided by moving us. Important habitat.

Site 139 – Upstream debris

Site 139 – Upstream boulders and debris

Site 139 – Upstream 33% cascade

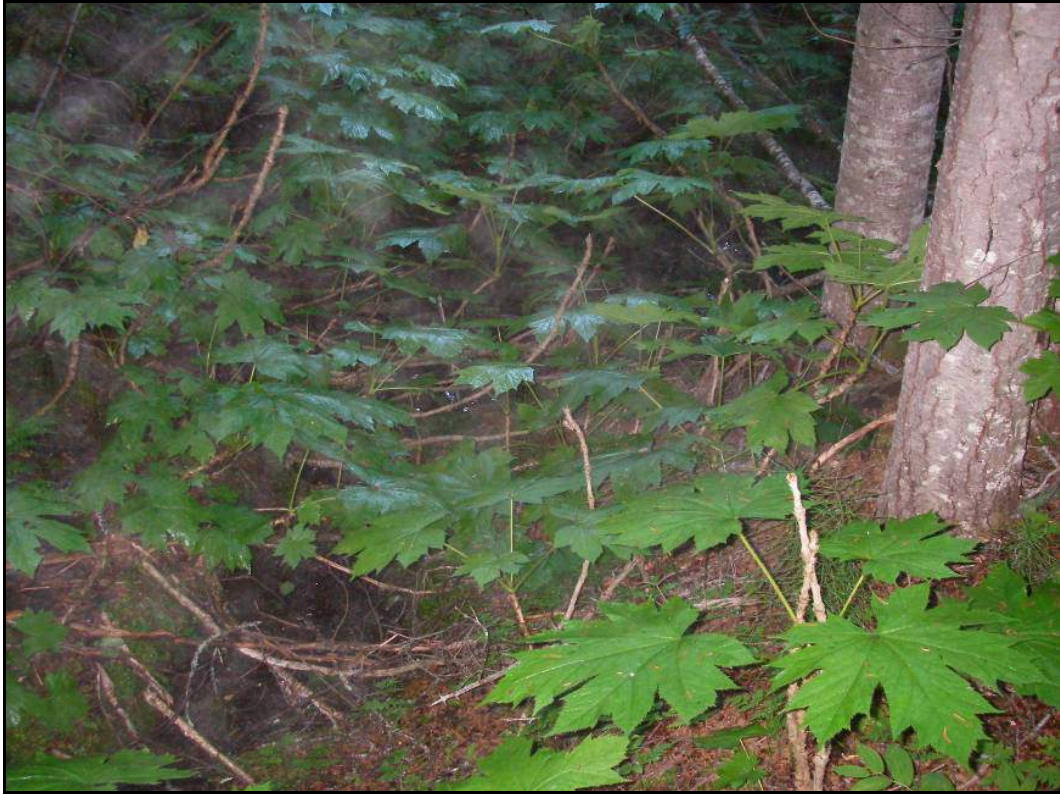
Section	Comments
CHANNEL	NCD - seepage (probably from last stream) shannelizes a bit at road crossing, then seeps out again ds. Could avoid by shifting previous rc upslope.
SITE CARD	NCD

Site 140 – Downstream channelized seepage

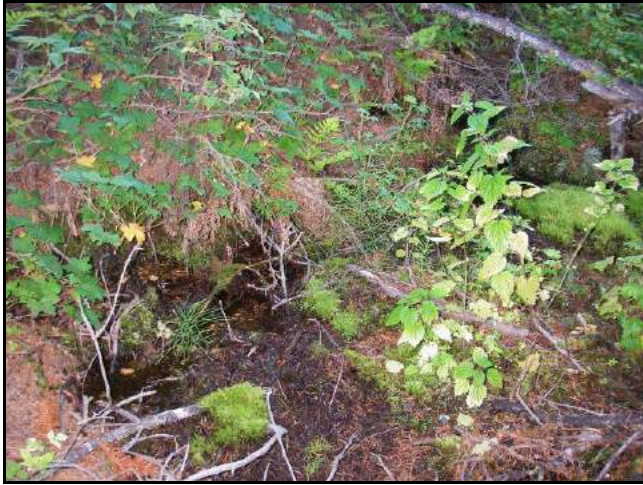
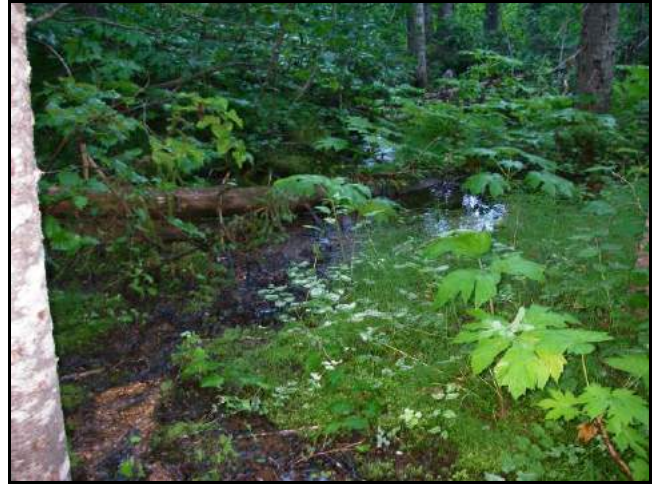
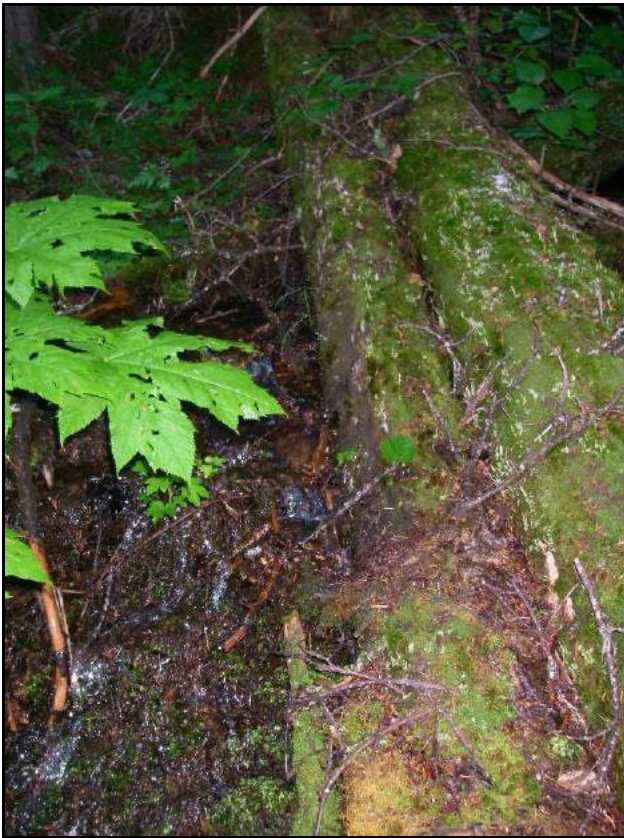
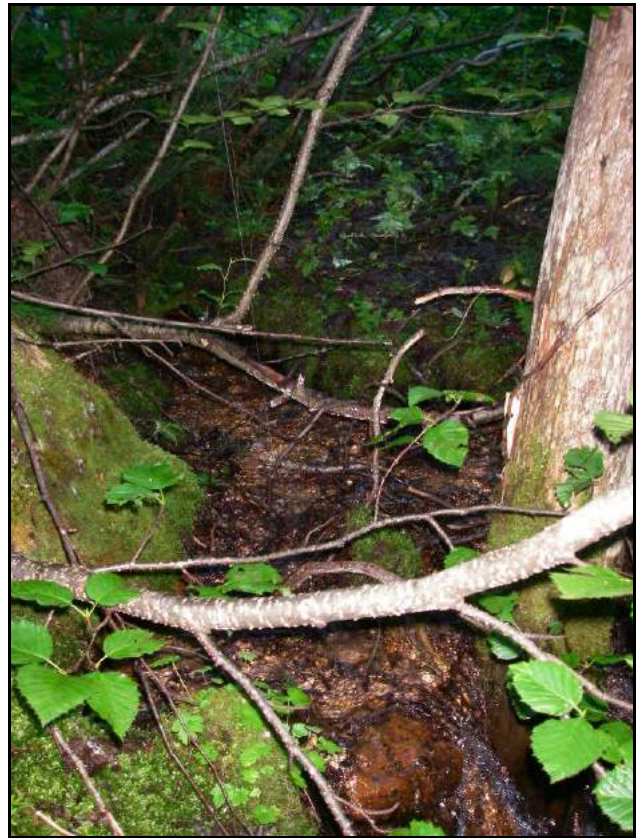
PHOTOS					
Photo		Foc Lg	Dir	Comments	
R:	101	F: 4024	STD	U	feature - source spring
R:	101	F: 4025	STD	U	feature - source spring
R:	101	F: 4026	STD	D	undefined area ds of rc
R:	101	F: 4027	STD	U	overland flow ds of rc
R:	101	F: 4028	STD	U	good channel bit near rc.
COMMENTS					
Section		Comments			
CHANNEL		S4 Default - borderline stream - mostly scoured but a couple of areas of overland flow, undefined channel. Good flow. Stream arised from spring at bottom of av. Chute. Can't really move rc up but try to make it more parallel to stream direction.

Site 141 – Upstream source spring

Site 141 – Downstream undefined area

Site 141 – Upstream, overland flow

Site 141 – Upstream, good channel

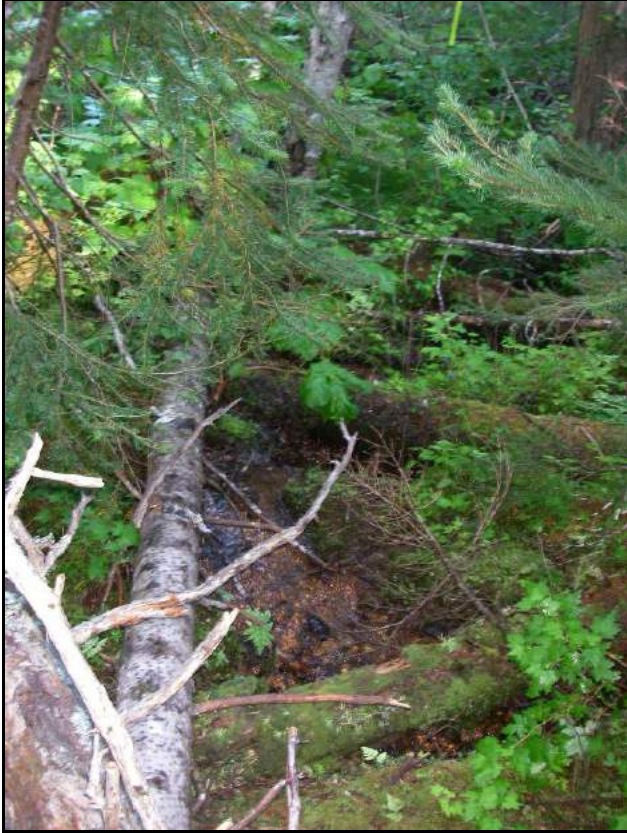
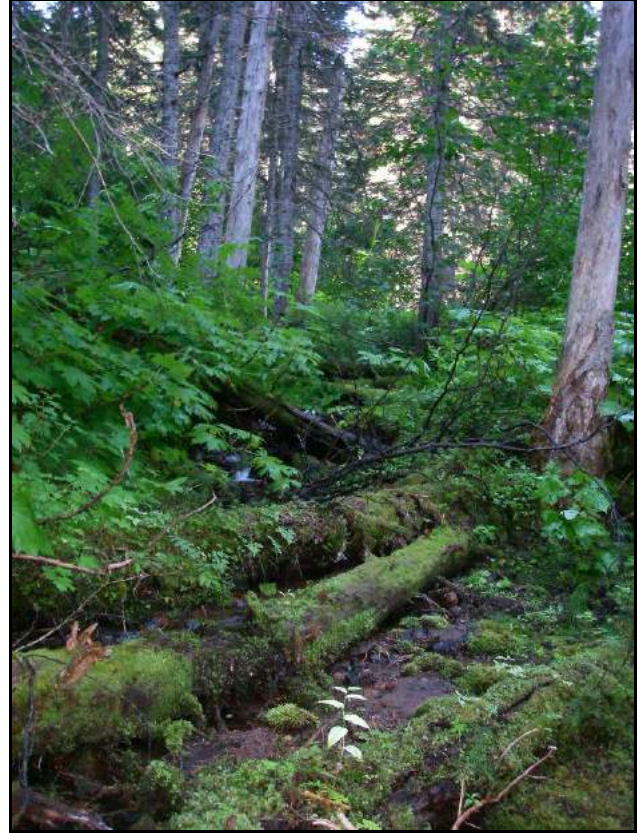
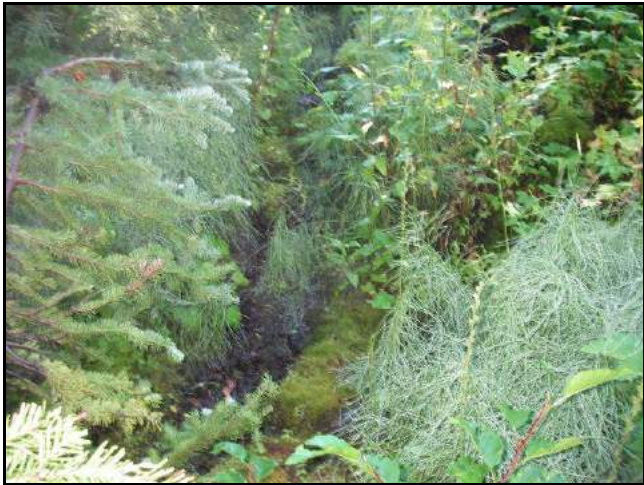
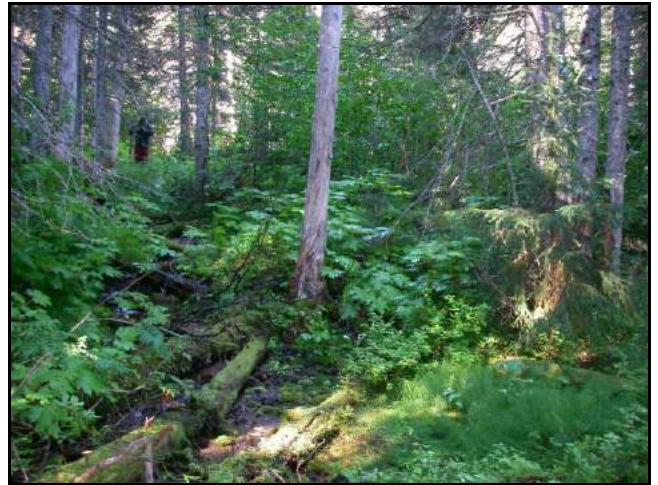
HABITAT QUALITY						
Name		Comments				
Spawning Habitat		poor - there's water but shallow. Too steep.				
OverWinter Habitat		none				
Rearing Habitat		fair - decent pools, good cover and good flow				
PHOTOS						
Photo		Foc Lg	Dir	Comments		
R:	101	F: 4029	STD	D	near rc	
R:	101	F: 4030	STD	U	near rc	
R:	101	F: 4031	STD	U	feature - spring source	
R:	101	F: 4032	STD	U	feature - spring source	
R:	101	F: 4035	STD	U	note road ribbon 5m to right of stream.	
COMMENTS						
Section		Comments				
CHANNEL		S4 Default - small stream arising from av chute springs and stream. Sp morph but decent pools. Low gradient and connected to Mess cr. Road runs parallel for ~20m on LB - alternate alignment so it crosses perpendicular to stream higher up.

Site 142 – Downstream view

Site 142 – Upstream view

Site 142 – Spring source

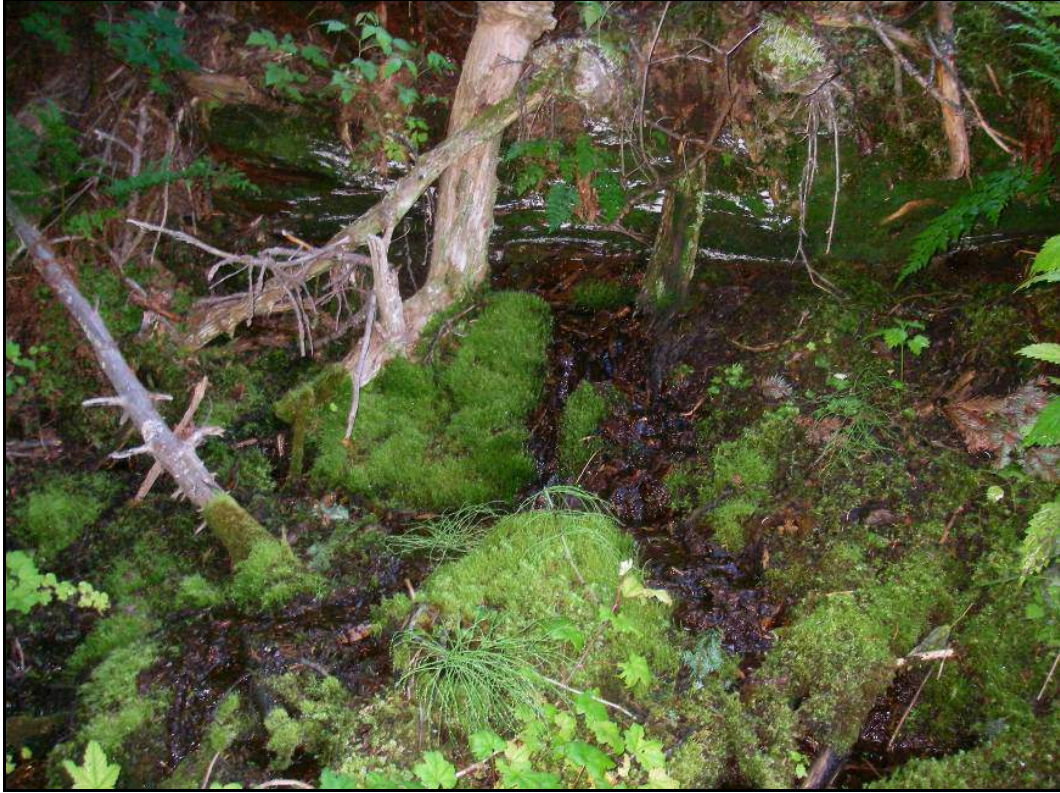
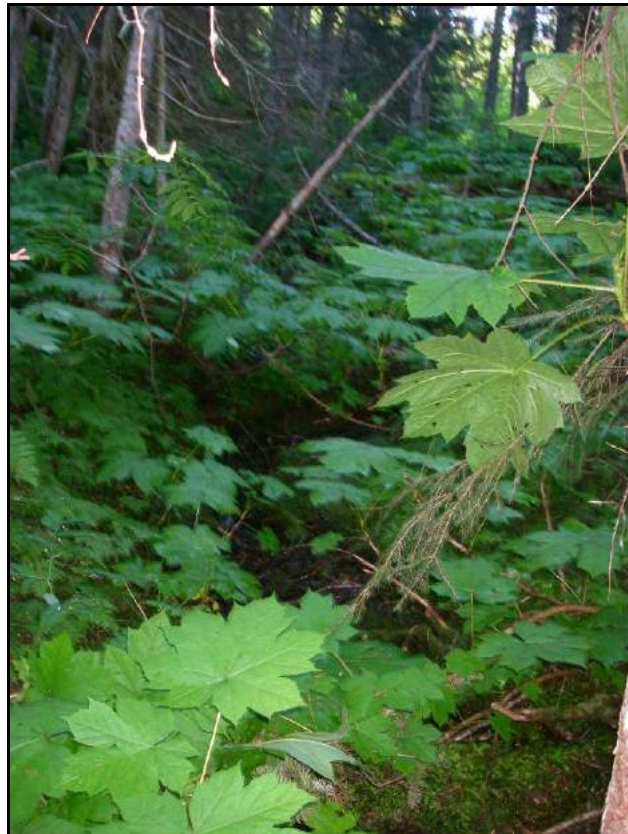
COMMENTS	
Section	Comments
CHANNEL	S6 - if rc moves us on left it will cross this stream at a better spot, arises from a spring in us av chute. Marginal habitat.

Site 143 – Upstream spring source

Site 143 – Upstream view
