Schaft Creek Fisheries Baseline 2007

Rescan Tahltan Environmental Consultants
Vancouver, British Columbia

March 2008

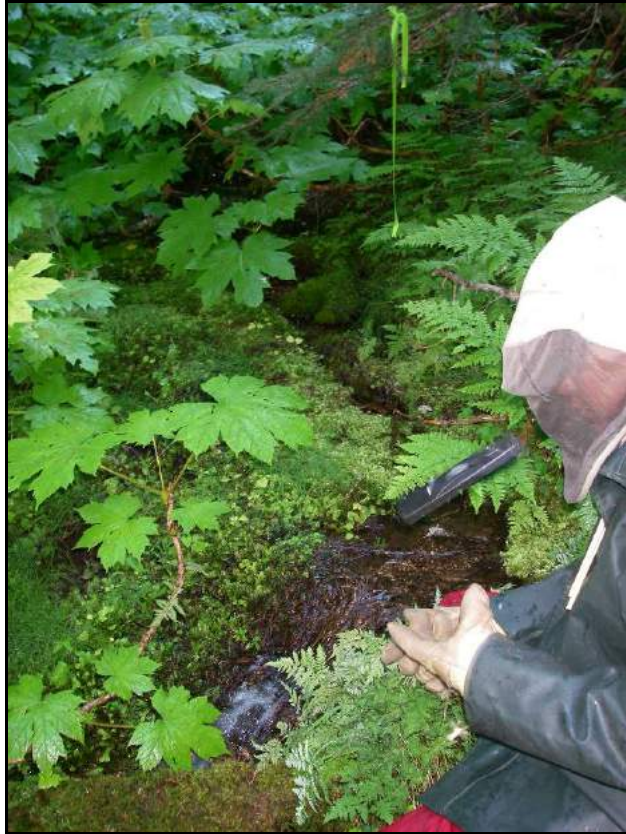
Site 144 – Upstream view

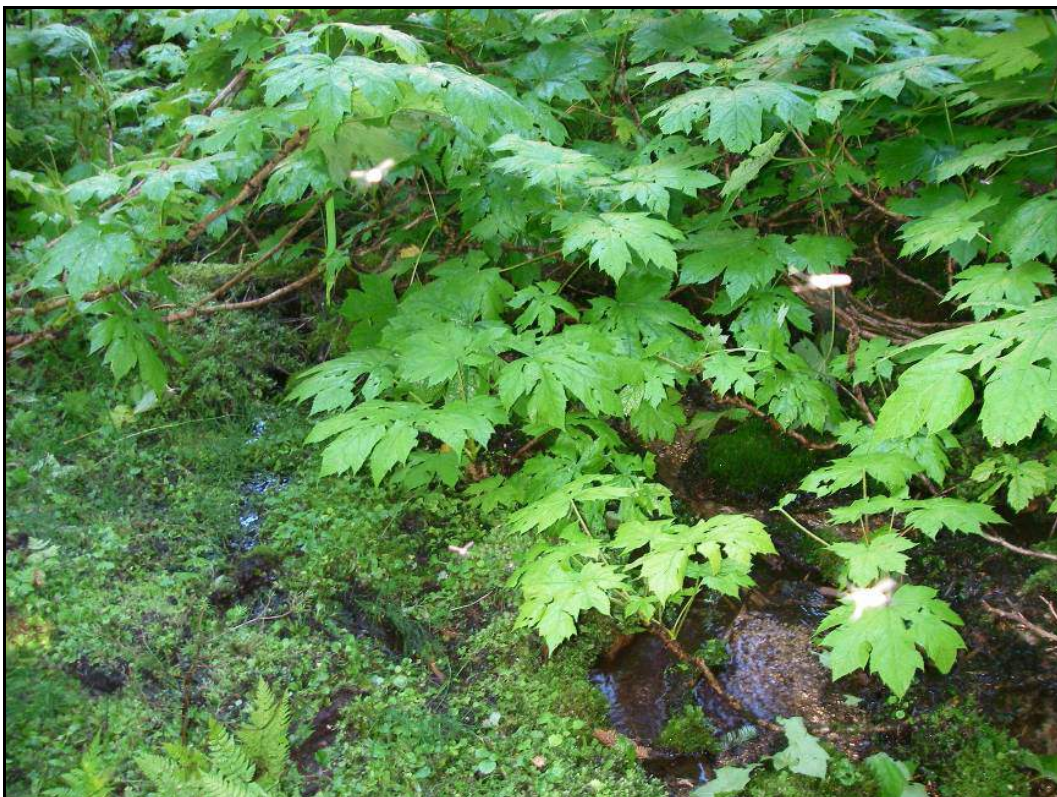
Site 144 – Downstream view

Section	Comments
CHANNEL	NCD - seepage channelizes a bit at rc. Overland flow and organic substrate dominate.
SITE CARD	NCD

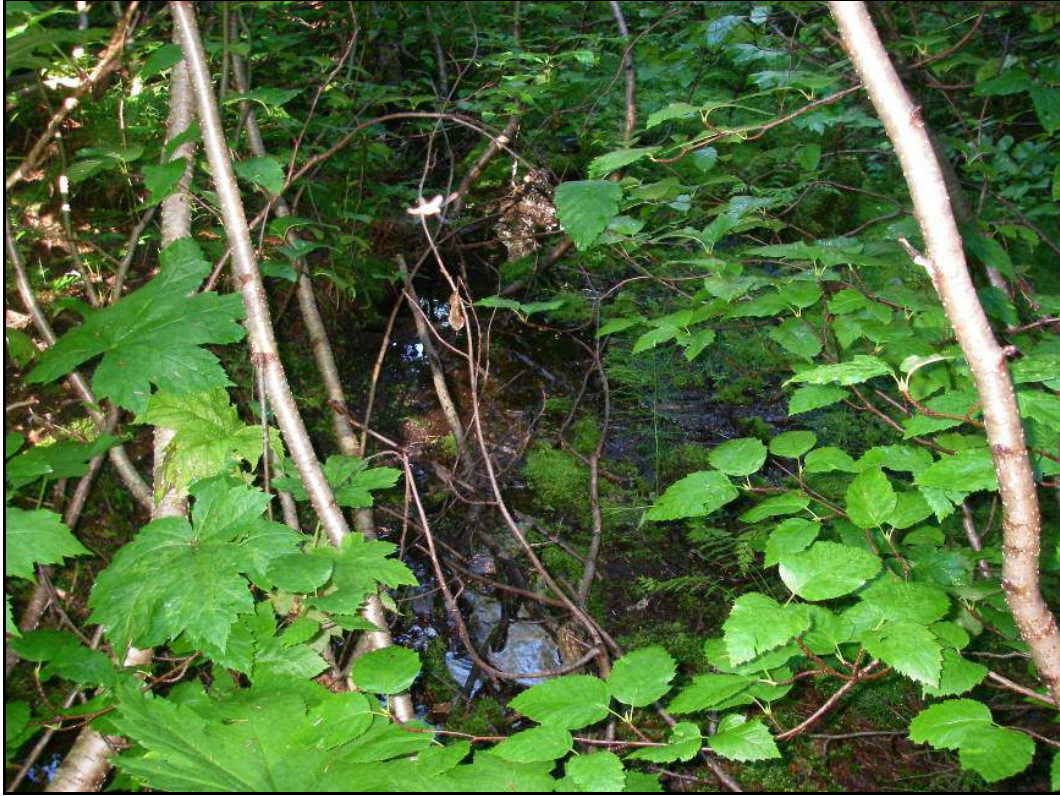
Site 145 – Downstream view

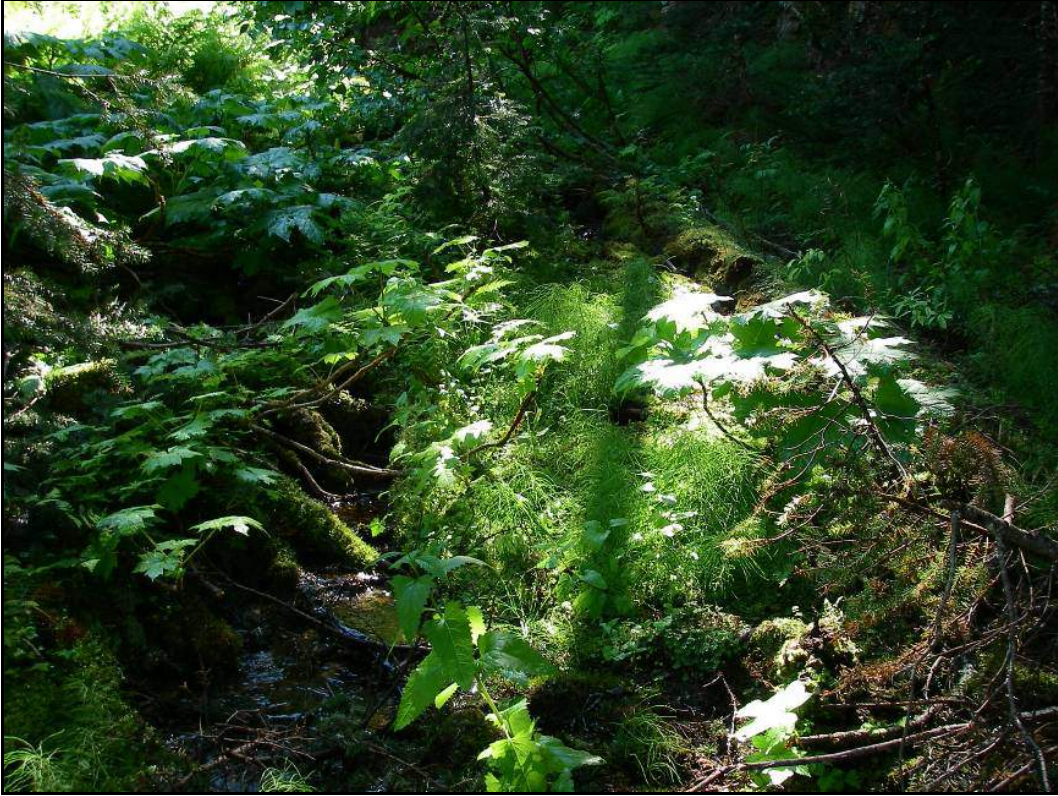
Watershed Code: 000-000000-00000-00000-0000-0000-000-000-000-000-000-000-000
Reach # 1.0 ILP Map # 104G.016 ILP # 1045 Site 146

COMMENTS	
Section	Comments
CHANNEL	S6 - wide poorly defined unconfined stream with multiple channels through moss and shrubs. No barriers ds to mess cr. Soft banks, no good for arch cv.

Site 146 – Upstream view

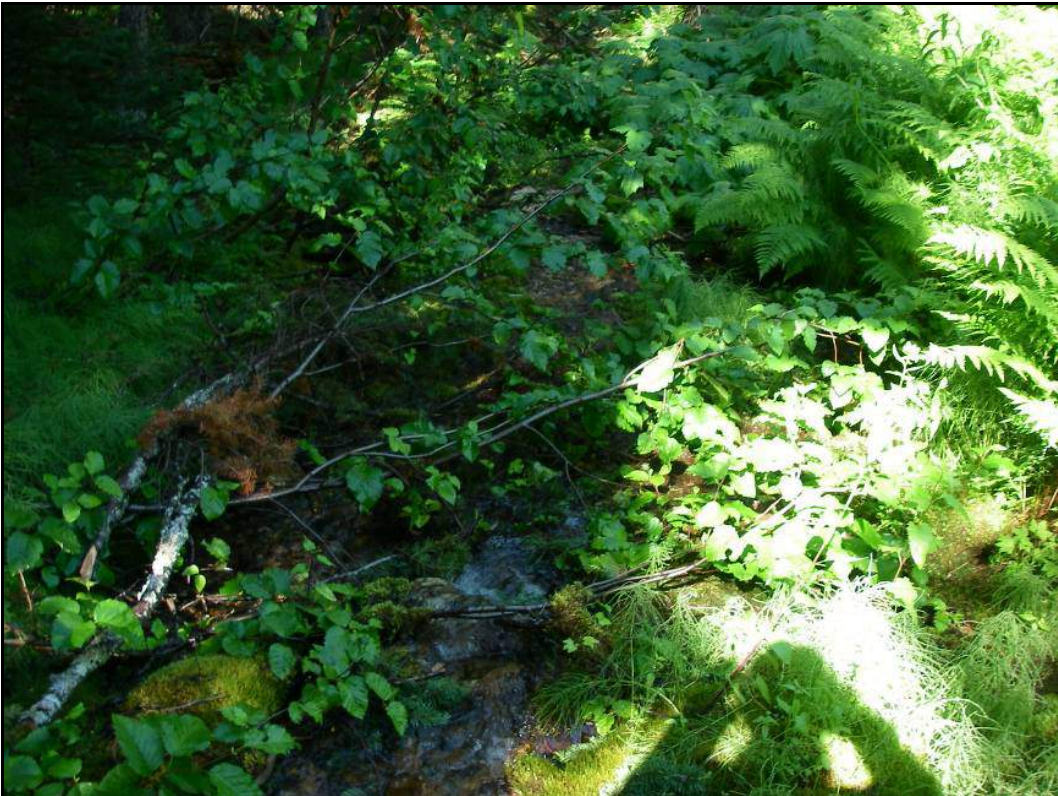
Site 146 – Downstream view

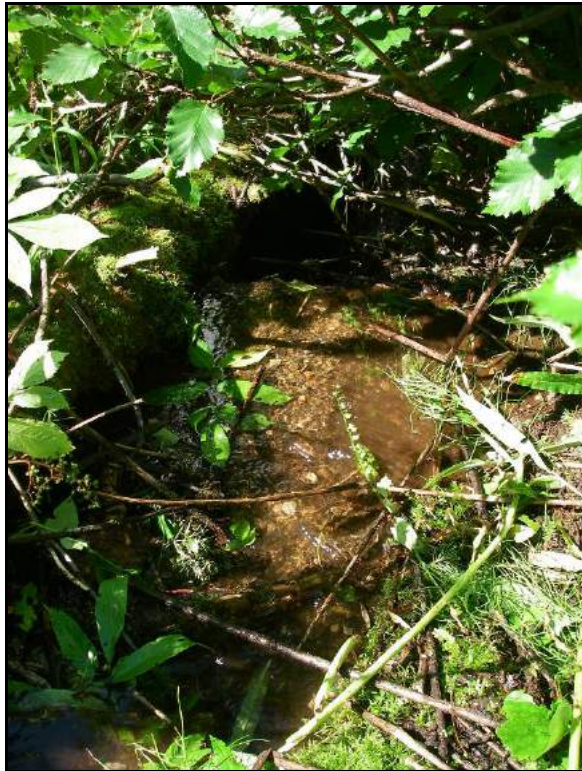
Site 147 – Downstream view

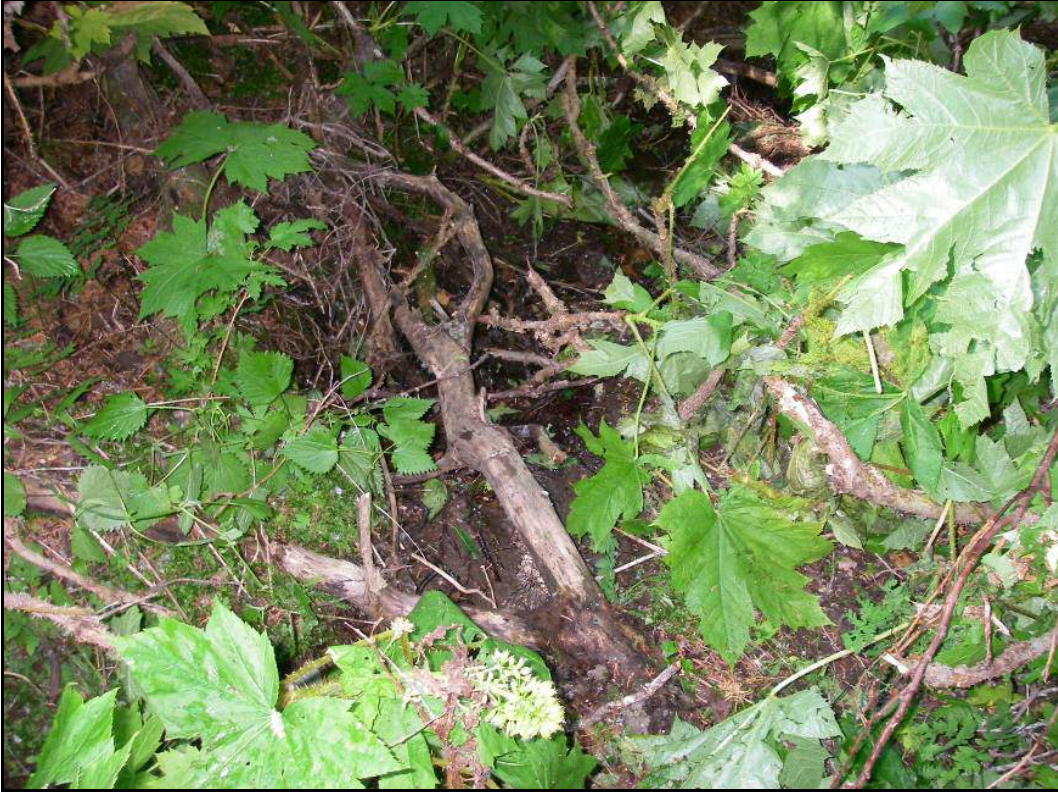
Section	Comments
CHANNEL	NCD - pockets of channelization interspersed with subsurface flow, overland flow and seepage. Not continuous.
SITE CARD	NCD

Site 149 – Downstream view

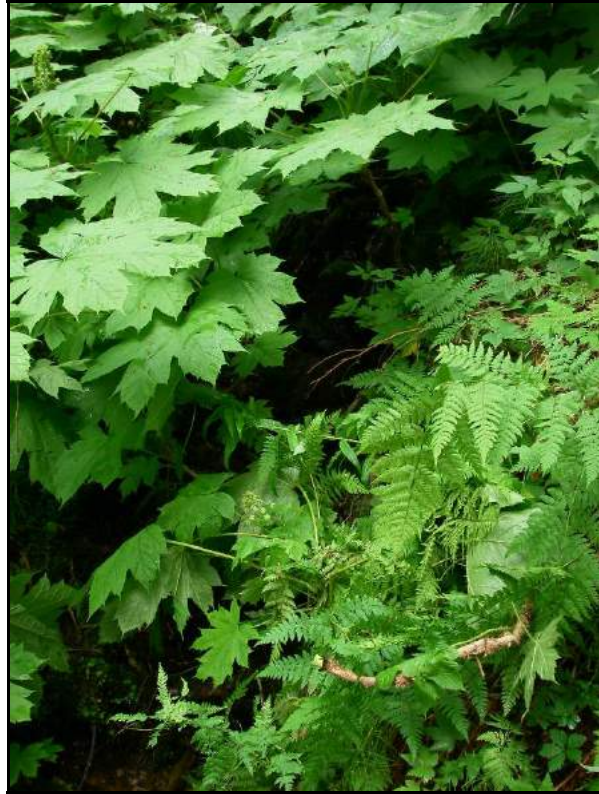
Photo	Foc Lg	Dir	Comments
R: 101 F: 4051	STD	U	at rc
R: 101 F: 4052	STD	D	ds of rc to mess cr.

Site 150 – Upstream view

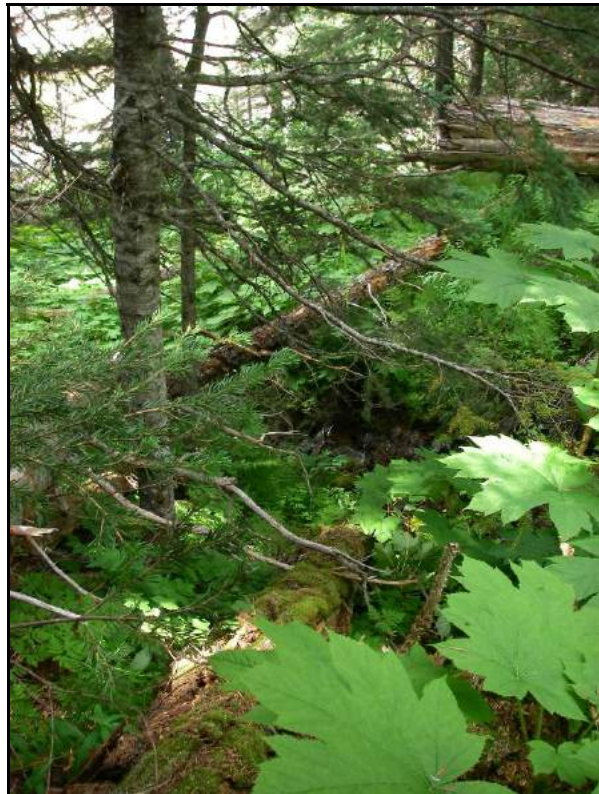
Site 150 – Downstream view

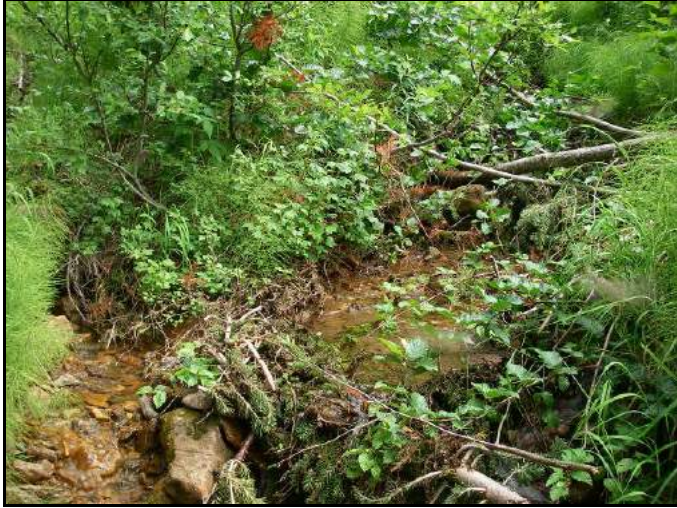
Watershed Code: 000-000000-00000-00000-0000-0000-000-000-000-000-000-000
Reach # 1.0 ILP Map # 104G.016 ILP # 1050 Site 151

COMMENTS	
Section	Comments
CHANNEL	S6 - evidence of avalanche debris - lots. Small stream through avalanche chute. Marginal habitat.

Site 151 – Upstream view

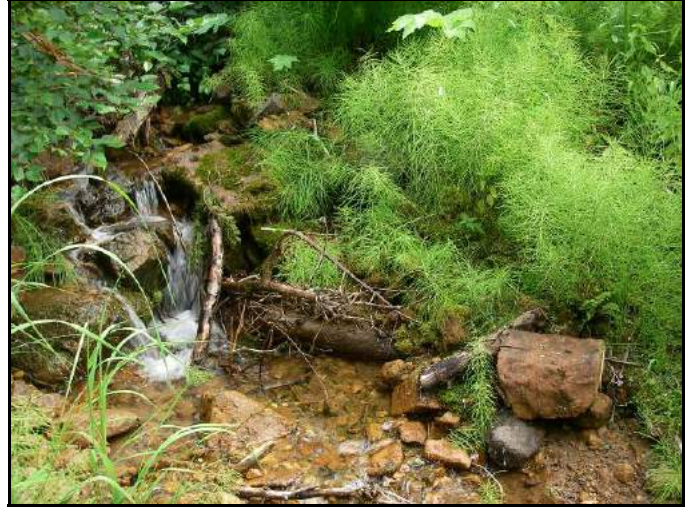
Site 151 – Upstream step-pool morphology

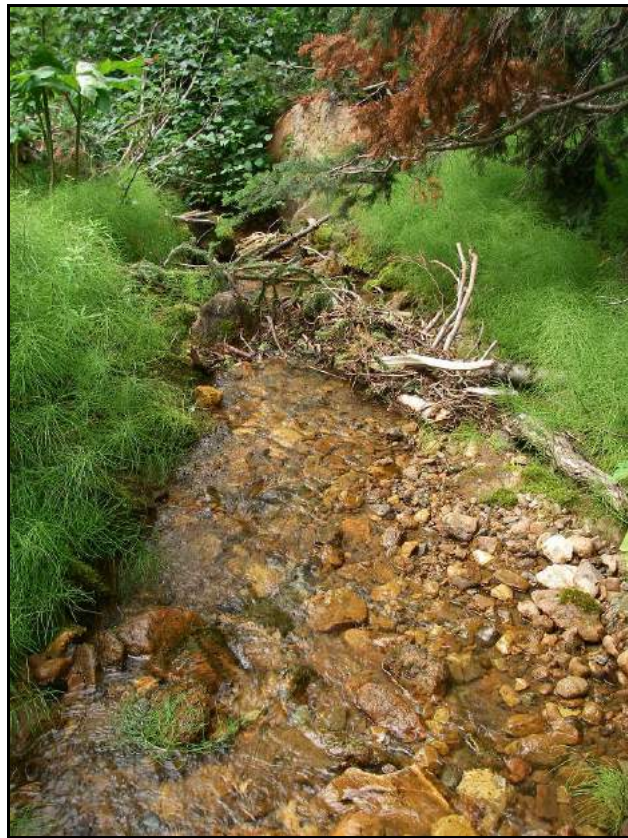
Site 151 – Downstream view

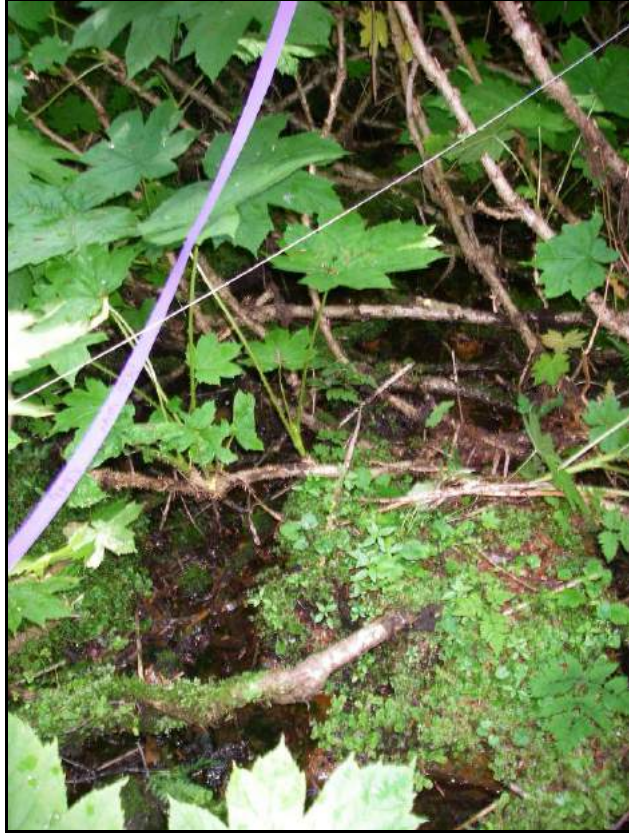
Section	Comments
CHANNEL	NCD - some surface water and flow, but no channel.
SITE CARD	NCD

Site 152 – Downstream seepage

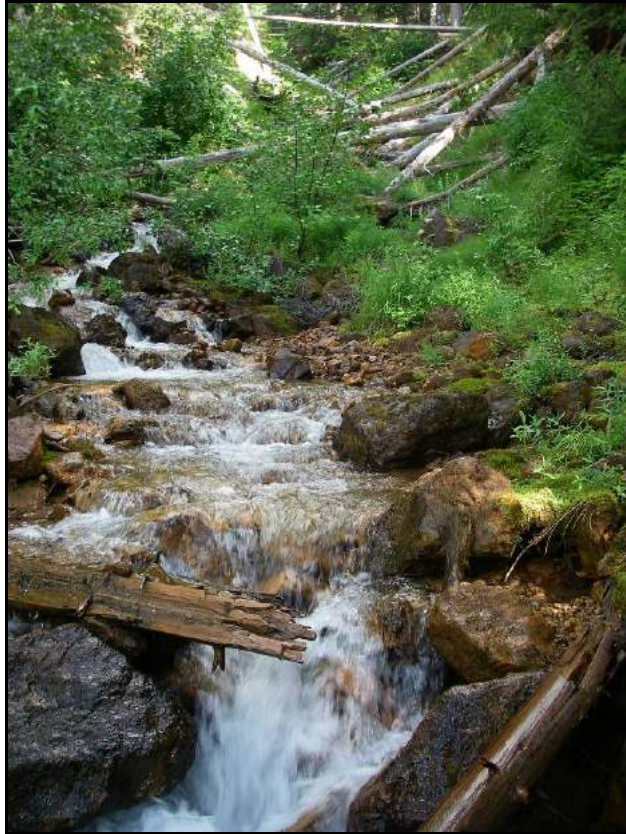
Reach #	ILP Map #	ILP #	Site
1.0	104G.016	1052	153

COMMENTS	
Section	Comments
CHANNEL	S3 Default - ds of rc nice stream with sp morph - lots of cover and good pools. Us of rc evidence of debris flow, extensive scour and downrutting. Still good pools, but less cover 24% slope. Important habitat in places. Return to EF.

Site 153 – Upstream scoured valley

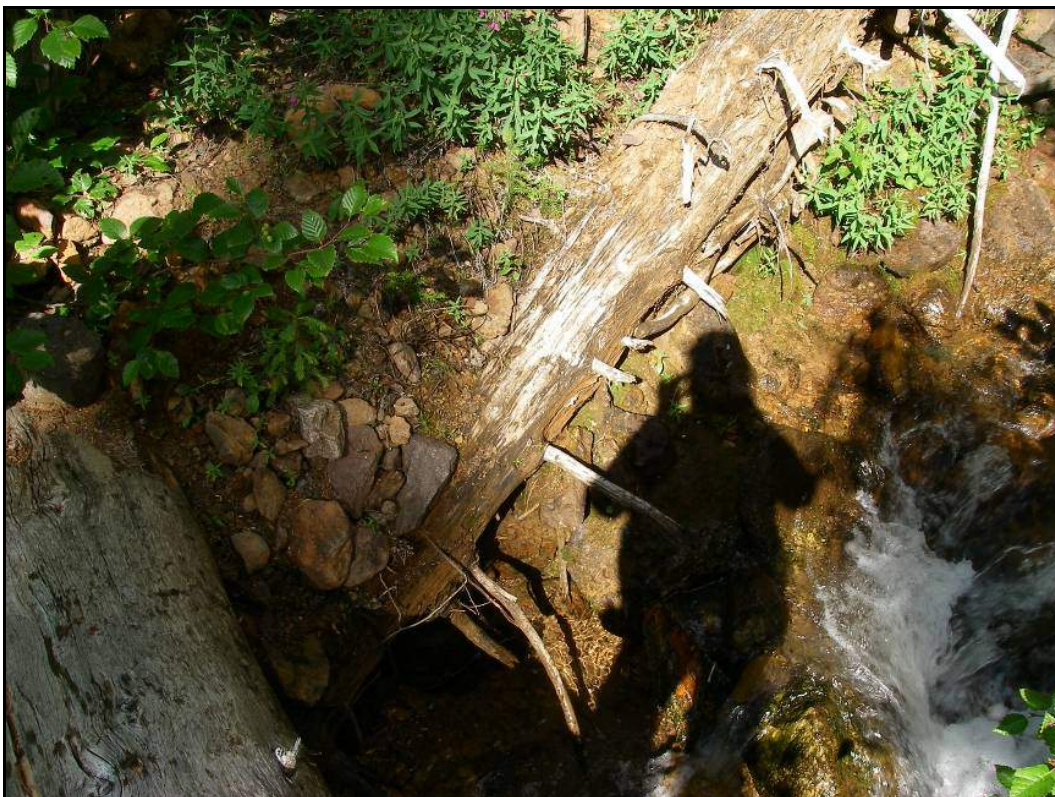
Site 153 – Across view, deposited debris on left bank

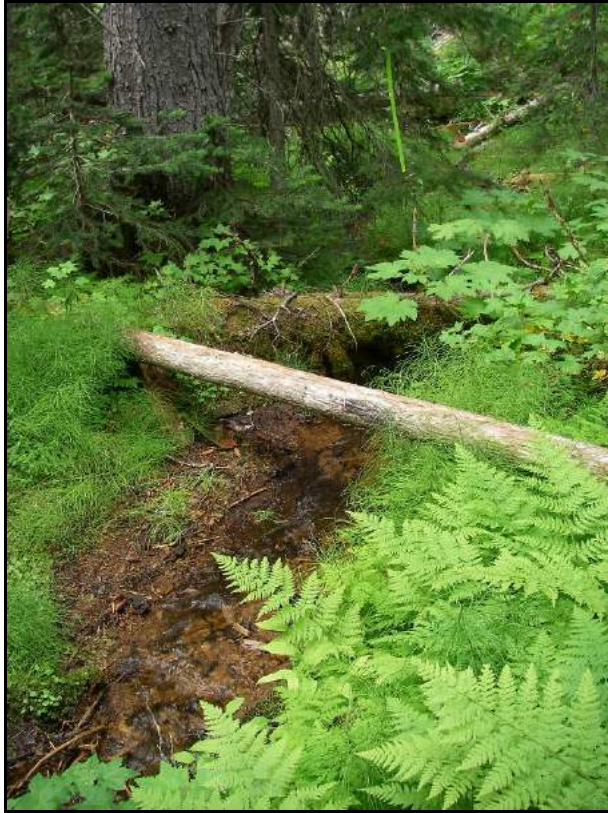
Reach #	ILP Map #	ILP #	Site
1.0	104G.016	1056	157

COMMENTS	
Section	Comments
CHANNEL	S4 Defult - 3 streams join at rc - this is the southernmost. Small gravel stream, good flow but shallow. Few pools. Connected to mess Cr. With out barriers. Marginal habitat.

Site 157 – Downstream view

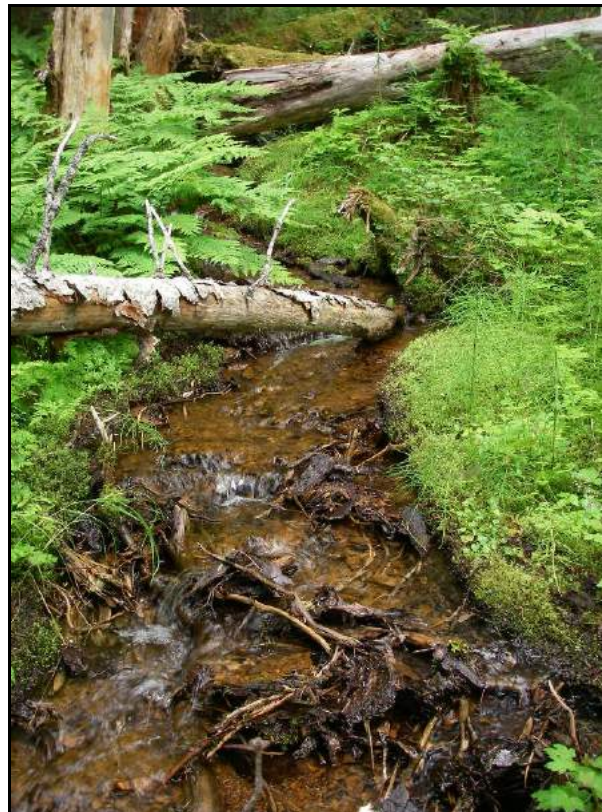
Site 157 – Upstream view

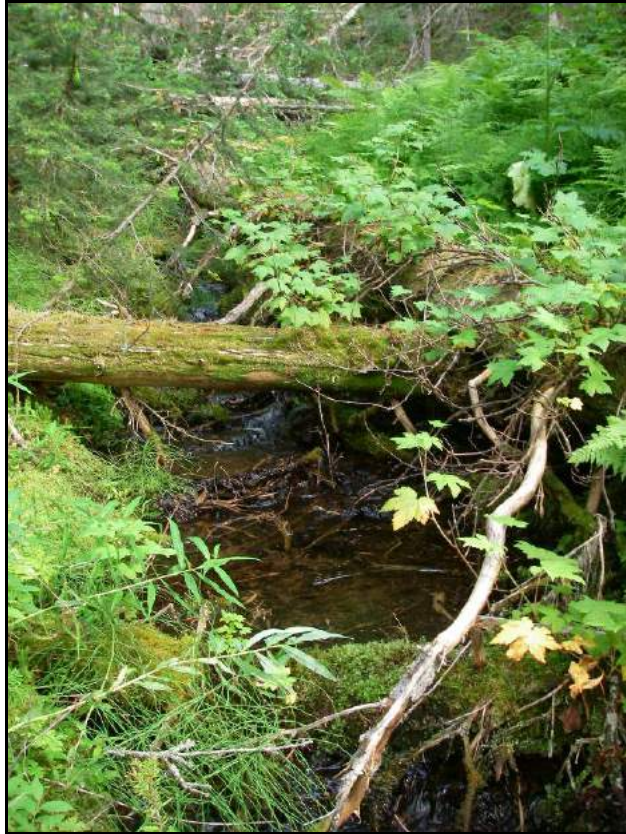
Photo	Foc Lg	Dir	Comments
R: 101 F: 4071	STD	U	us of rc
R: 101 F: 4072	STD	D	us of rc

Site 158 – Upstream view

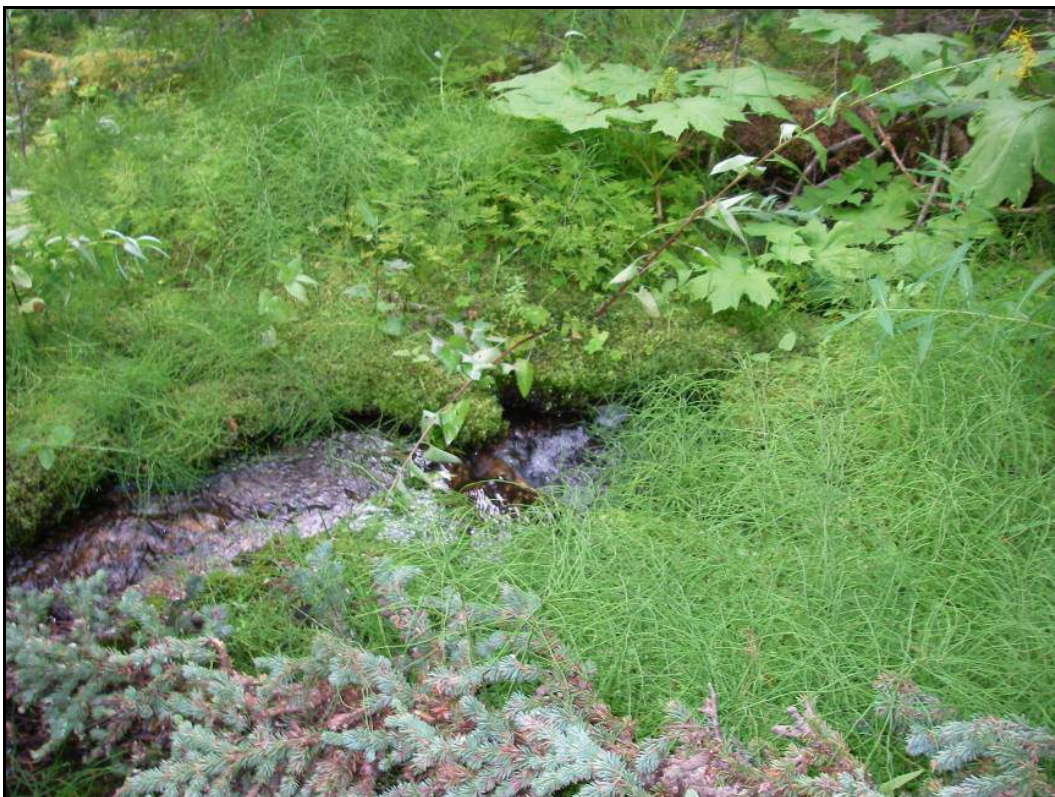
Site 158 – Downstream view

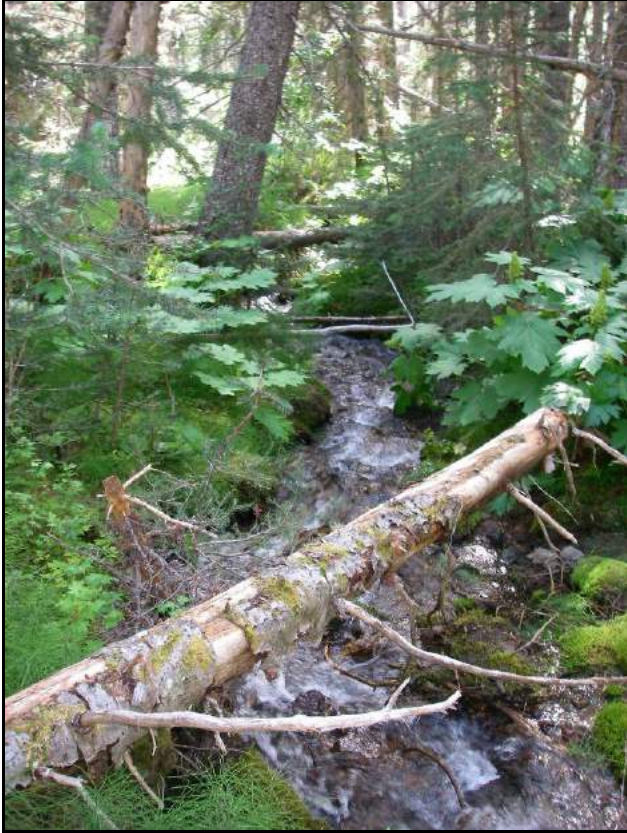
Site 159 – Downstream cascade

PHOTOS					
Photo		Foc Lg	Dir	Comments	
R:	101	F: 4076	STD	D	ds from rc to Mess Cr.
R:	101	F: 4086	STD	U	critical sp habitat at outlet to Mess Cr.
R:	101	F: 4087	STD	D	critical sp habitat at outlet to Mess Cr.
COMMENTS					
Section		Comments			
CHANNEL		S4 Default - Low gradient, connected to Mess Cr. 3rd stream at rc M53. main waterbody - good flow but fast, steeper and few pools. Excellent spawning habitat at outlet to Mess Cr. Recommend bridge.

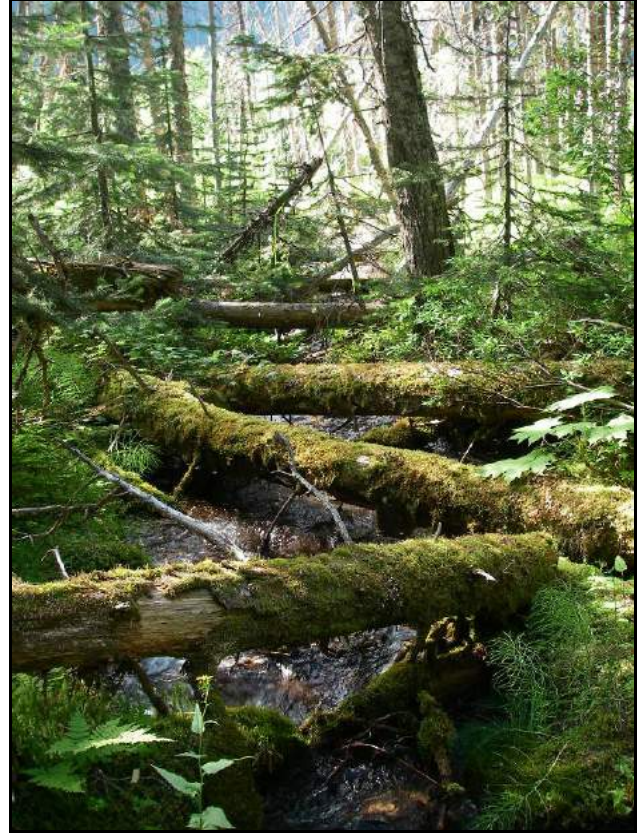
Site 159 – Downstream view

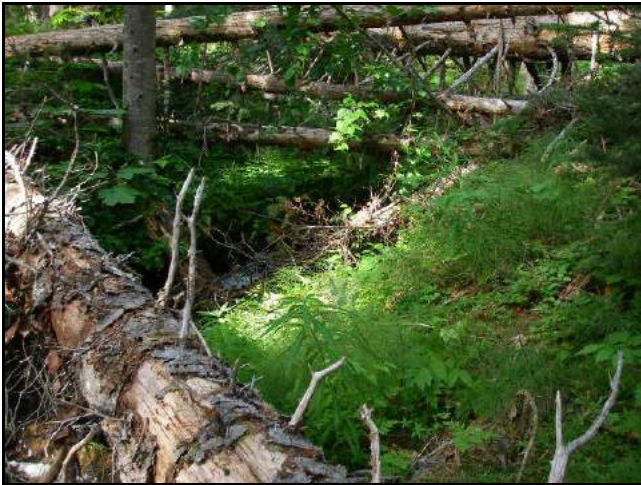
Site 159 – Upstream viewSite

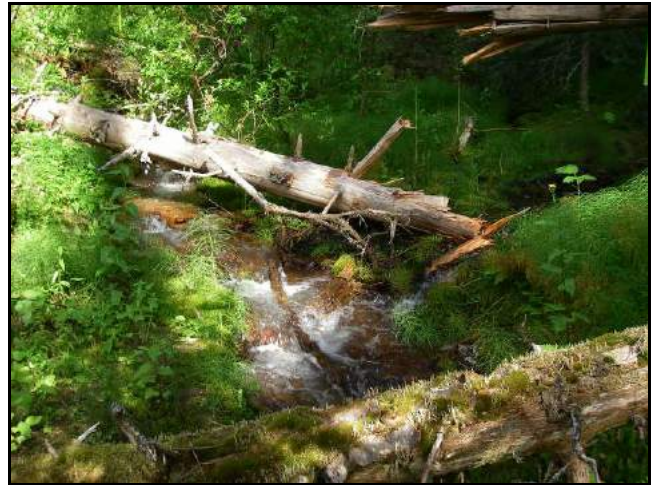
159 – Upstream showing 3 streams joining

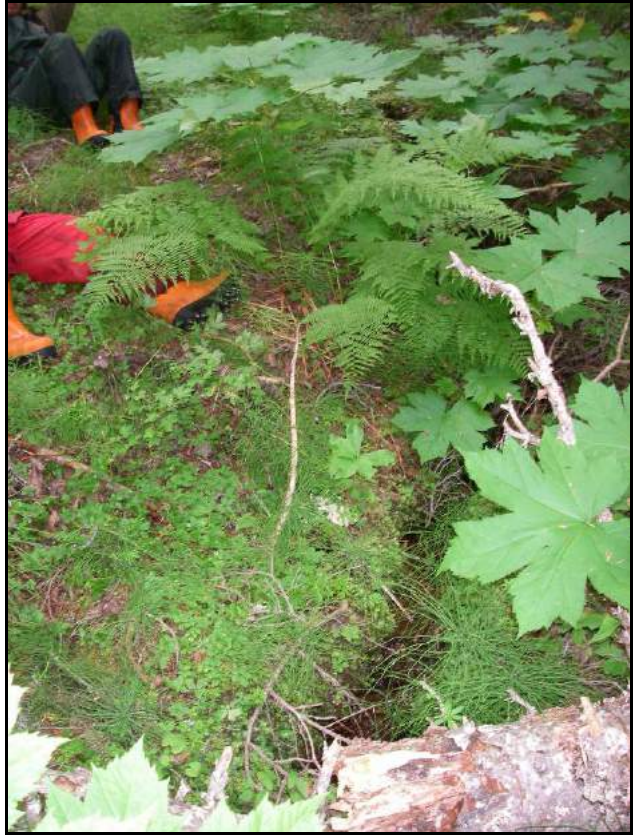
Reach #	ILP Map #	ILP #	Site
1.0	104G.026	1059	160

CHANNEL	NCD - w/-5m of channel @ rc - underground flow everywhere else.
SITE CARD	NCD

Site 160 – Upstream NCD

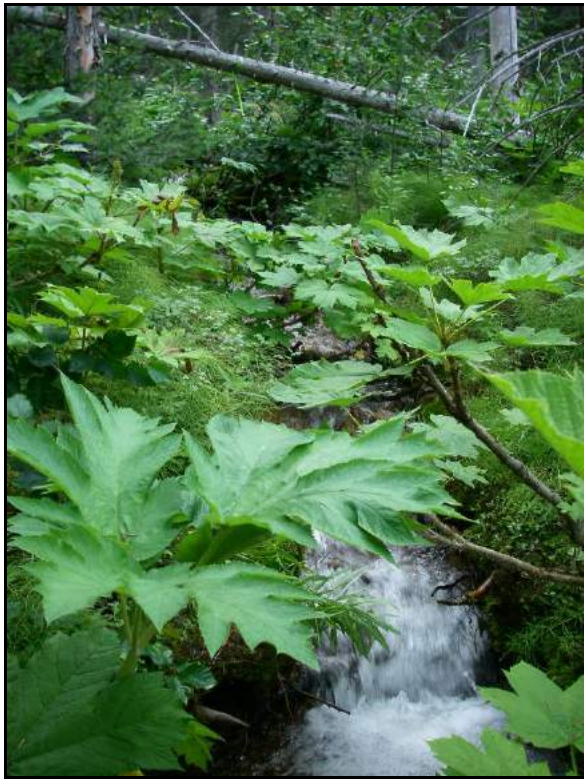
Reach # 1.0 ILP Map # 104G.026 ILP # 1060 Site 161

PHOTOS					
Photo		Foc Lg	Dir	Comments	
R:	102	F: 4089	STD	U	pool and cascade
R:	102	F: 4090	STD	U	look us to rc
R:	102	F: 4091	STD	NS	falls
COMMENTS					
Section		Comments			
CHANNEL		S6 - swift shallow stream, cascades w/some steps. Possible barrier (~1m falls) located ~30m ds of rc. Ds pool is 30cm deep.

Site 161 – Upstream pool and cascade

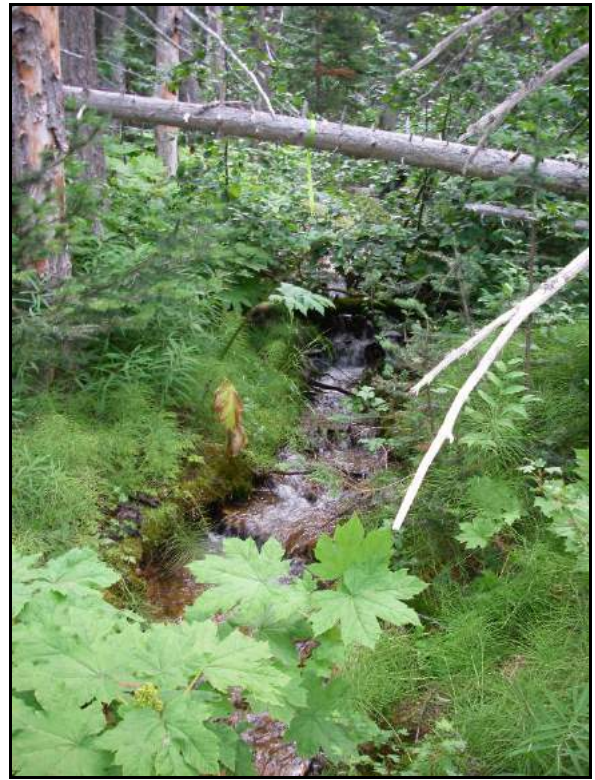
Site 161 - Upstream

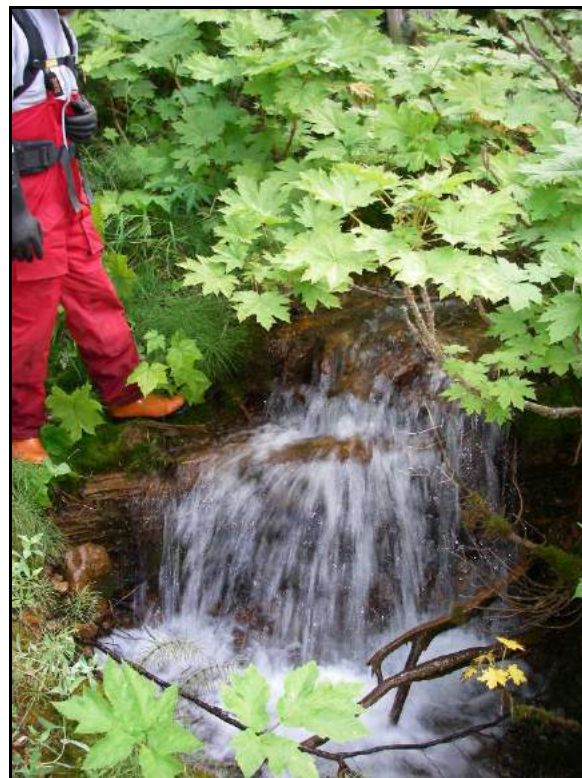
Site 161 – Falls

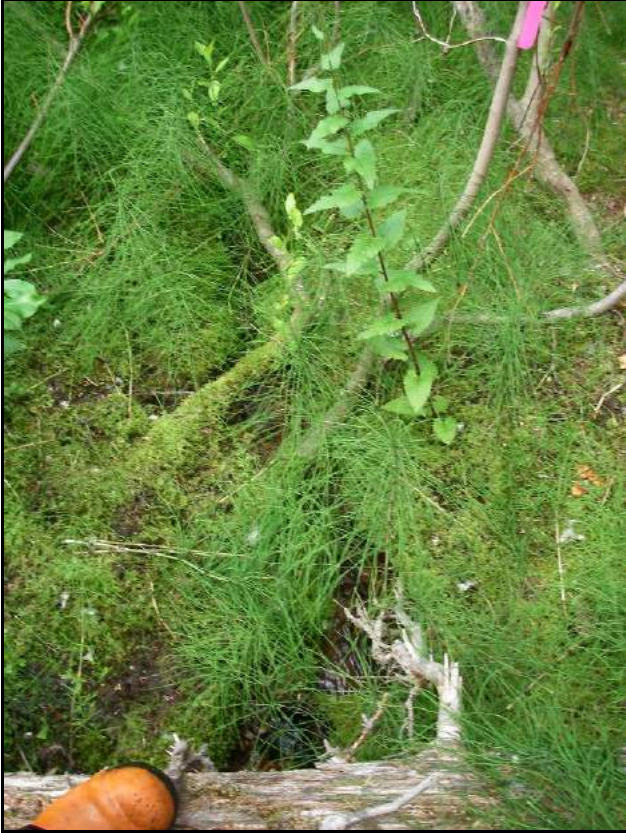
Reach #	ILP Map #	ILP #	Site
1.0	104G.026	1061	162

COMMENTS	
Section	Comments
CHANNEL	NCD - small, partially scoured NCD, scoured down to Mess Cr but overland flow us of rc. Very narrow and shallow. Flows into FSZ @ Mess Creek. Take care to keep construction well back from here. Move alignment us slightly.
SITE CARD	NCD

Site 162 – Downstream scour

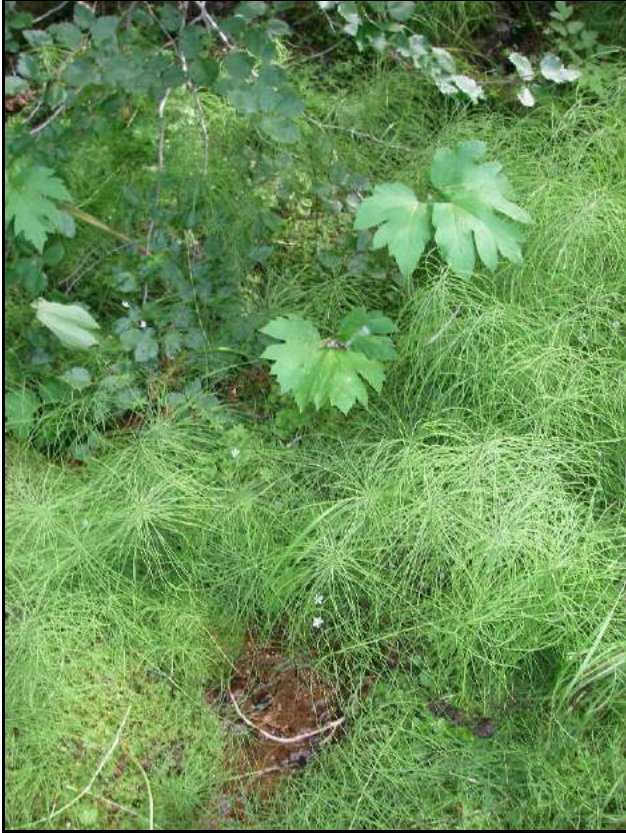
Site 162 – Upstream scour and overland flow

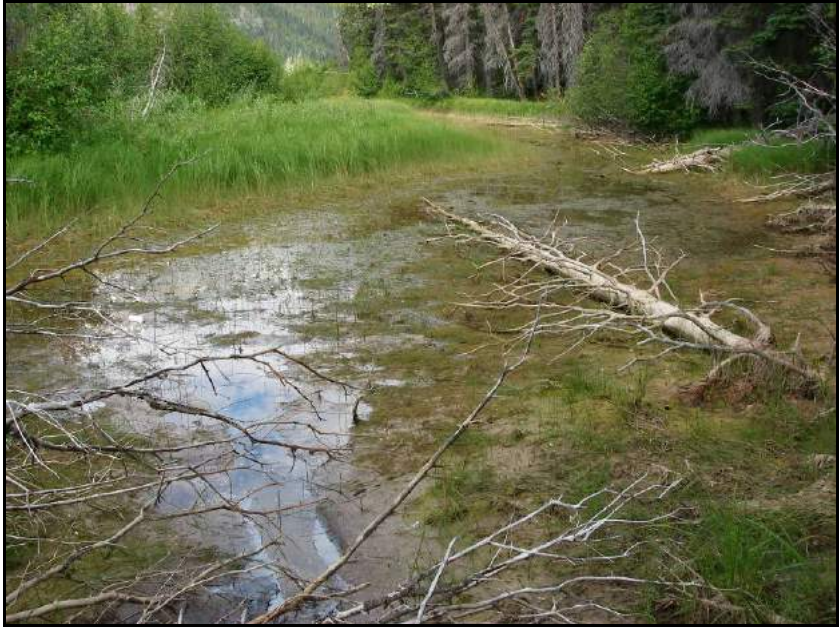
Site 162 – FSZ at outlet

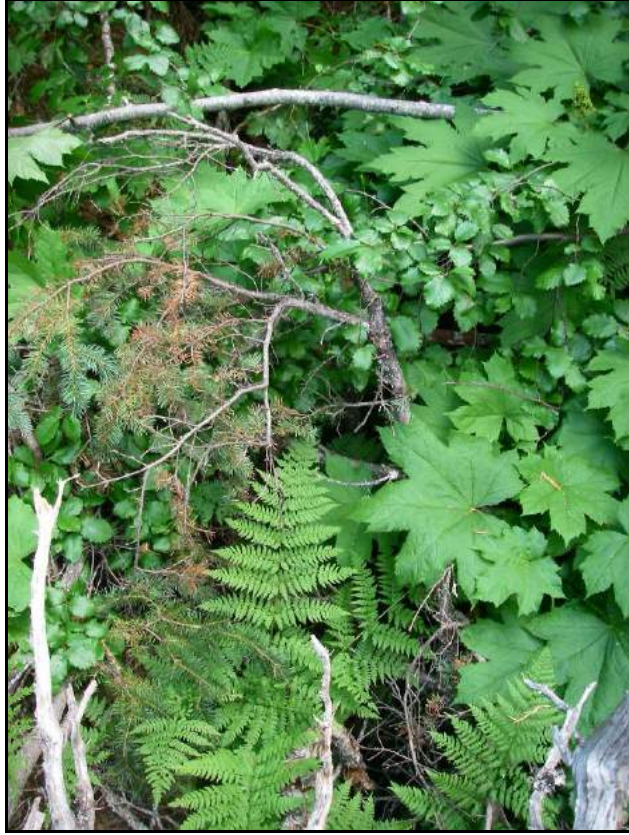
Section	Comments
CHANNEL	NCD - partially channelized NCD. Flows over organic fines and debris @ rc. Very low flow.
SITE CARD	NCD

Site 163 – NCD covered by overhanging vegetation

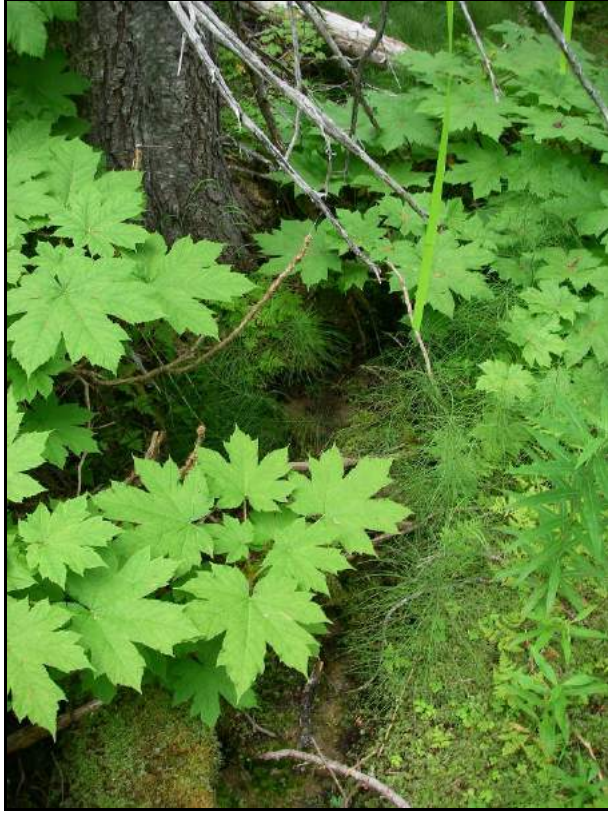
Reach #	ILP Map #	ILP #	Site
1.0	104G.026	1063	164

Section	Comments
CHANNEL	NCD - channelized in places but lots of overland and subsurface flow. Outflow into wetland ~15m ds of rc and 100m of approach on low chain side is within 15m of wl. Recommend moving upslope to avoid sidecast into wl and FSZ
SITE CARD	NCD

Site 164 – Downstream dry patch

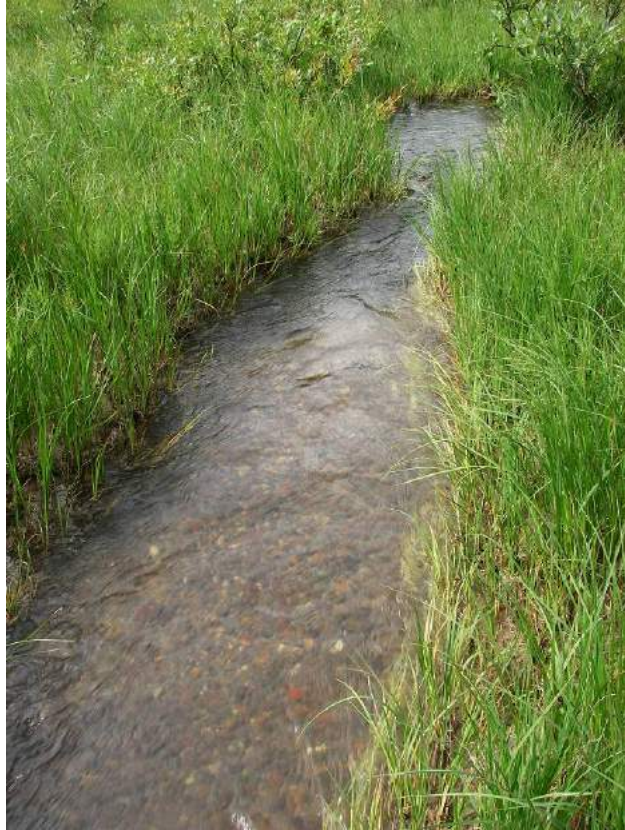
Site 165 – Downstream good spawning area

PHOTOS					
Photo		Foc Lg	Dir	Comments	
R:	102	F: 4098	STD	D	good spawning habitat in WL ds of rc
COMMENTS					
Section		Comments			
CHANNEL		S4 - steep stream w/marginal habitat at rc, flows into WL with great spawning and rearing habitat. Recommend bridge to avoid introducing sed to critical spawning habitat.

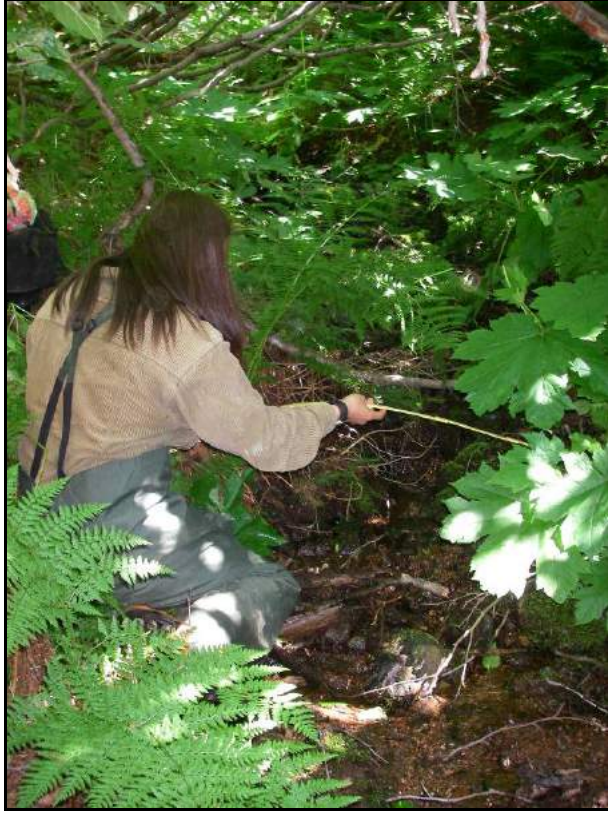
Site 166 – Upstream view

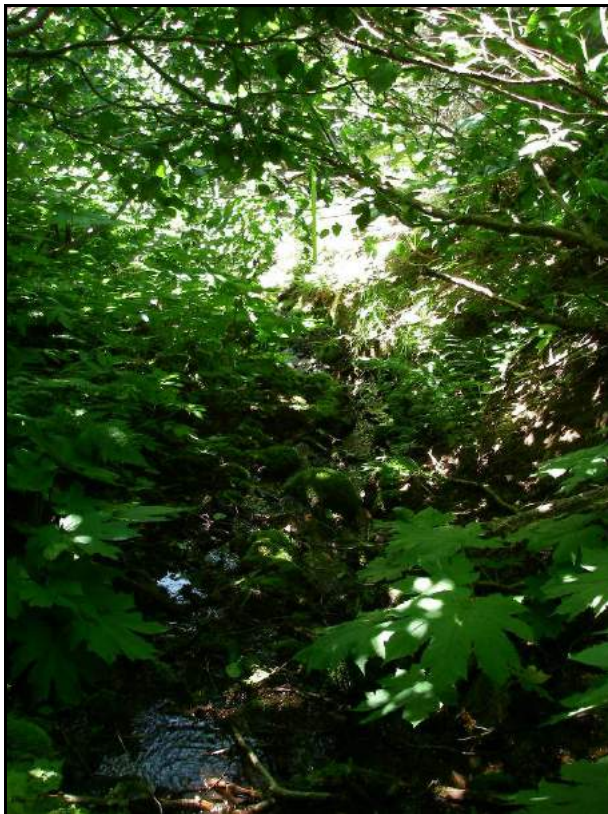
Site 166 – Downstream view

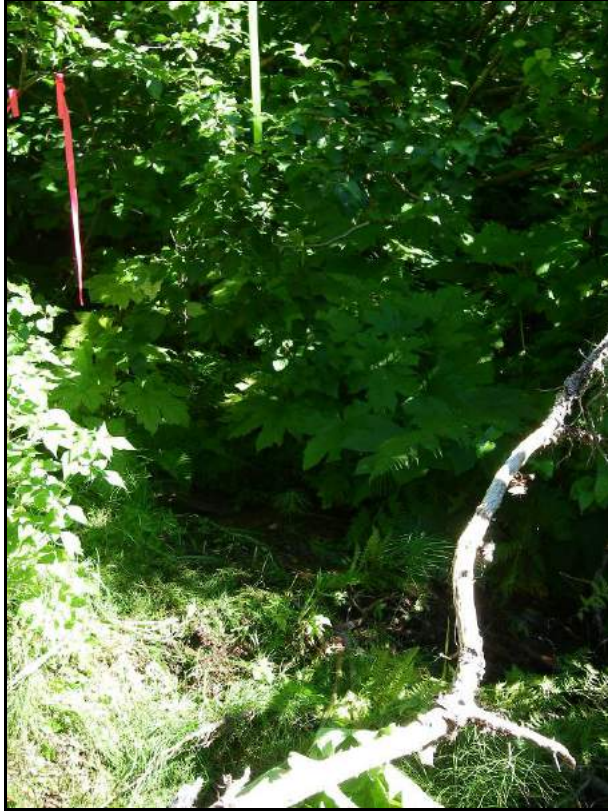
Photo	Foc Lg	Dir	Comments
R: 102 F: 4102	STD	U	at rc
R: 102 F: 4103	STD	U	swd ds of rc

Site 167 – Upstream view

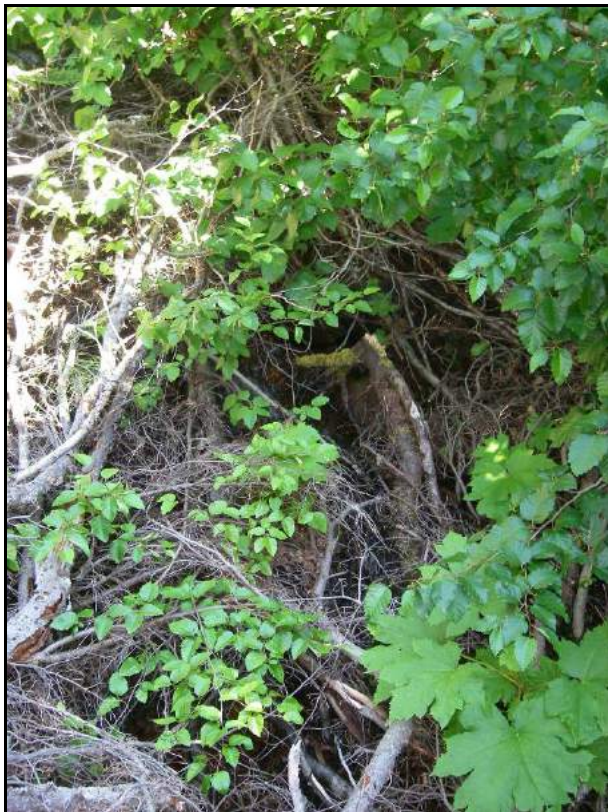
Site 167 – Upstream SWD

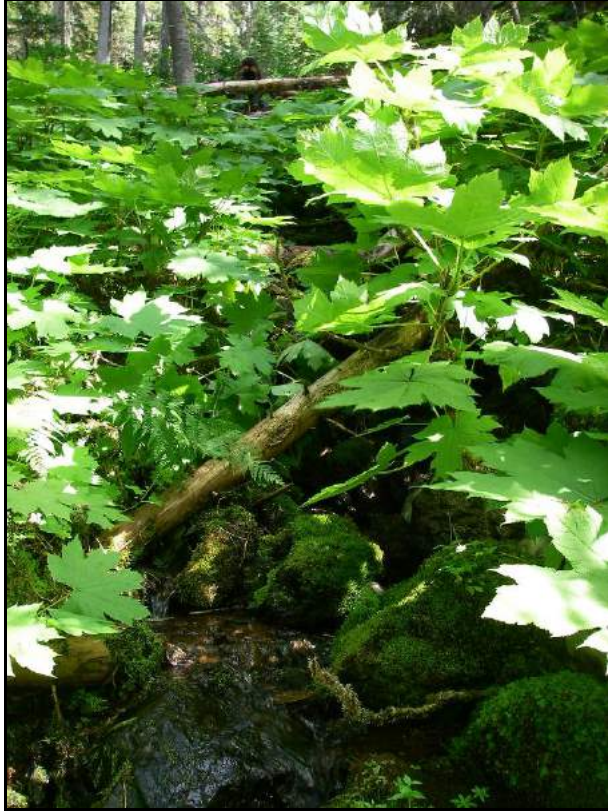
Site 168 – Upstream view

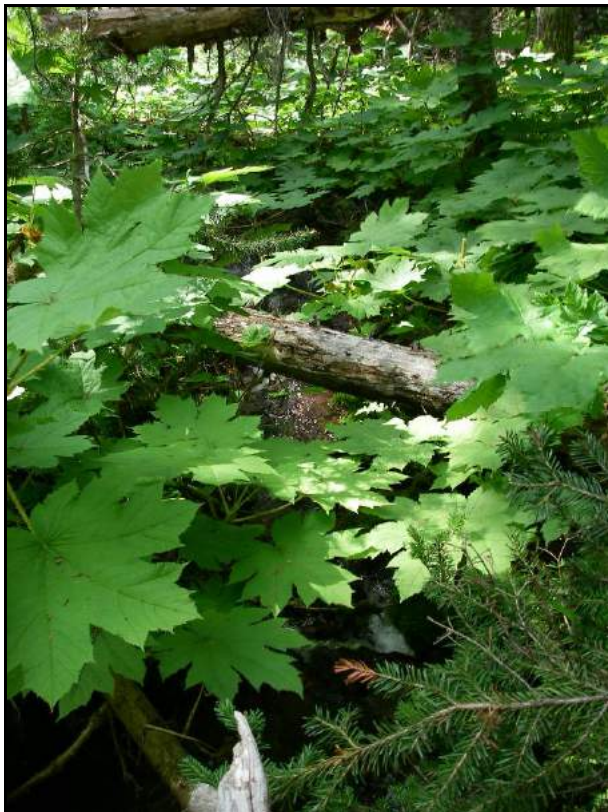
Site 168 – Downstream view

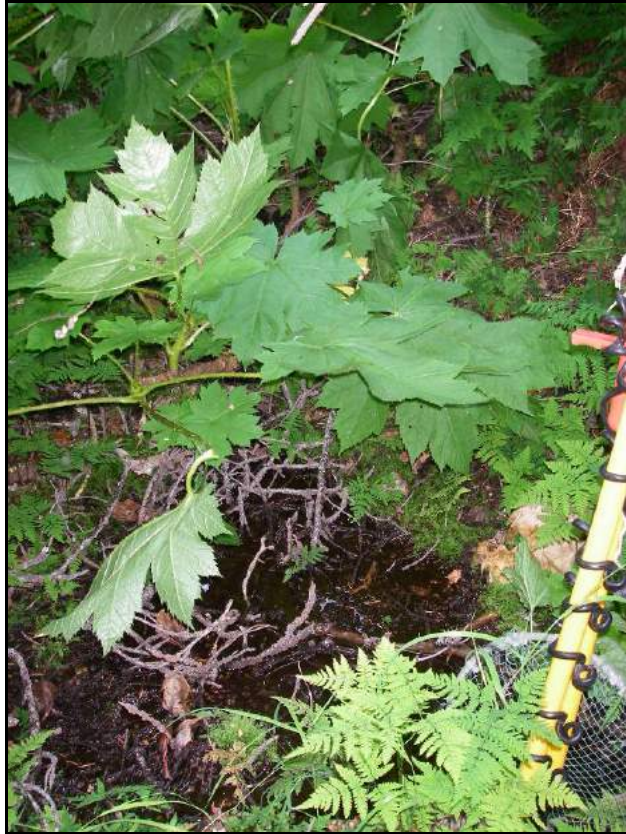
Section	Comments
CHANNEL	NCD - seepage w/some flow @ rc. No fish habitat.
SITE CARD	NCD

Site 169 – Upstream view, seepage, overland flow
