Schaft Creek Fisheries Baseline 2007

Rescan Tahltan Environmental Consultants
Vancouver, British Columbia

March 2008

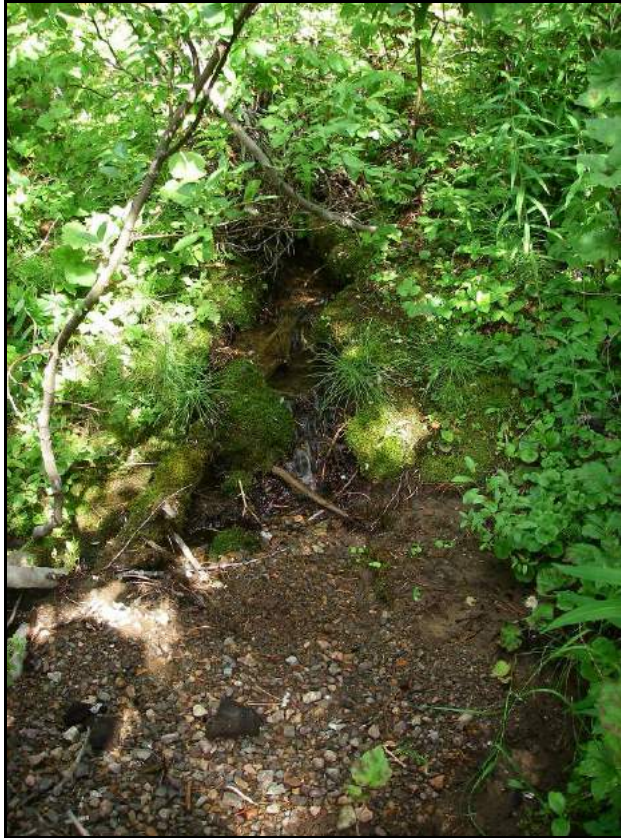
Watershed Code: 000-000000-00000-00000-0000-0000-000-000-000-000-000-000
Reach # 1.0 ILP Map # 104G.026 ILP # 1070 Site 171

-----	-----
CHANNEL	S6 - tiny little stream, sp through moss. High gradient, shallow, no fish habitat

Site 171 – Upstream view

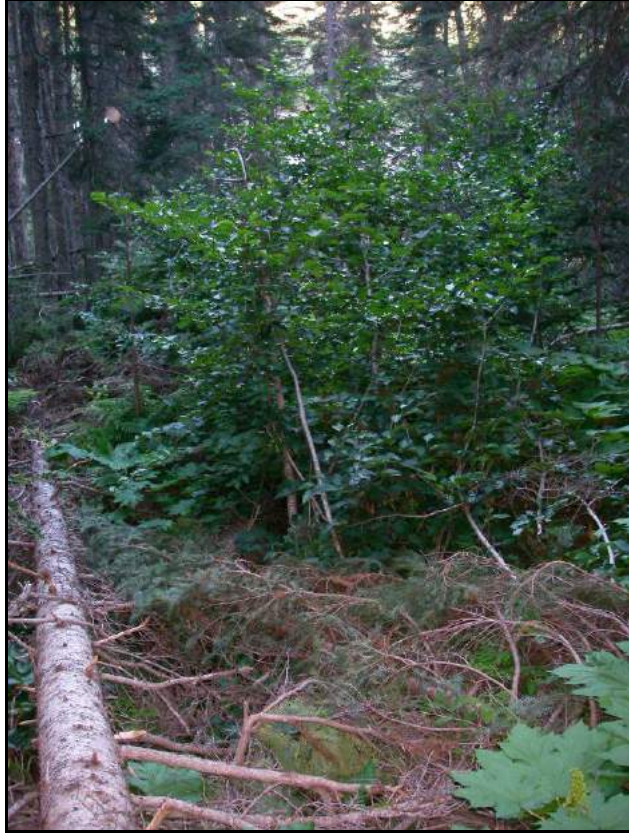
Section	Comments
CHANNEL	NCD - dry channel through dc and alder. No fish habitat.
SITE CARD	NCD

Site 172 – Downstream seepage draw

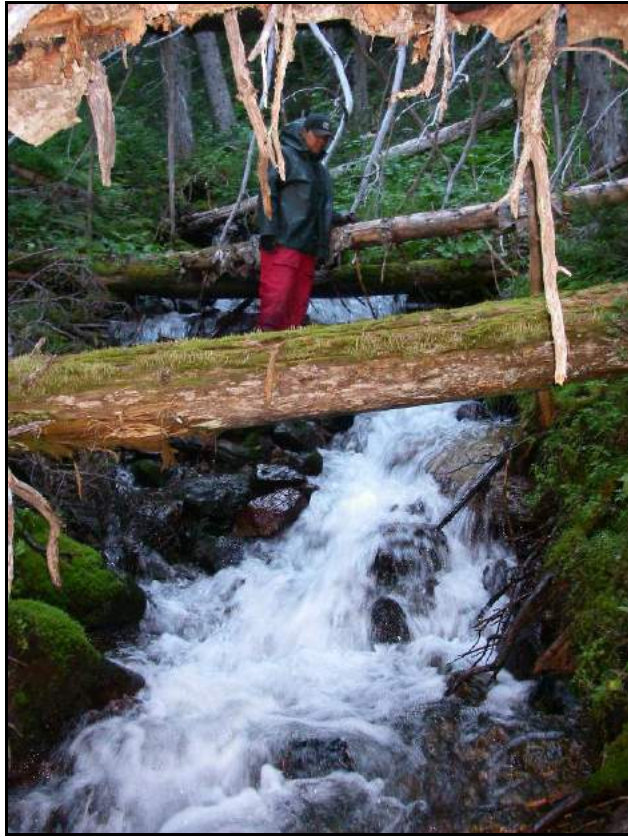
PHOTOS					
Photo		Foc Lg	Dir	Comments	
R:	100	F: 4120	STD	NS	2nd shot
R:	100	F: 4121	STD	NS	3rd shot
R:	100	F: 4122	STD	NS	4th shot
R:	100	F: 4123	STD	NS	5th shot
R:	100	F: 4124	STD	NS	6th shot
R:	100	F: 4125	STD	NS	7th shot
R:	100	F: 4126	STD	X	erosion and slope failure on rb at rc
R:	100	F: 4127	STD	U	slope failure on LB just us of rc
COMMENTS					
Section		Comments			
CHANNEL		S5 default - slopes on both banks failing. Stream at current rc is probably s5 but moving ds, might make it S3. couple of good cascade barriers ds of rc. Steps up to .8m.

Site 173 – Upstream steep cascade

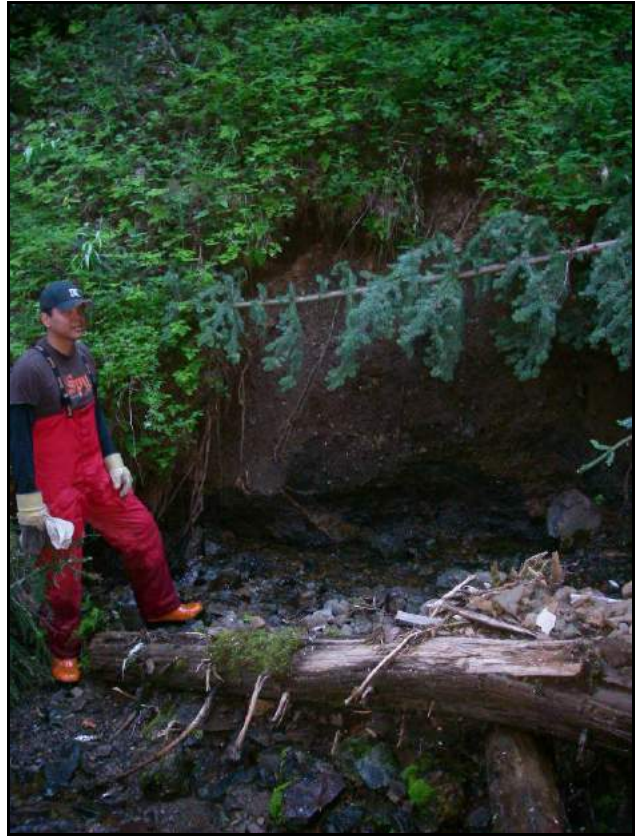
Site 173 – Upstream slope failure

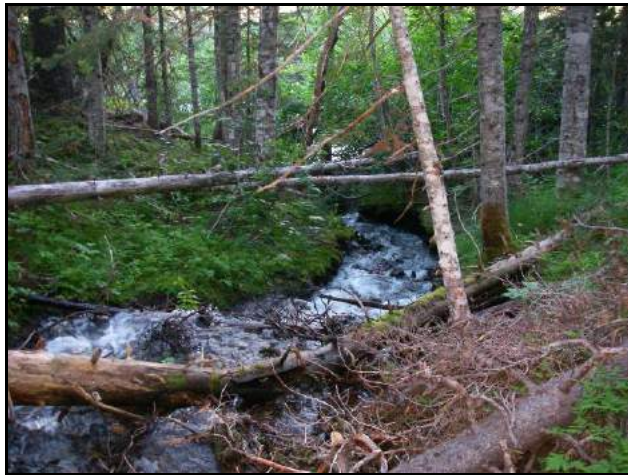
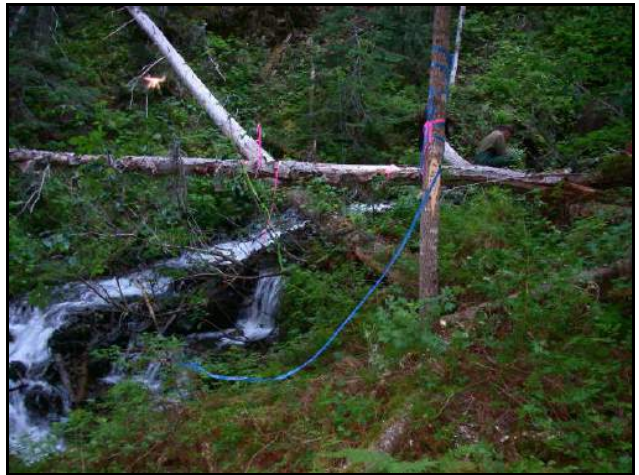
Site 173 – Downstream 20% cascade

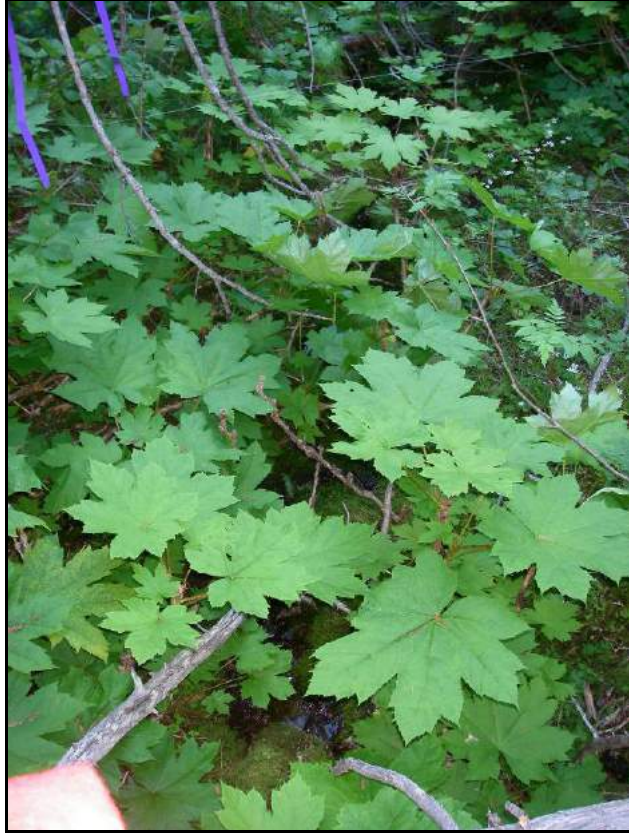
Section	Comments
CHANNEL	NCD - overland and seepage flow at rc. No fish habitat.
SITE CARD	NCD

Site 174 – Downstream NCD

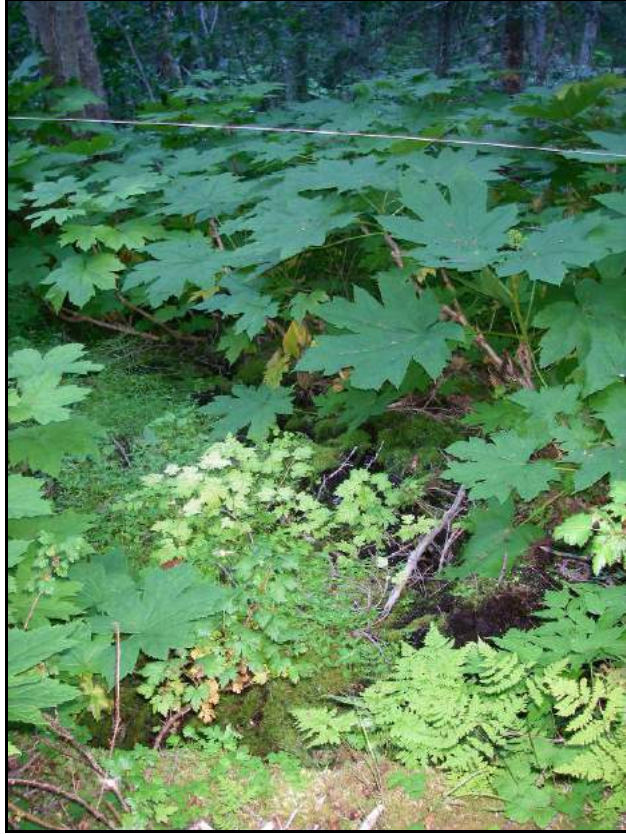
Section	Comments
CHANNEL	NCD - seepage through dc.
SITE CARD	NCD

Site 175 – Downstream seepage

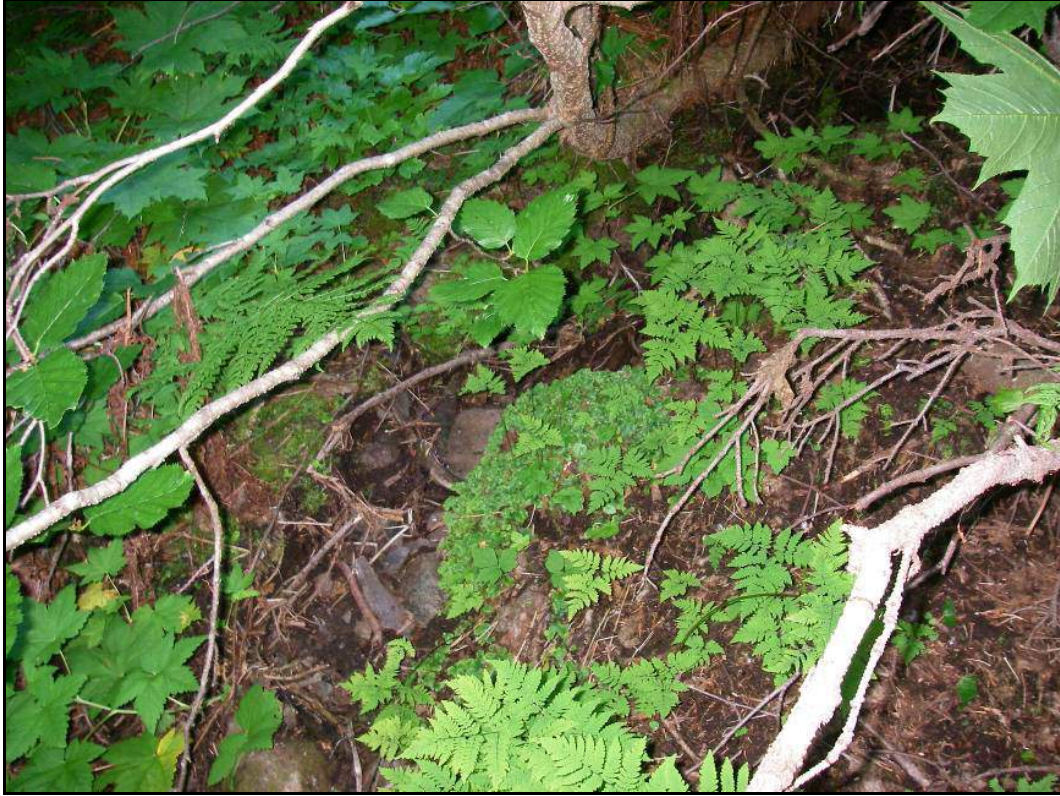
Section	Comments
CHANNEL	NCD - dry partially channelized NCD, no fish habitat.
SITE CARD	NCD

Site 176 – Upstream dry NCD

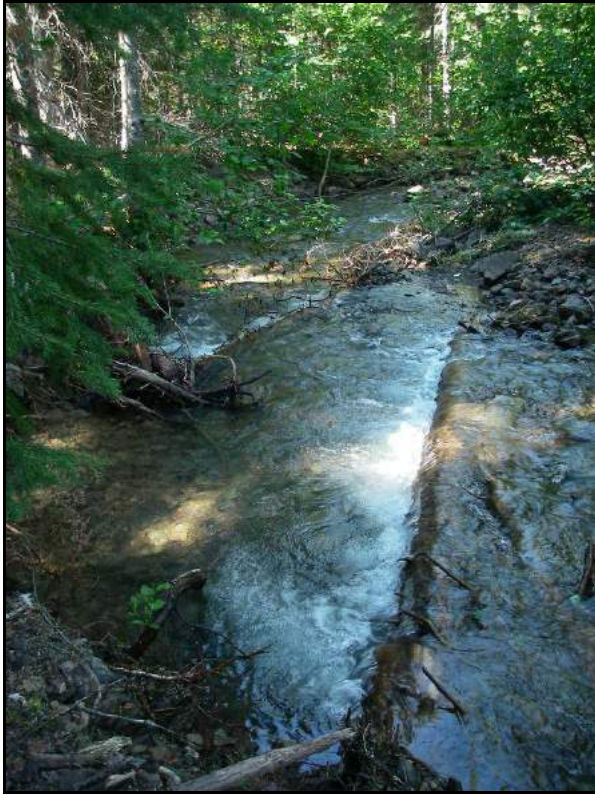
PHOTOS				
Photo		Foc Lg	Dir	Comments
R: 100	F: 4139	STD	X	deposited alluvial sand (this year) ds of rc
R: 100	F: 4140	STD	NS	8 angles for tc starting w/look ds and working clockwise. 4140-4147
COMMENTS				
Section		Comments		
CHANNEL		S2 - extensive evidence of debris flows/bedload movt. Alluvial deposits start 40m back from lb of stream. Old channels evident. Spreads out over alluvial fan as it approached mess cr. No barriers. Better bridge location 384904 6347060, more confined.

Site 179 – Downstream LWD

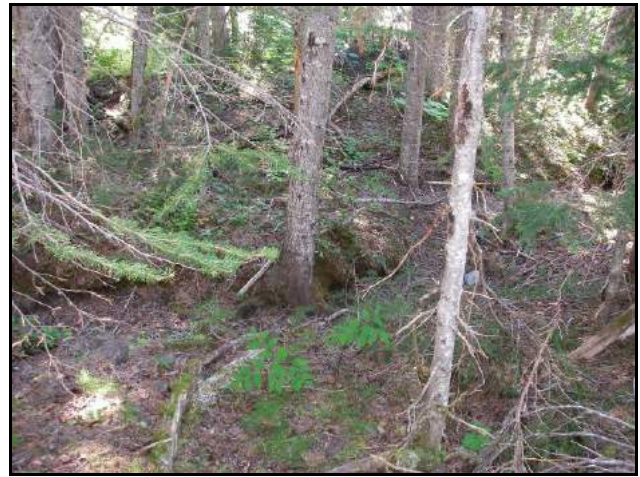
Site 179 – Downstream abandoned channel

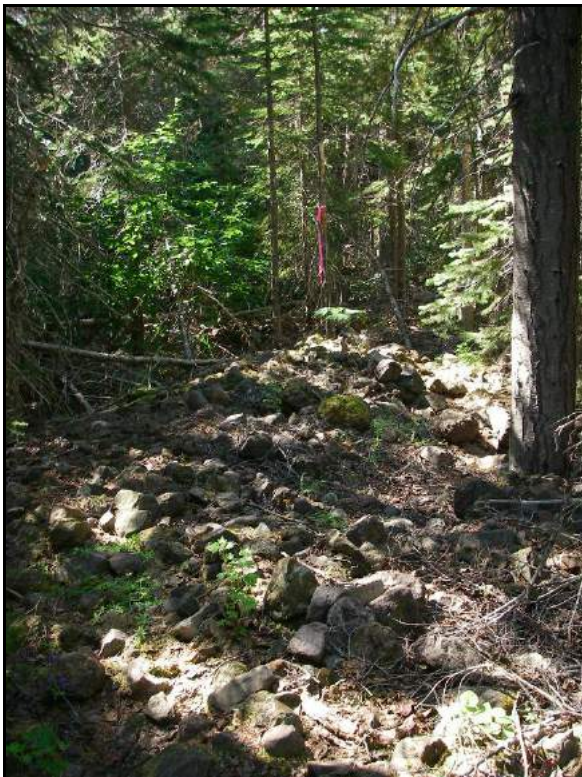
Site 179 – Deposited cobble and boulders

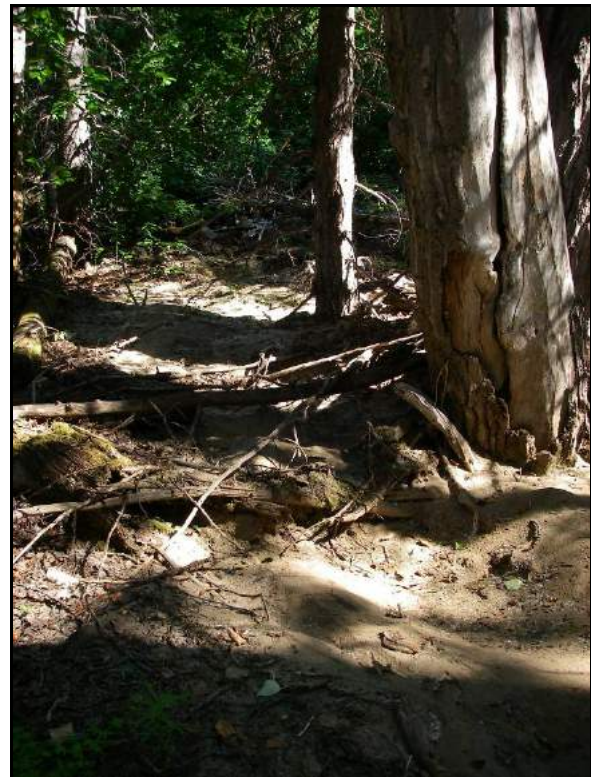
Site 179 – Deposited alluvial sand

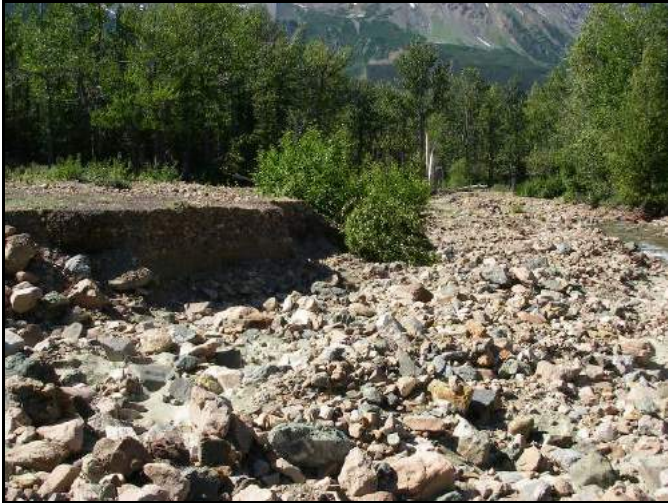
PHOTOS					
Photo			Foc Lg	Dir	Comments
R:	100	F: 4154	STD	NS	TC
R:	100	F: 4155	STD	NS	TC
R:	100	F: 4156	STD	NS	TC
R:	100	F: 4157	STD	NS	TC
R:	100	F: 4158	STD	NS	TC
R:	100	F: 4159	STD	NS	TC
R:	100	F: 4160	STD	D	fresh erosion on lb ds of rc
R:	100	F: 4161	STD	X	lb at crossing note alluvial fan and erosion
COMMENTS					
Section			Comments		
CHANNEL			S2 - very dynamic channel w/ wide floodplain (~80m wide w/ sparse alder & avens). Lots of evidence of bedload movement and channel migration. Banks are eroded. Bridge is @ narrowest spot b/w treed areas, but there is a wide alluvial floodplain just US.

Site 180 – Downstream fresh erosion

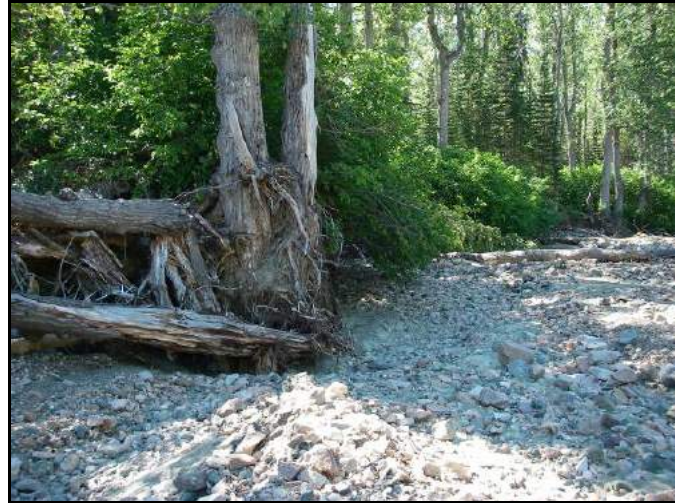
Site 180 – Downstream fresh erosion

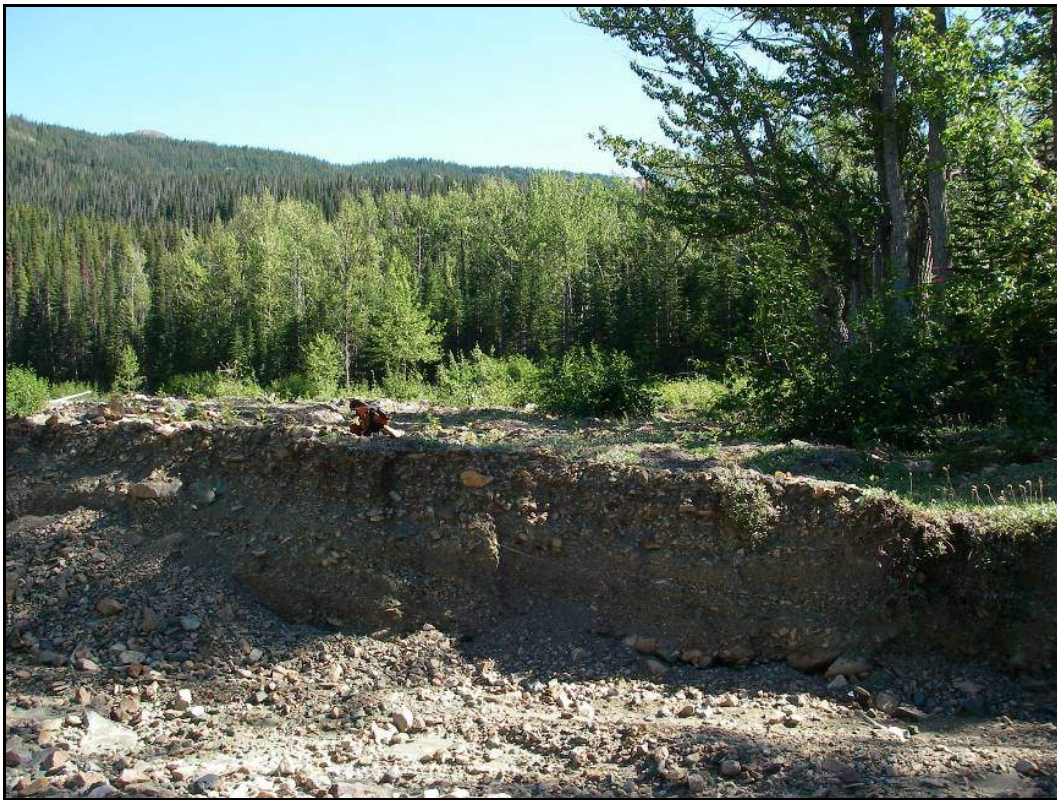
Site 180 – Left bank at crossing, note alluvial fan and erosion

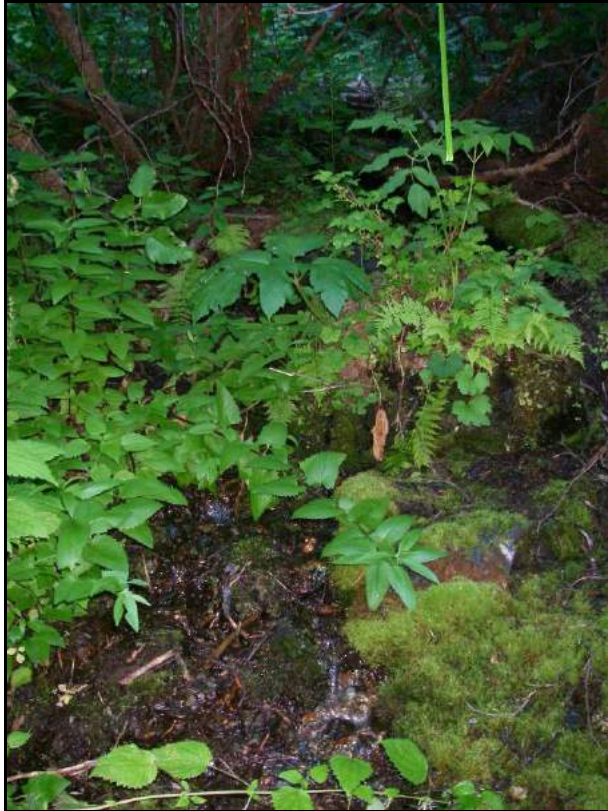
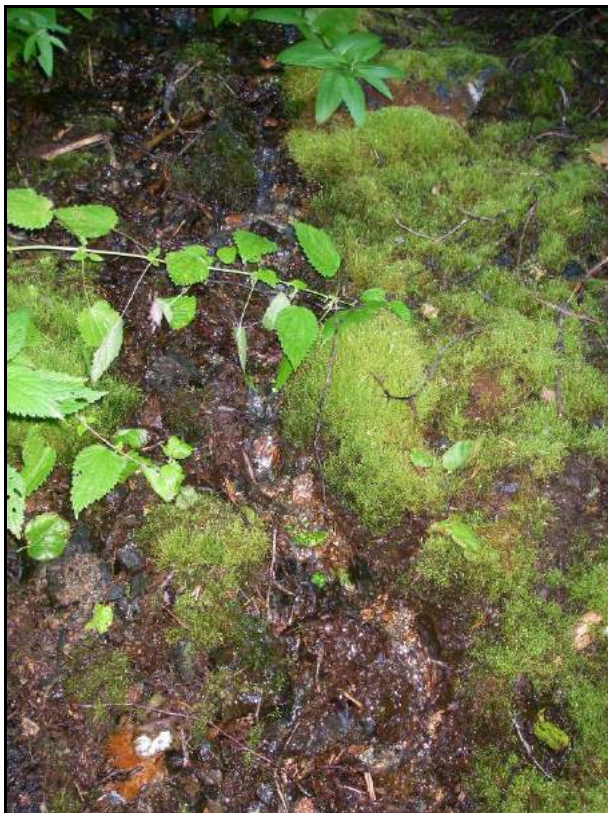
Section	Comments
CHANNEL	NCD - pours out of sprign at rc, partially channelized but mostly undefined overland flow. Turns into a stream ~30m ds of rc.
SITE CARD	NCD

Site 181 – Close up of NCD

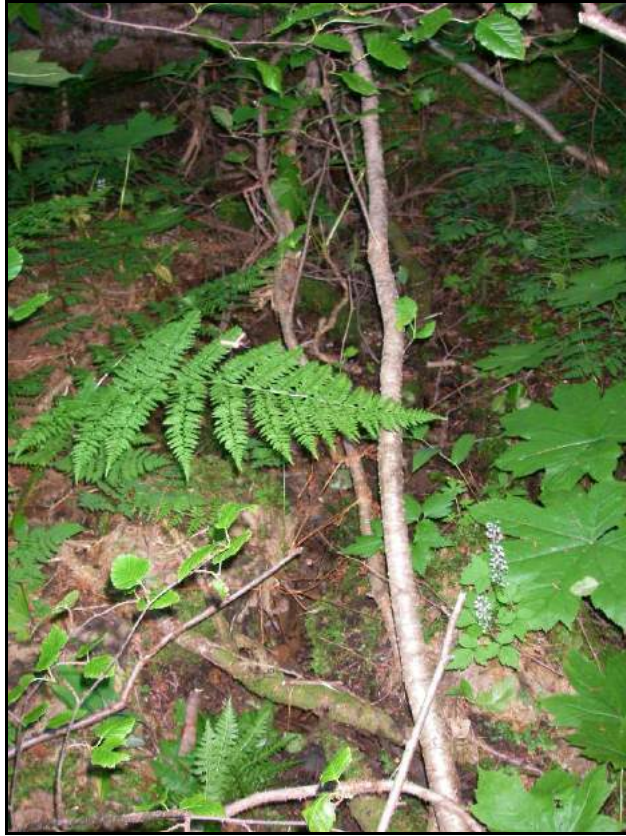
Section	Comments
CHANNEL	NCD - dry with some areas of channelization at rc, mostly overland and subsurface flow.
SITE CARD	NCD

Site 182 – Downstream, dry NCD

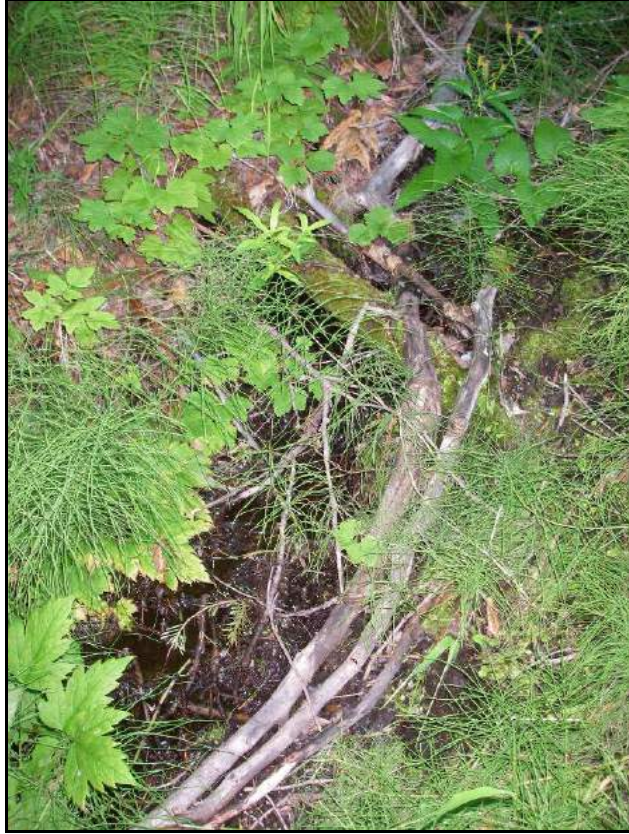
Section	Comments
CHANNEL	NCD - dry seepage no fish habitat.
SITE CARD	NCD

Site 183 – Downstream seepage

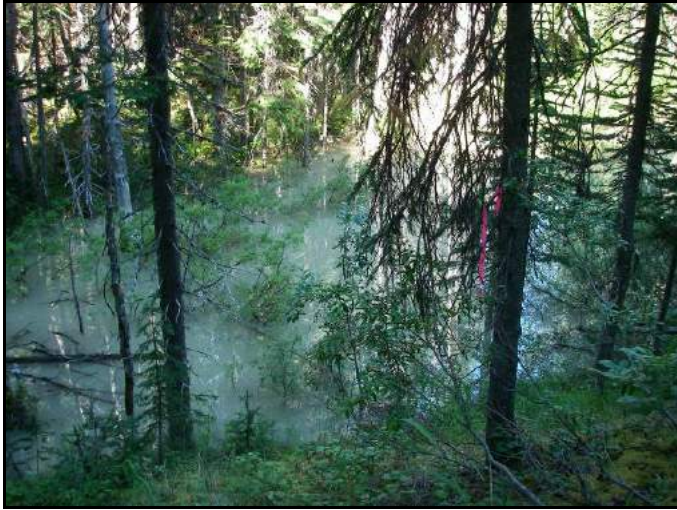
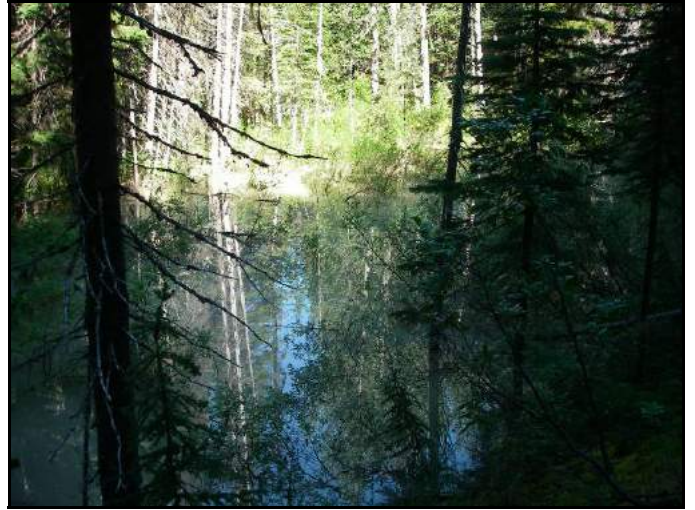
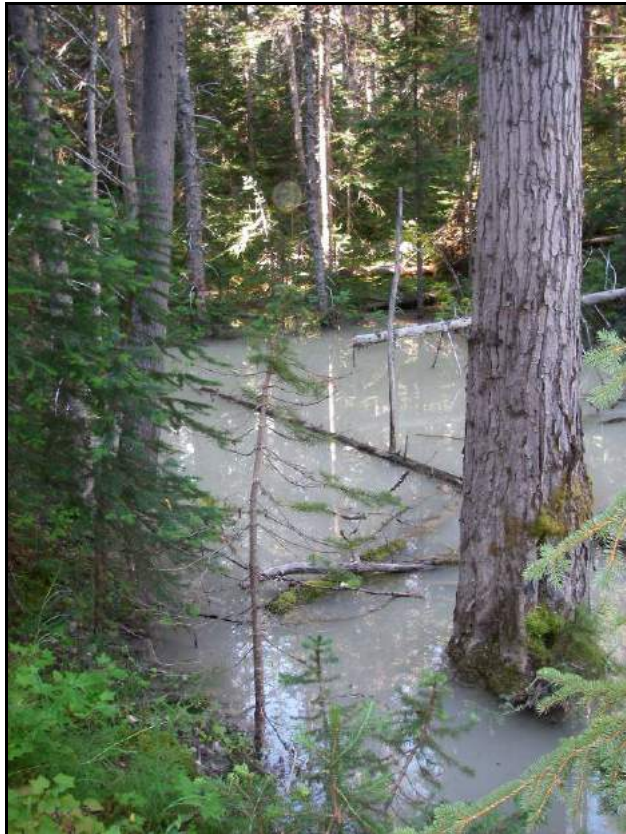
COMMENTS	
Section	Comments
CHANNEL	FSZ - off channel habitat of Mess Cr within 5m of proposed alignment - shift road upslope at least 20m to avoid sidecast debris. ~70m long x 20m wide, inlet from Mess Cr at N end. Ribbon says ILP 1084
SITE CARD	FSZ not all measurements taken

Site 184 – Across view

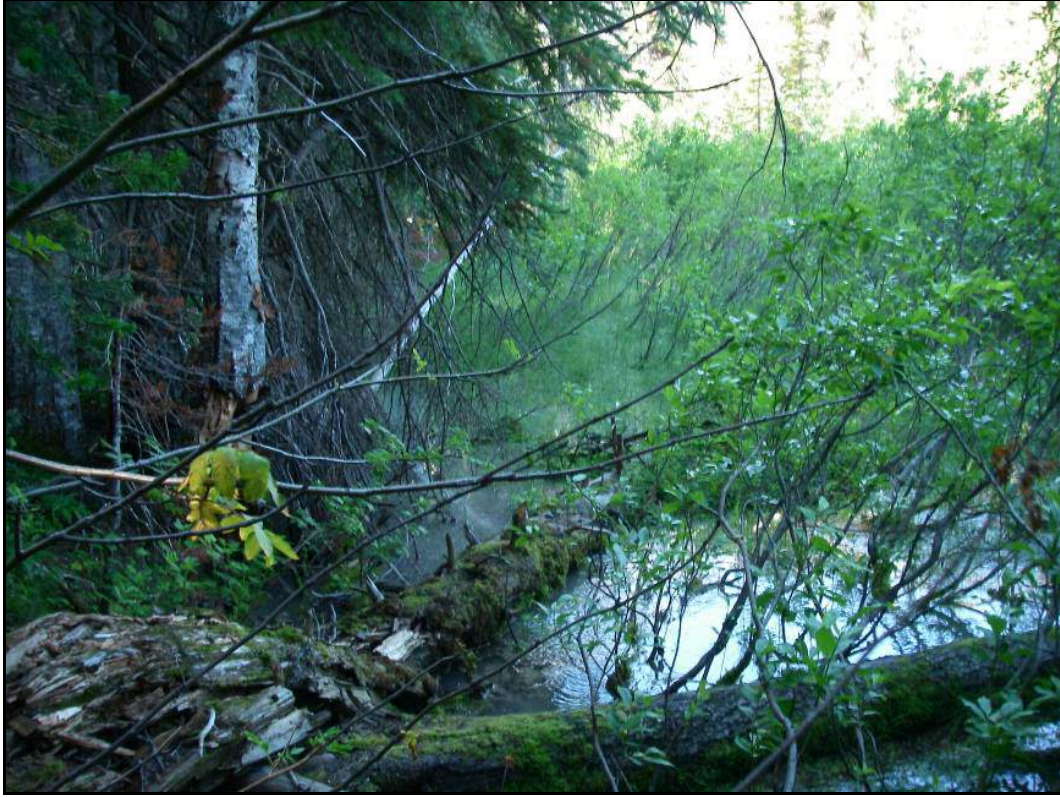
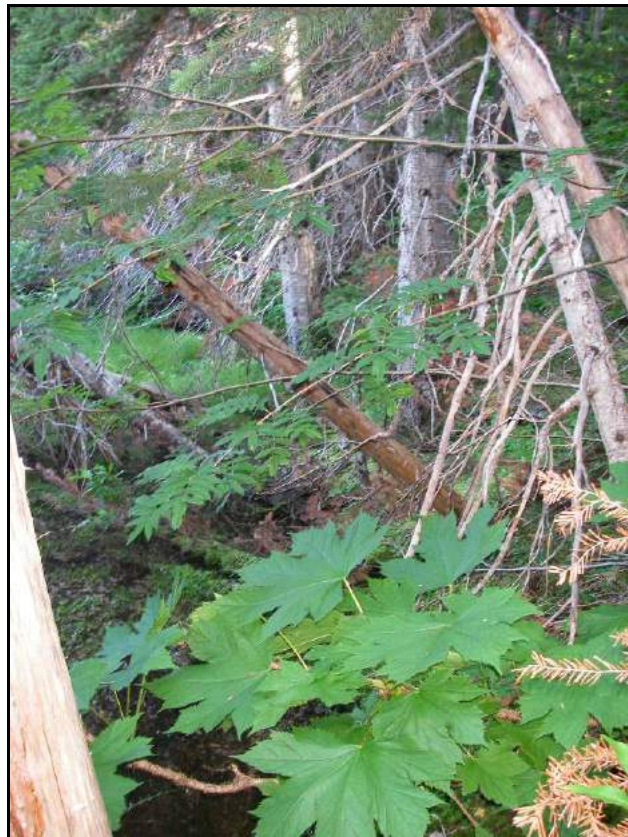
COMMENTS	
Section	Comments
CHANNEL	FSZ - road passes within 5m of another FSZ - this one a wetland. May be accessible to fish during floods. Recommend moving road ~20m us to avoid FSZ
SITE CARD	FSZ

Site 185 – Upstream view

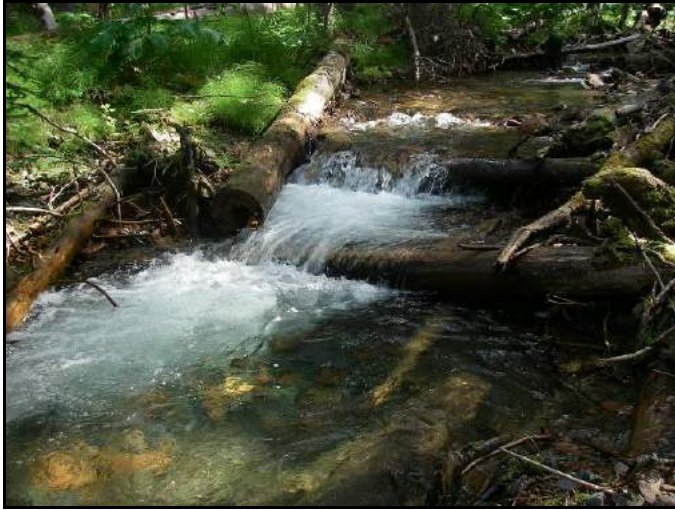
Site 187 – Upstream step-pools

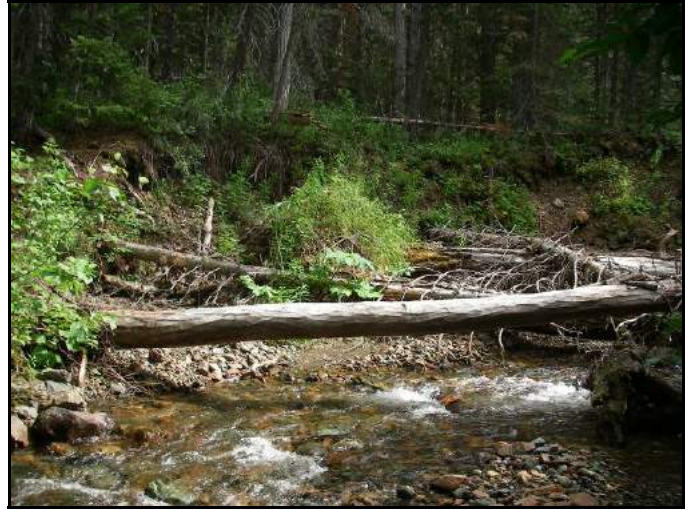
Site 187 – Upstream bank erosion

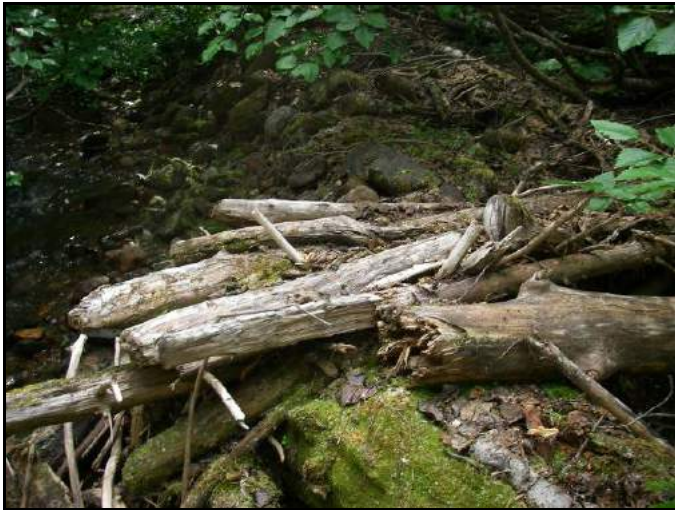
Site 187 – Upstream log jam on left bank

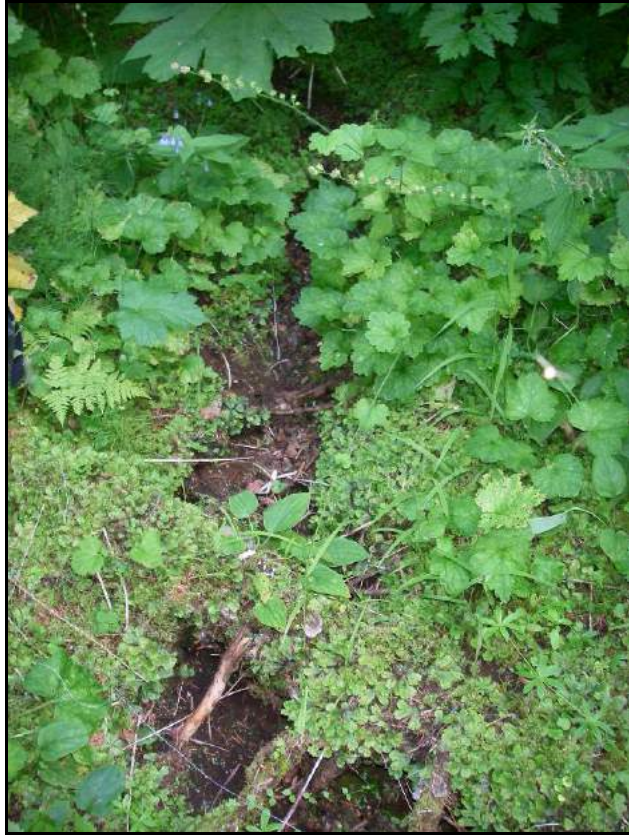
Section	Comments
CHANNEL	NCD - dry with pockets of scour, mostly overland flow. No fish habitat.
SITE CARD	NCD

Site 188 – Downstream view

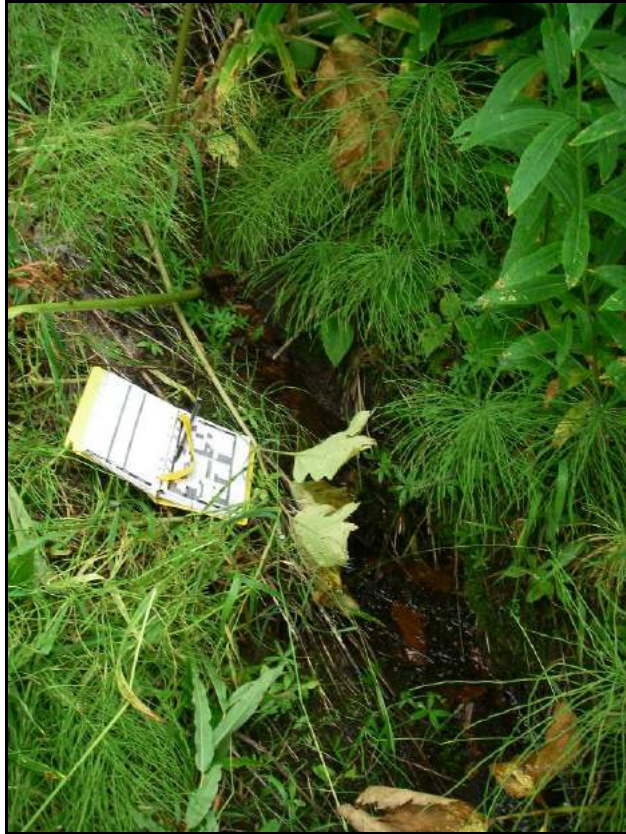
COMMENTS	
Section	Comments
CHANNEL	S6 - small stream flowing through dc, alder and balsam. Most of water diverted overland just us of rc by LWD. Rechannelizes just ds of rc and flows into lake. Good flow us of rc but nearly a seepage ds. Multiple seepage like channels ds of rc several barr

Site 190 – Upstream view, barely a stream

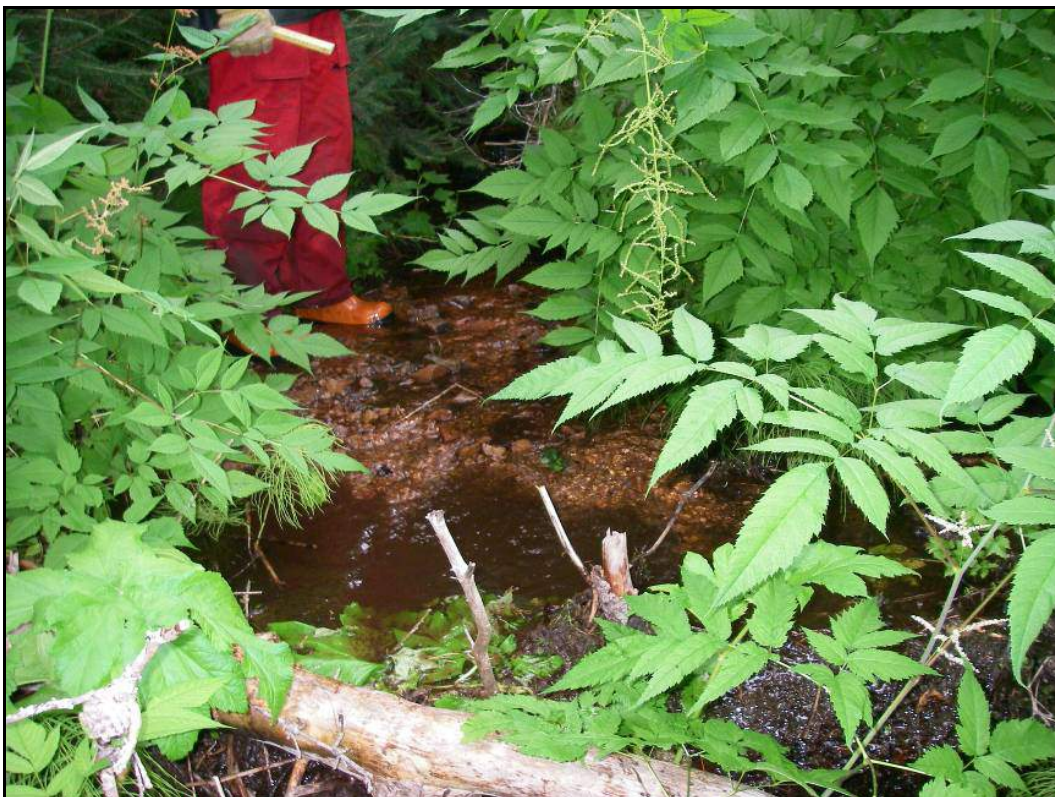
Site 190 – Upstream dispersal overland

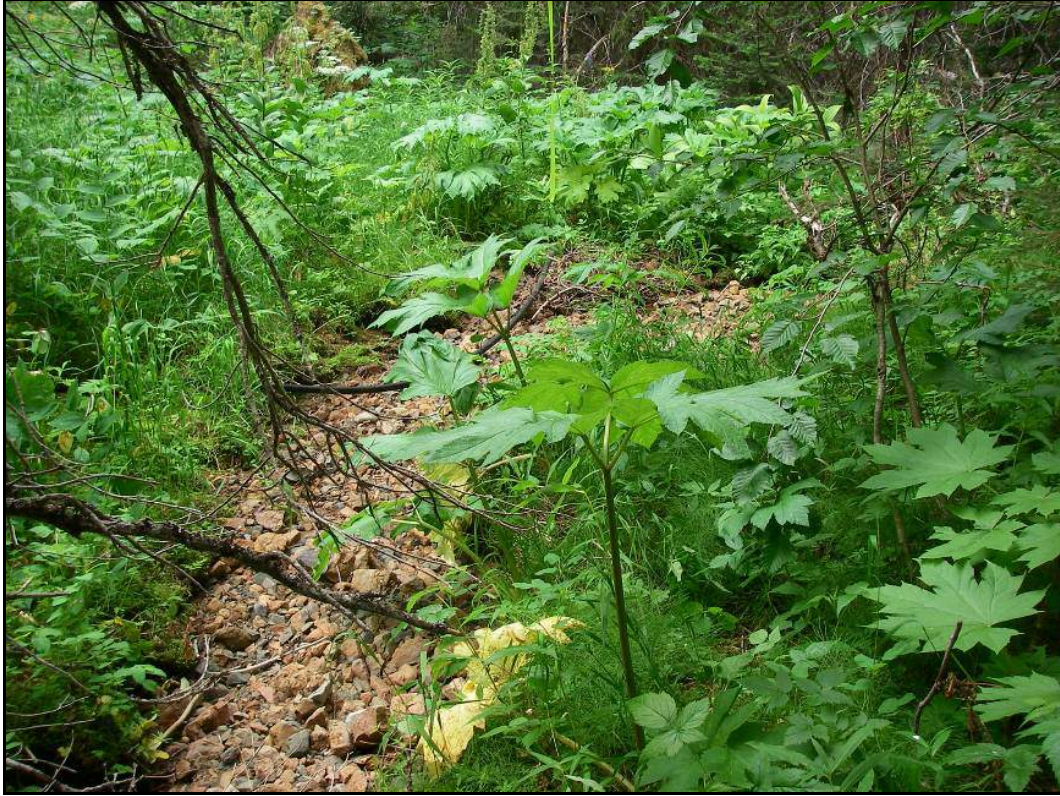
COMMENTS	
Section	Comments
CHANNEL	S4 default - dry but decent sized stream channel - evidence of flooding this year - deposited sand up to 5m from rb, evidence of overland flow. Dd drilling hose just ds of road. Recommend EF at higher water. Low gradient flows into fb lake without barrier

Site 193 – Downstream view

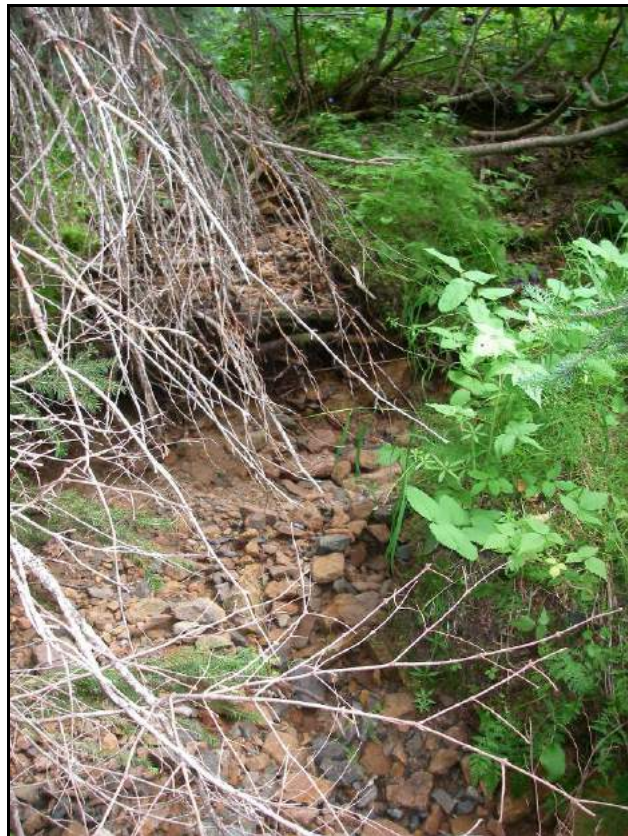
Site 193 – Upstream view, dry pool

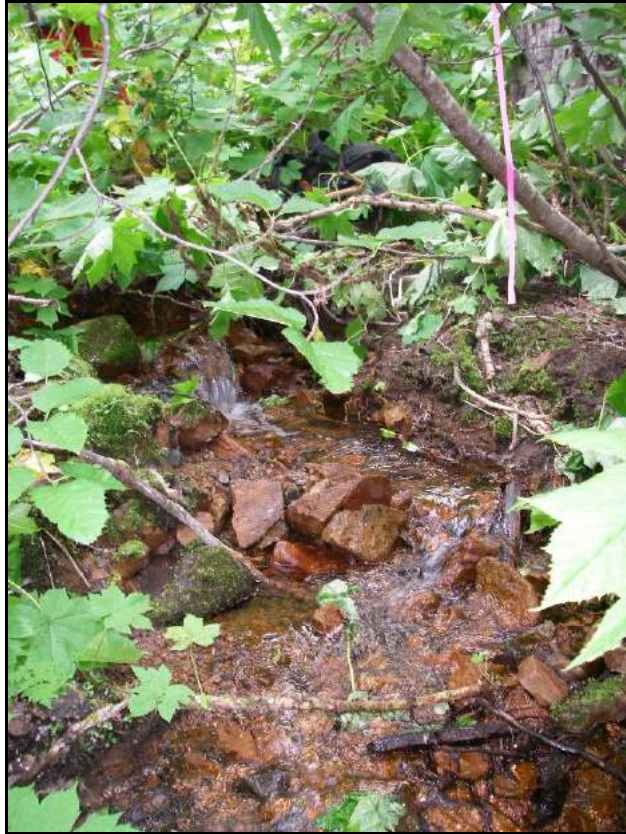
Watershed Code: 000-000000-00000-00000-0000-0000-000-000-000-000-000-000-000
Reach # 1.0 ILP Map # 104G.036 ILP # 1094 Site 195

COMMENTS	
Section	Comments
CHANNEL	S3 default - nice sp stream with lots of cover, but few pools. Moderate gradient, important habitat return to EF

Site 195 – Upstream view

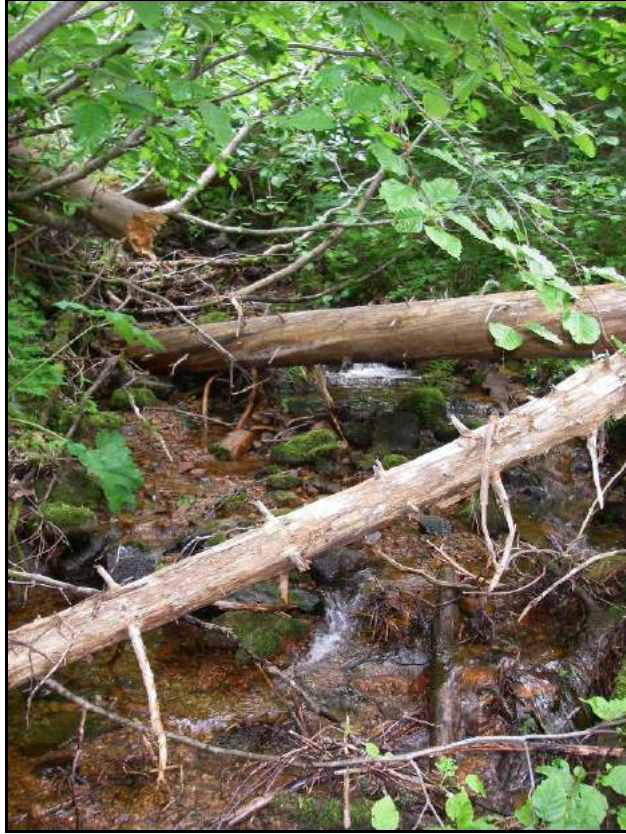
Section	Comments
CHANNEL	NCD - dry with evidence of overland flow.
SITE CARD	NCD

Site 198 – Upstream, showing some scour

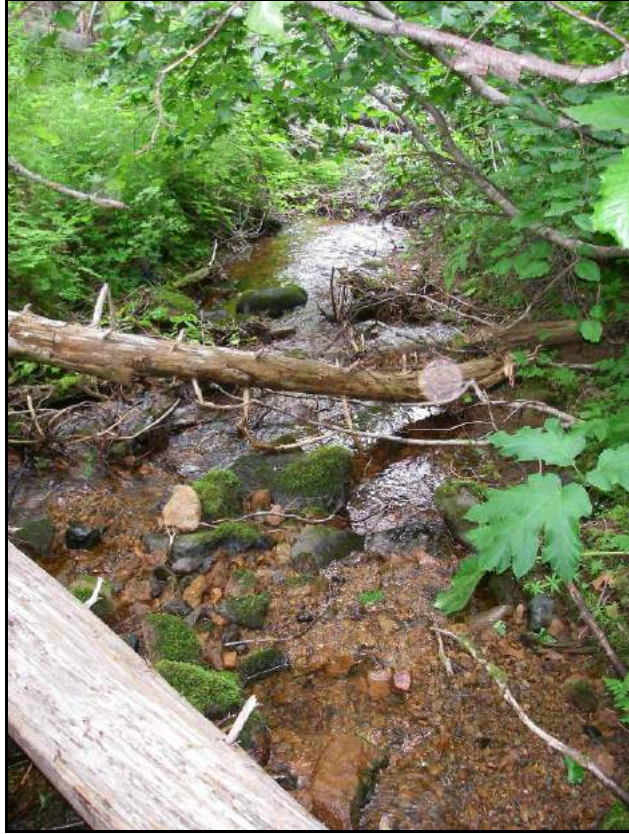
Section	Comments
CHANNEL	NCD - dry - somewhat channelized us of rc but mostly overland flow.
SITE CARD	NCD

Site 199 – Upstream view

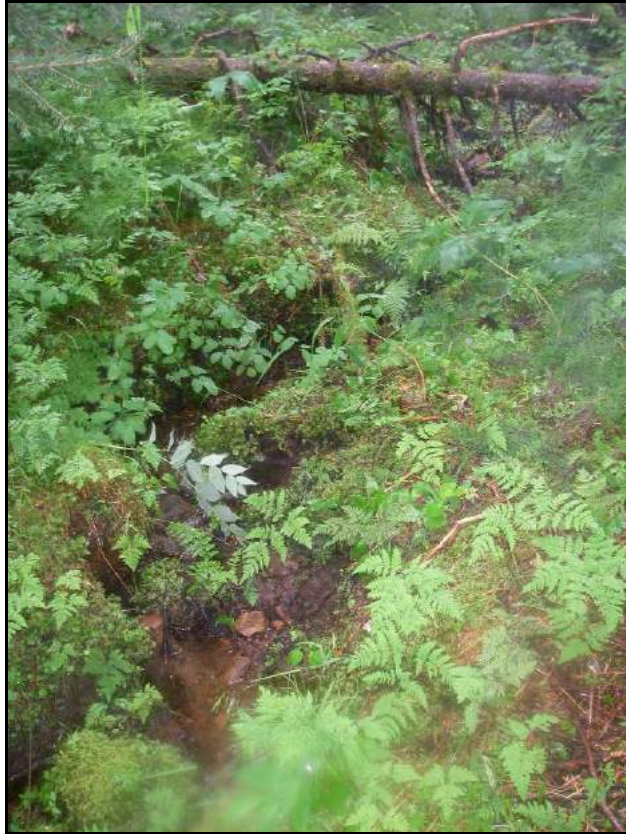
Section	Comments
CHANNEL	NCD - seepage channelizes ~15m us for rc then seeps out ~20m ds of rc. Not a stream, no fish habitat.
SITE CARD	NCD

Site 202 – Upstream channelized section

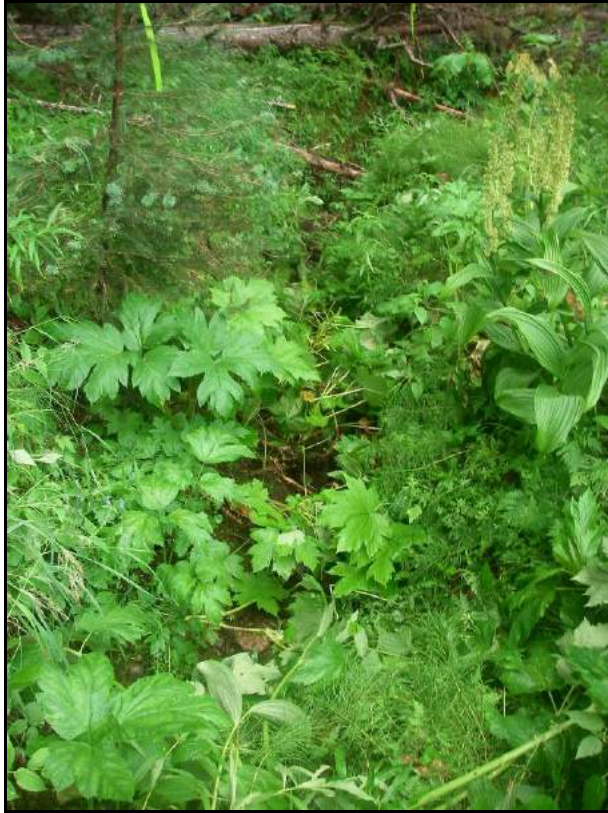
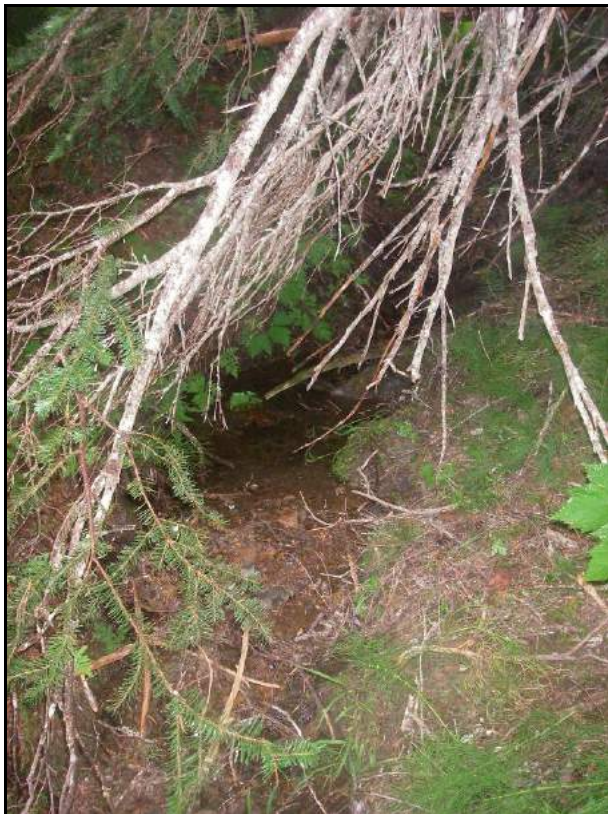
Photo	Foc Lg	Dir	Comments
R: 103 F: 4223	STD	D	dry section ds of rc
R: 103 F: 4224	STD	U	flowing section us of rc

Site 203 – Downstream dry section

Site 203 – Upstream flowing section

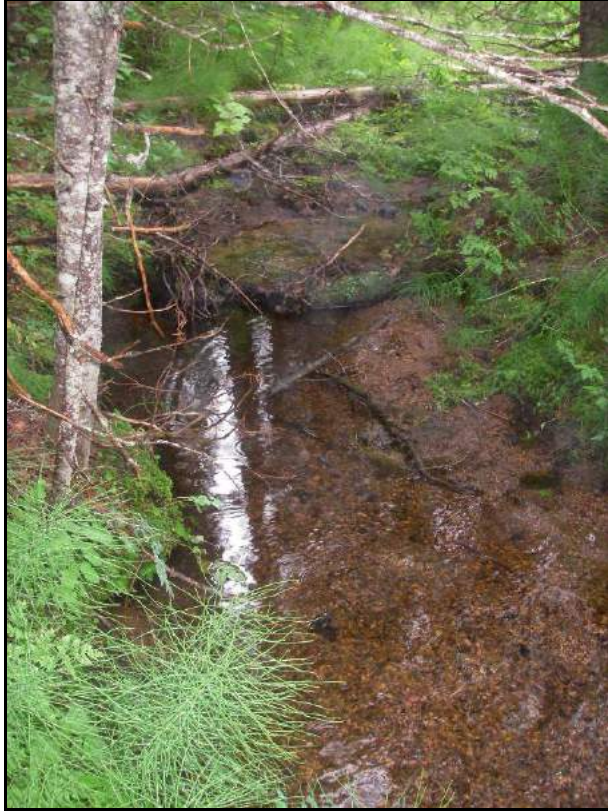
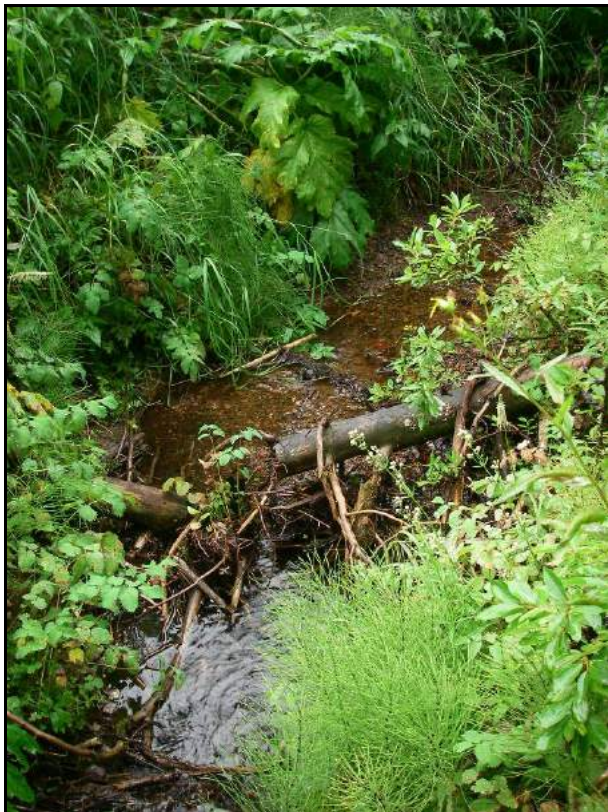
Watershed Code: 000-000000-00000-00000-0000-0000-000-000-000-000-000-000-000
Reach # 1.0 ILP Map # 104G.036 ILP # 1103 Site 204

COMMENTS	
Section	Comments
CHANNEL	S4 default - very nice fishy looking small stream. Abundant cover, some pools, good spawning gravels. Important habitat.

Site 204 – Upstream view

Site 204 – Downstream view
