Schaft Creek Fisheries Baseline 2007

Rescan Tahltan Environmental Consultants
Vancouver, British Columbia

March 2008

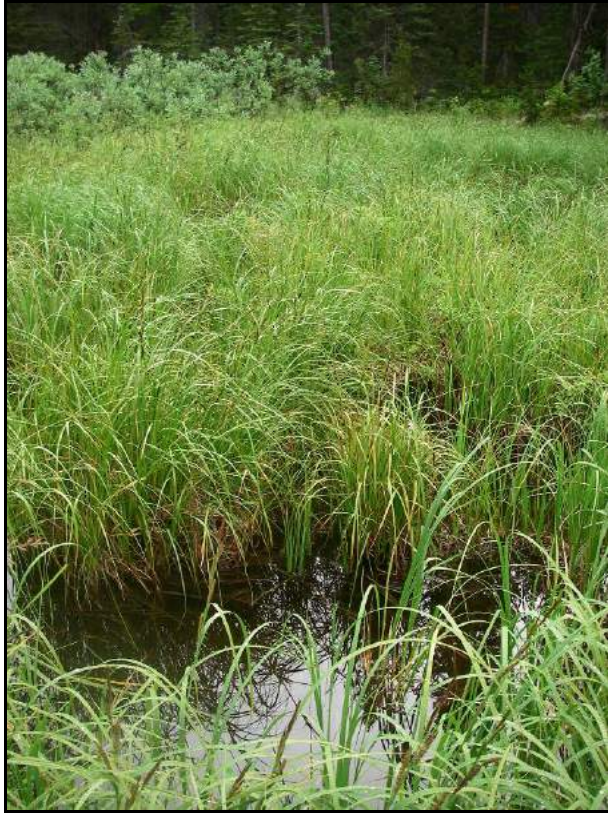
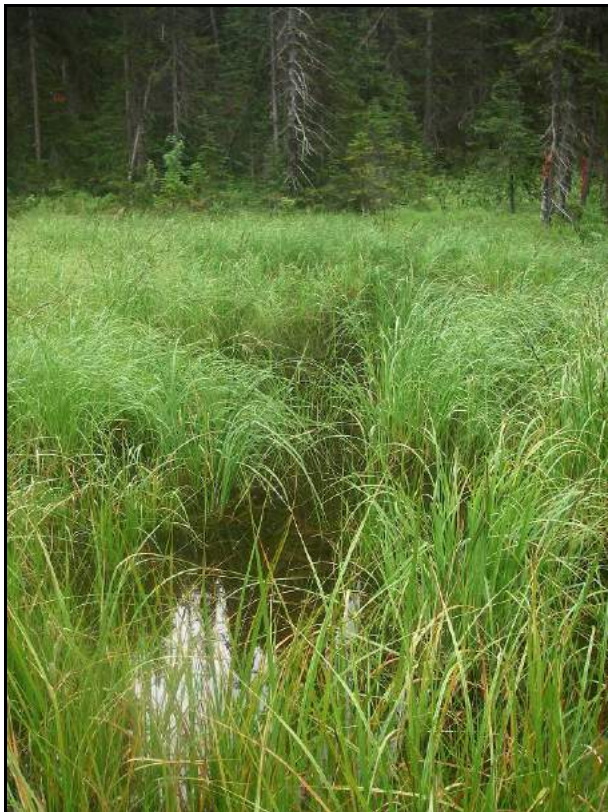
Section	Comments
CHANNEL	NCD - small wetland with some open water but poor connectivity. Wetland is at headwater of stream M85 and should be avoided if possible to avoid screwing up water flow ds.
SITE CARD	NCD

Site 205 – Across view

Site 205 – Downstream view, open water

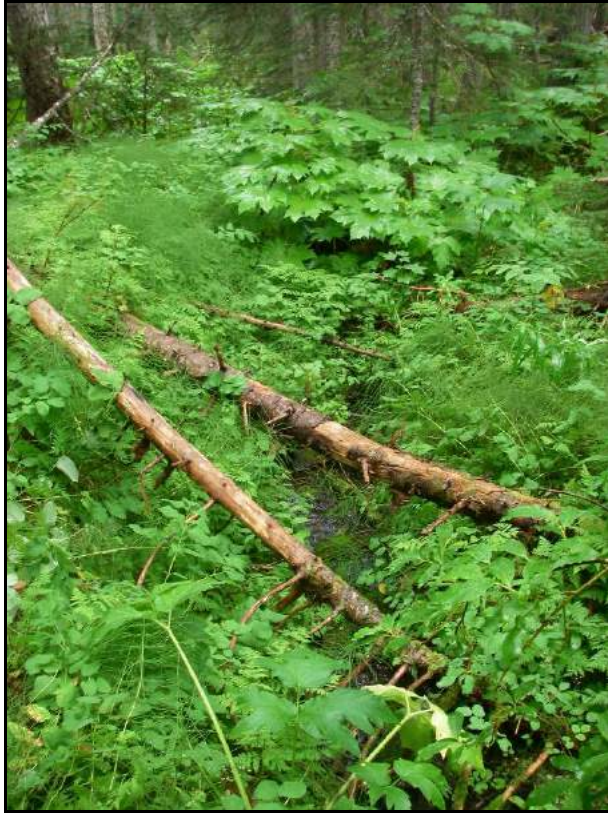
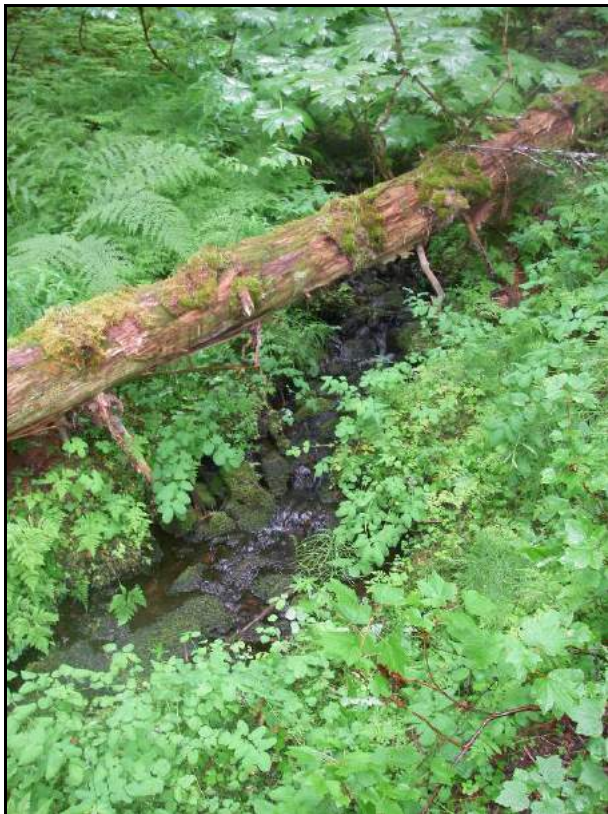
Reach #	ILP Map #	ILP #	Site
1.0	104G.036	1105	206

COMMENTS	
Section	Comments
CHANNEL	S6 - small stream through balsam and dc. Borderline gradient (20-21%) and marginal habitat= not fish bearing.

Site 206 – Downstream view

Site 206 – Upstream view

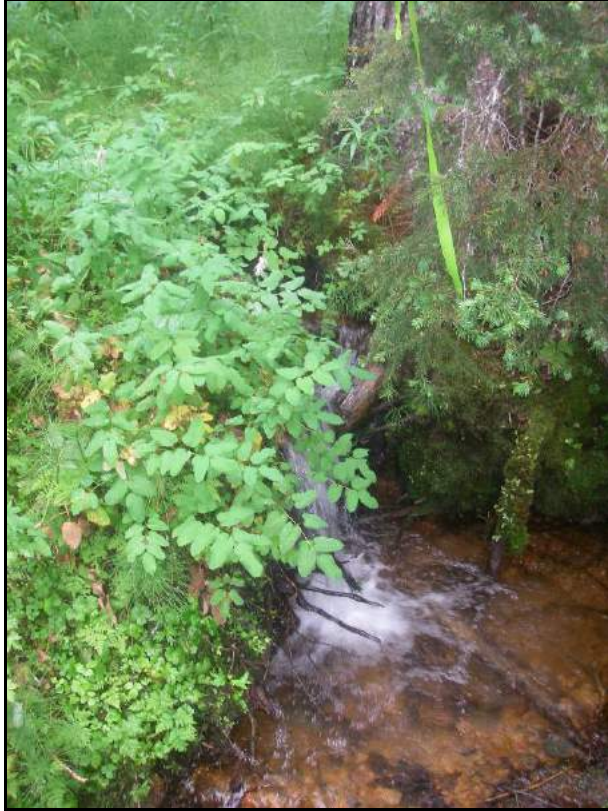
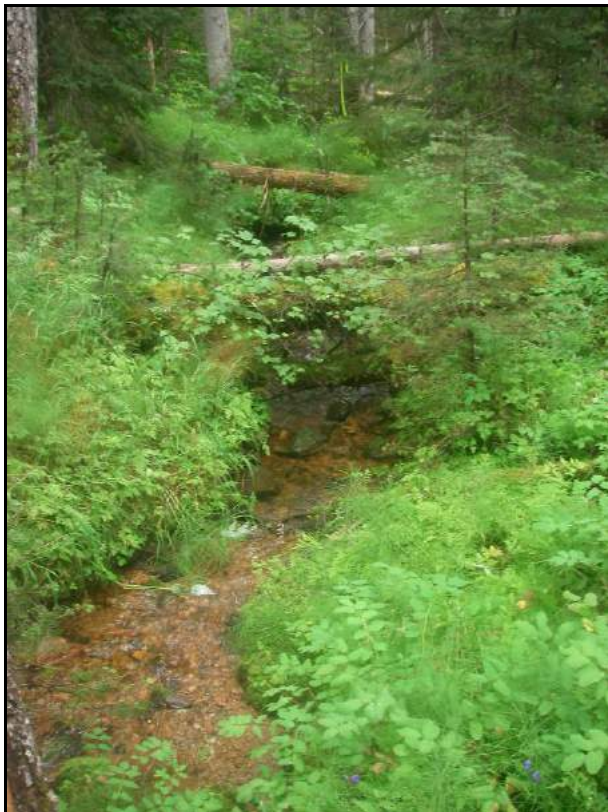
Photo	Foc Lg	Dir	Comments
R: 103 F: 4232	STD	U	.5m step at rc
R: 103 F: 4233	STD	D	ds rp/cp habitat

Site 207 – Upstream 0.5m step-pool

Site 207 – Downstream view

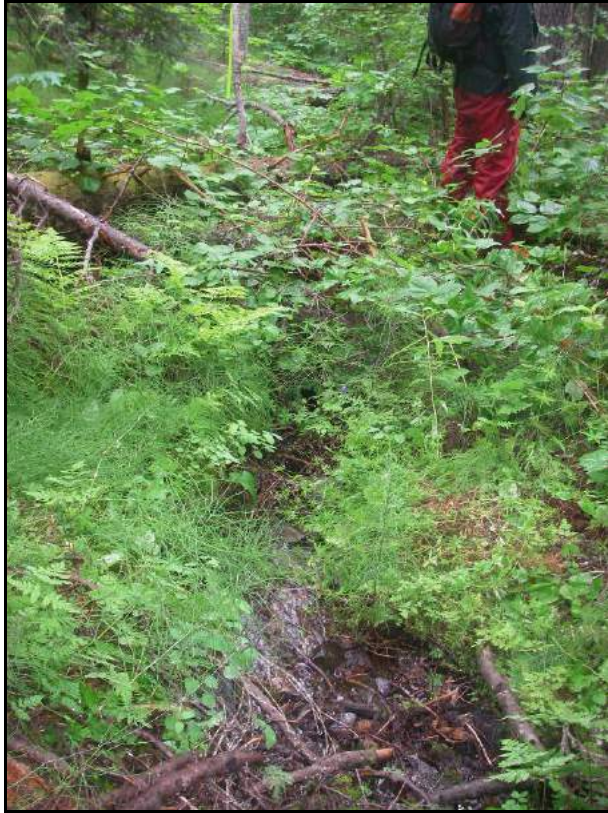
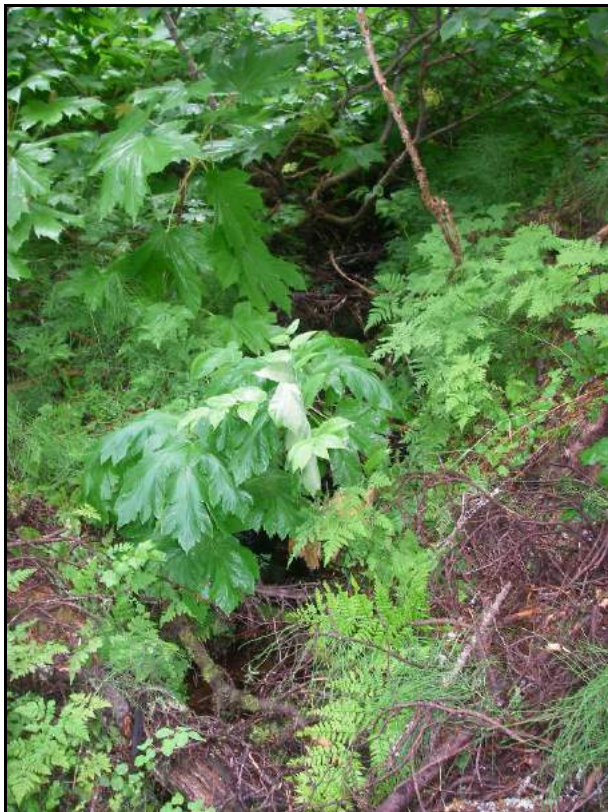
Watershed Code: 000-000000-00000-00000-0000-0000-000-000-000-000-000-000-000
Reach # 1.0 ILP Map # 104G.036 ILP # 1107 Site 208

COMMENTS	
Section	Comments
CHANNEL	S6 - small steep cp stream through alder and dc. No fish habitat.

Site 208 – Downstream view

Site 208 – Upstream view

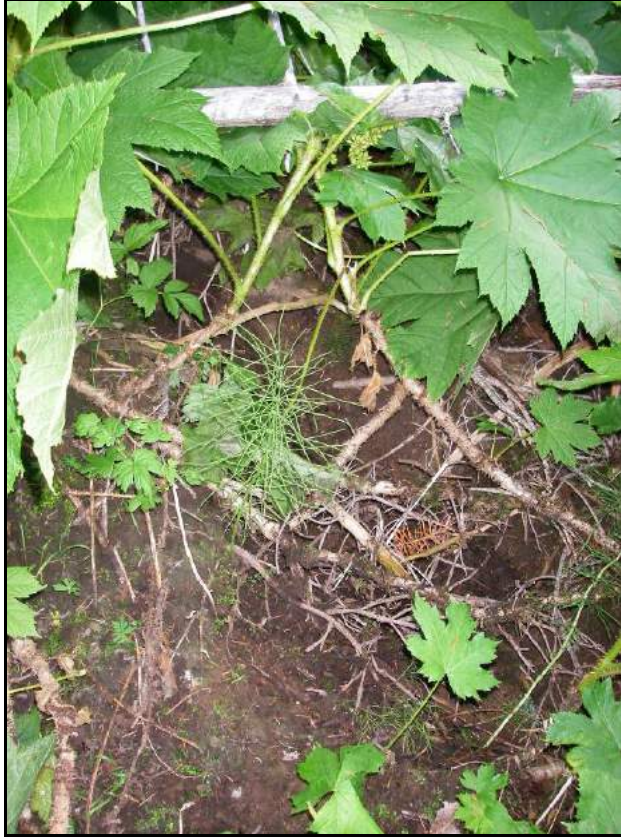
Section	Comments
CHANNEL	NCD - overland flow over organics a couple of areas of scour. Dry. No fish habitat.
SITE CARD	NCD

Site 210 – Upstream dry channel and gravel

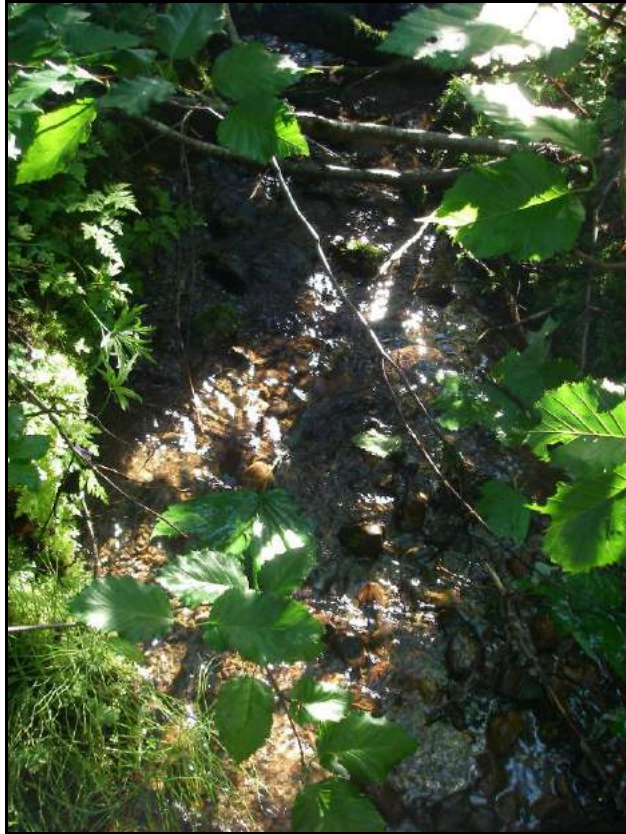
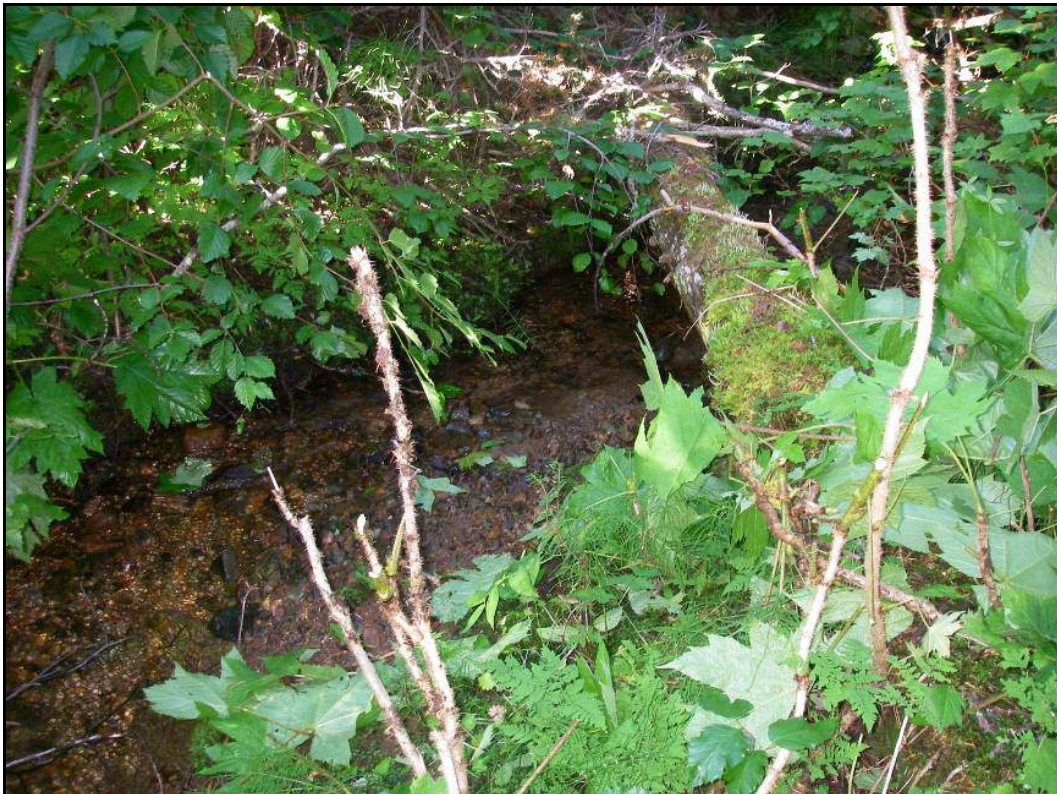
Reach #	ILP Map #	ILP #	Site
1.0	104G.036	1110	211

COMMENTS	
Section	Comments
CHANNEL	S4 default - small rp stream. Decent habitat but possible poor connectivity due to multiple small swd jams that create steps up to .3m high. Site not flagged.

Site 211 – Upstream view

Site 211 – Downstream view

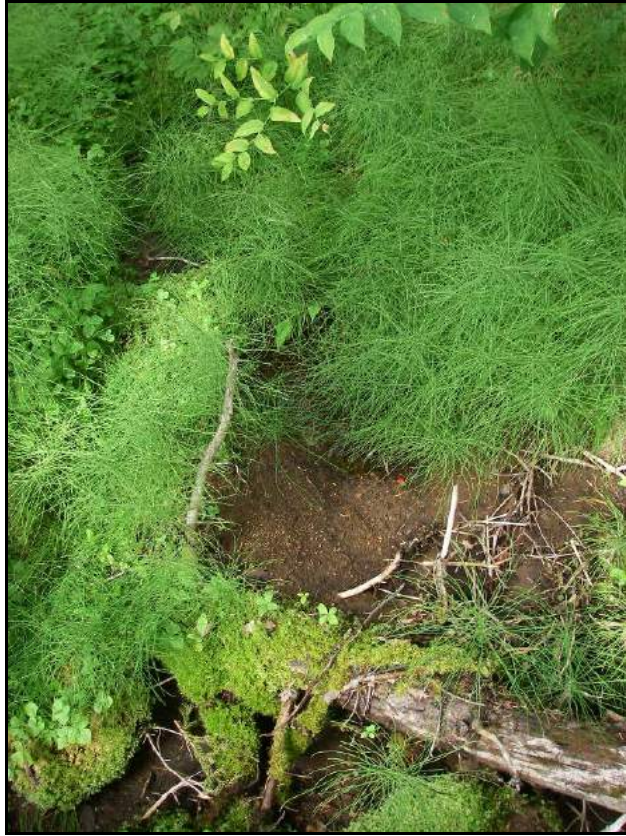
Section	Comments
SITE CARD	NCD
CHANNEL	NCD - channelized for ~15m at rc, seeps out goes underground and pops out again ~20m ds of rc. No fish habitat.

Site 214 – Upstream end of channelized section

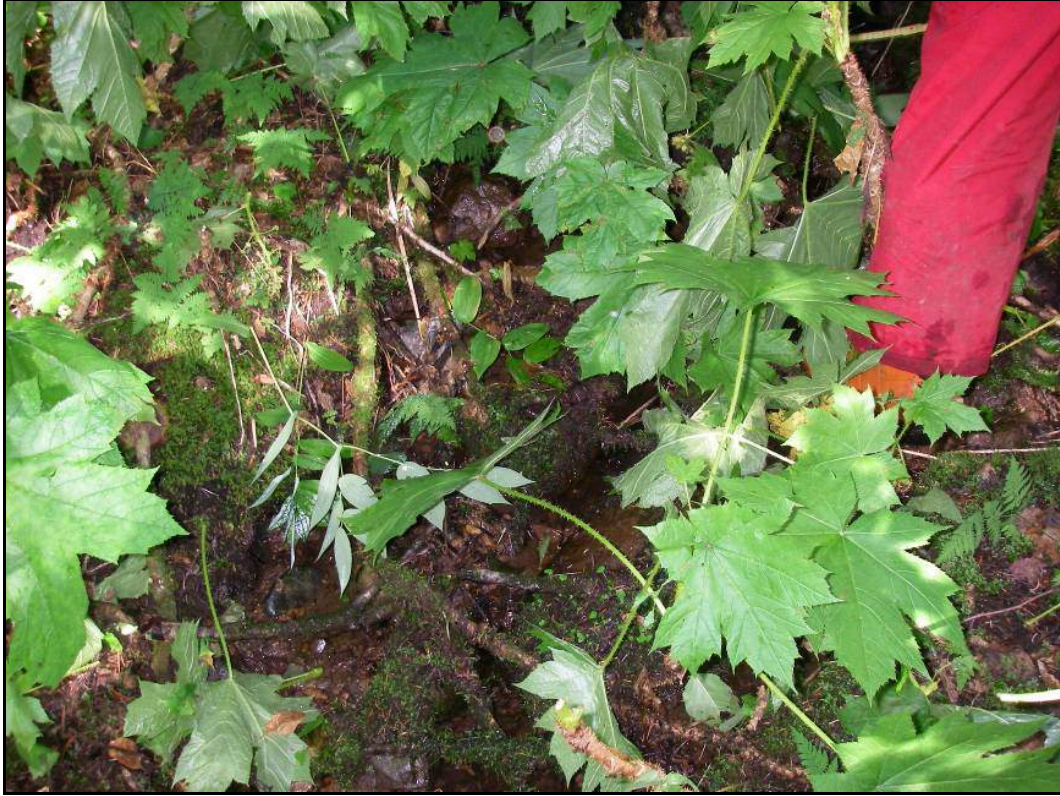
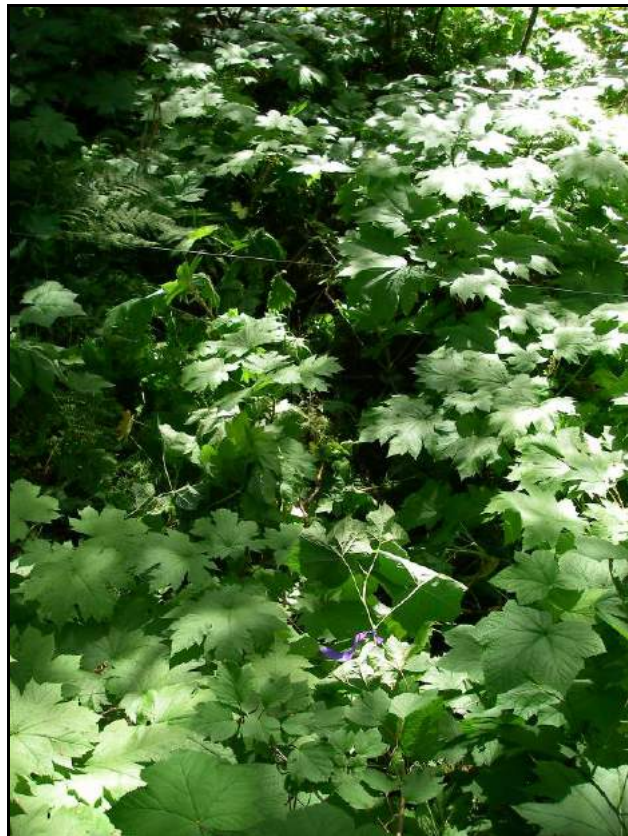
Photo	Foc Lg	Dir	Comments
R: 104 F: 4292	STD	U	trickle at rc
R: 104 F: 4293	STD	D	channel observed by dc

Site 216 – Upstream view, trickle

Site 216 – Downstream view

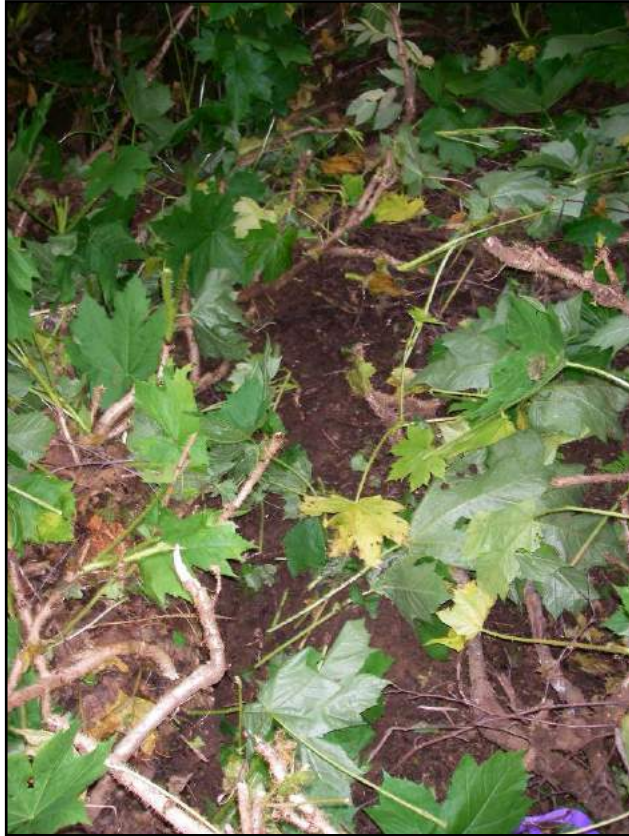
Section	Comments
CHANNEL	NCD - dry, organic substrate
SITE CARD	NCD

Site 219 – Downstream view

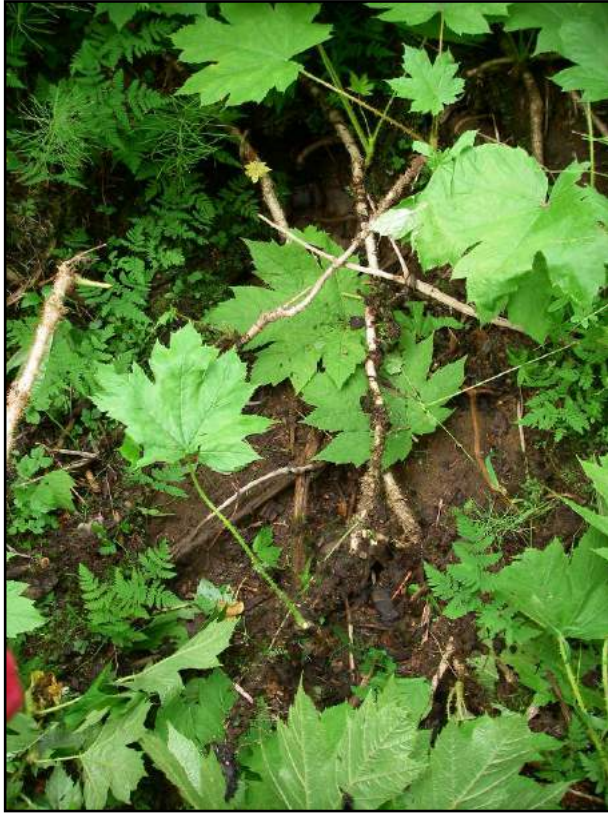
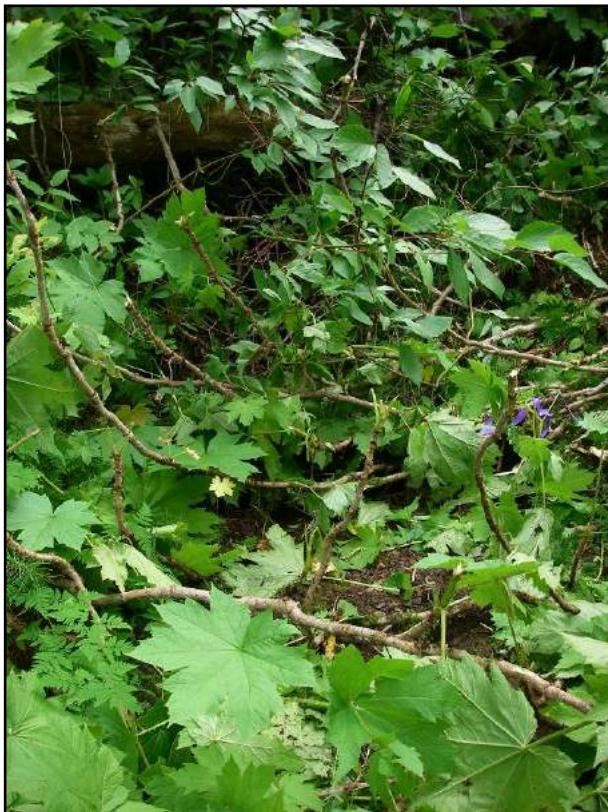
Watershed Code: 000-000000-00000-00000-0000-0000-000-000-000-000-000-000-000
Reach # 1.0 ILP Map # 104G.036 ILP # 1120 Site 221

COMMENTS	
Section	Comments
SITE CARD	water measurements not taken.
CHANNEL	S6 - small dry streambed, totally covered in dc. Steep no fish habitat.

Site 221 – Downstream view

Site 221 – Upstream view

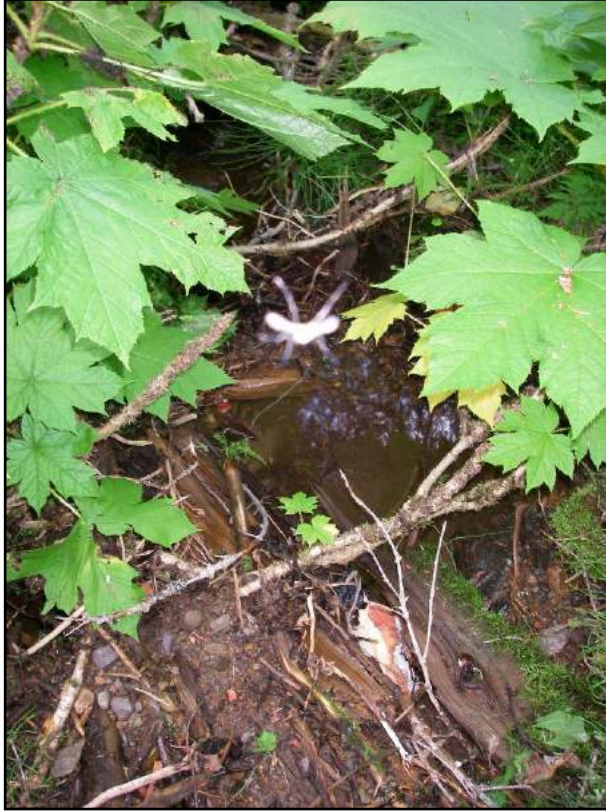
Reach #	ILP Map #	ILP #	Site
1.0	104G.036	1122	223

COMMENTS	
Section	Comments
CHANNEL	S6 - small barely flowing creek through dc and balsam. Choked w/SWD. High gradient 27%. Portions of subsurface flow. No fish habitat.

Site 223 – Downstream view

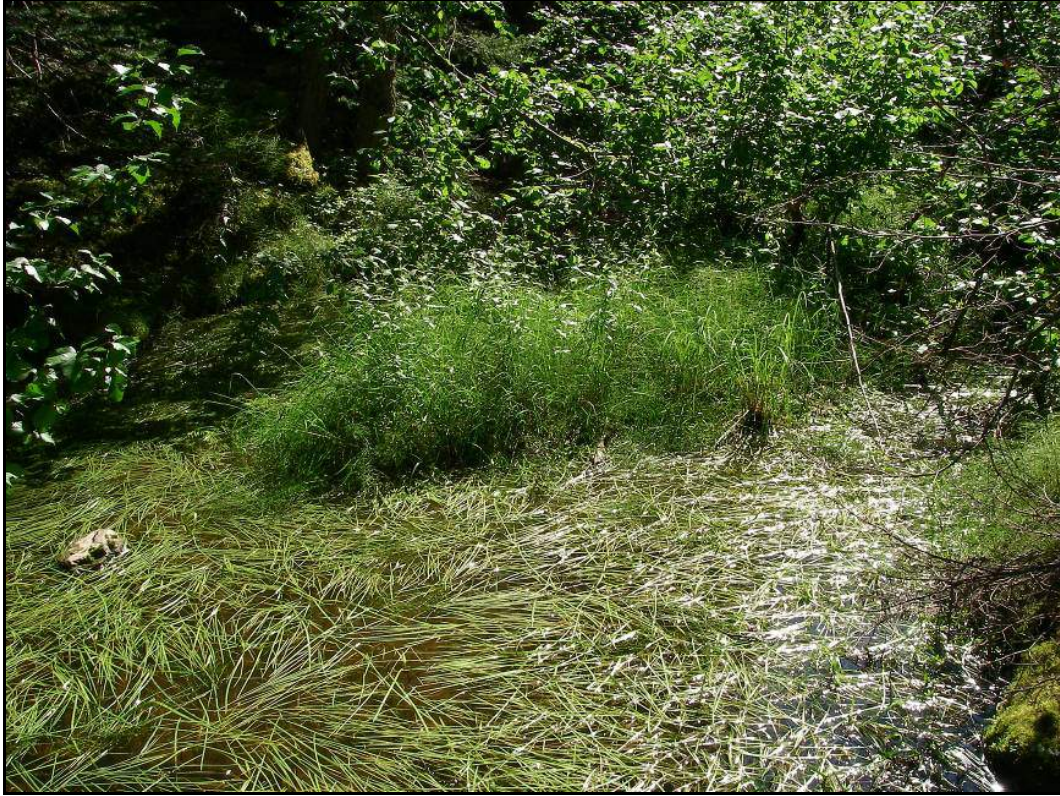
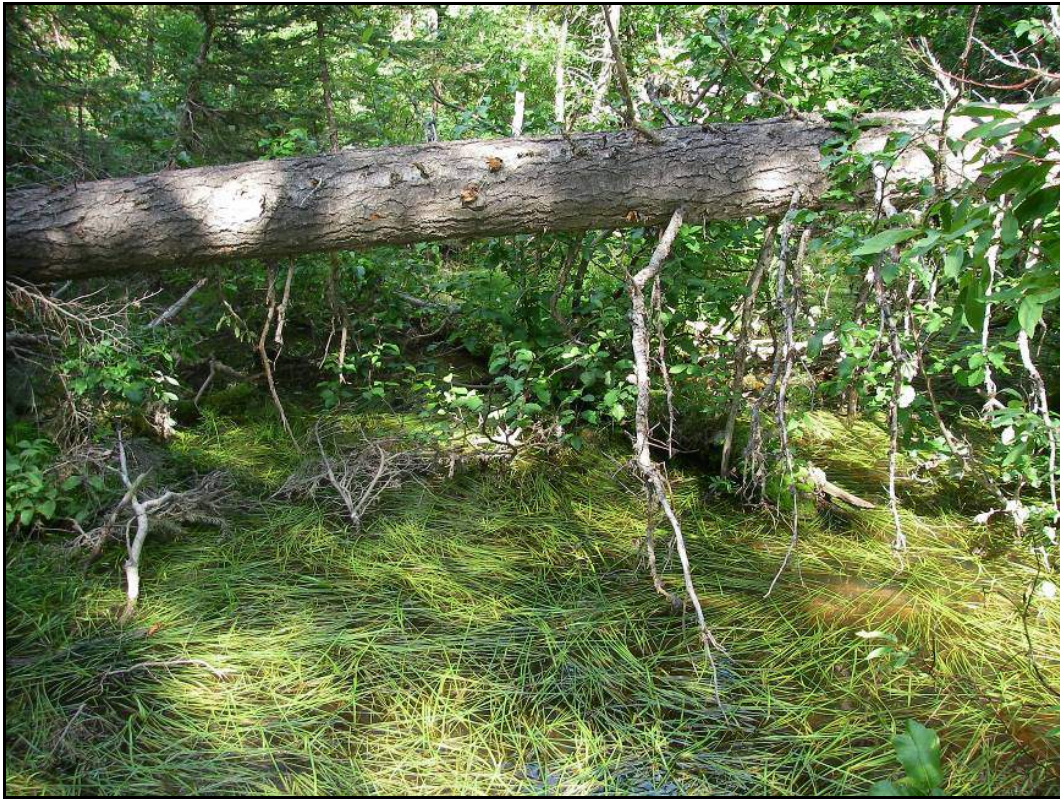
Site 224 – Downstream view

Site 224 – Upstream view

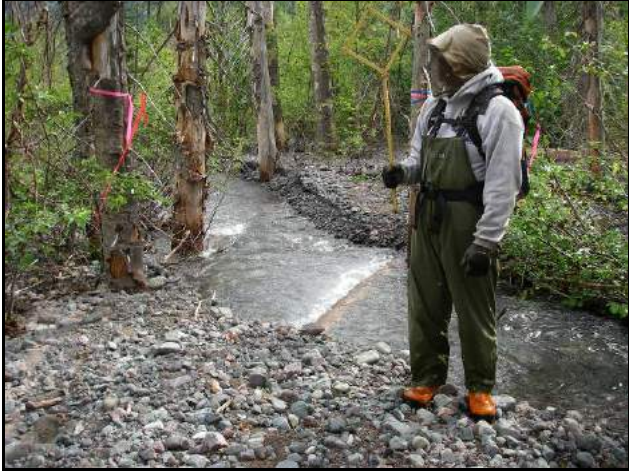
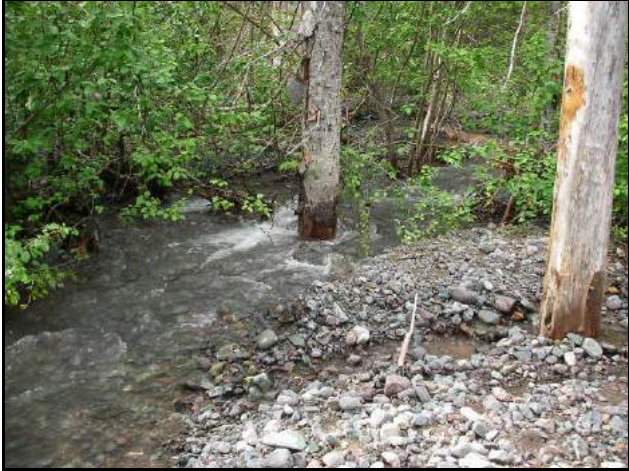
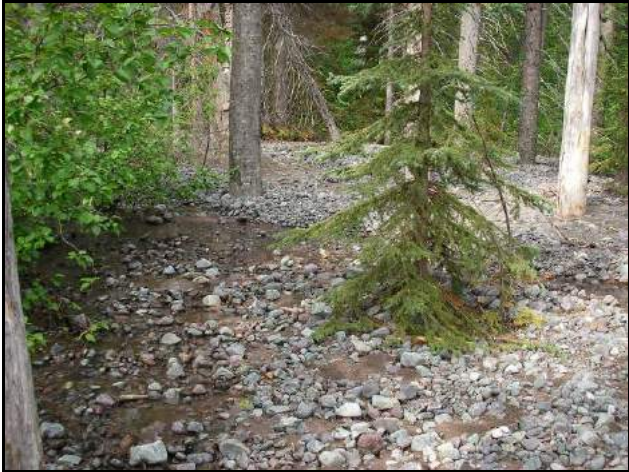
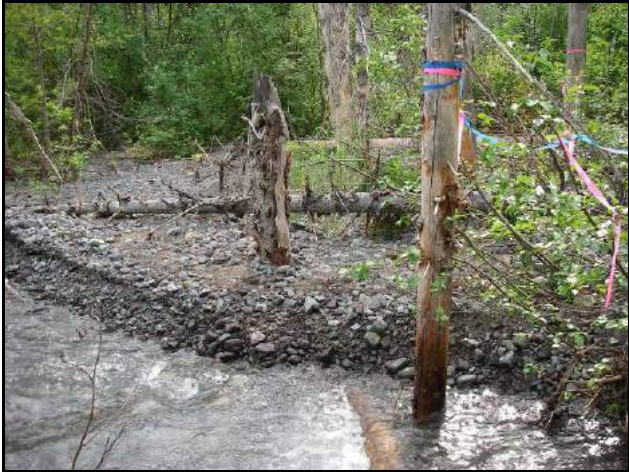
PHOTOS				
Photo		Foc Lg	Dir	Comments
R:	101	F: 4348	STD	X RB
COMMENTS				
Section		Comments		
CHANNEL		S3 - this crossing is on a dynamic constantly changing alluvial fan, RB present during previous trips. Extensive bedload movement, recommend moving crossing to top of fan where stream is more confined		
SITE CARD		main channel down alluvial fan, no banks, so some measurements not taken

Site 232 – Downstream view

Site 232 – Upstream view

Site 232 – Left bank

Site 232 – Right bank

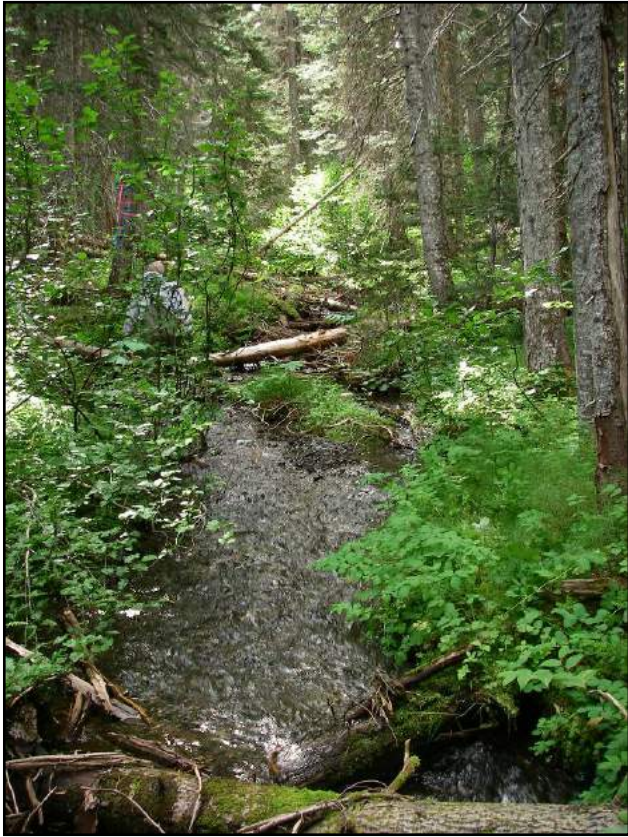
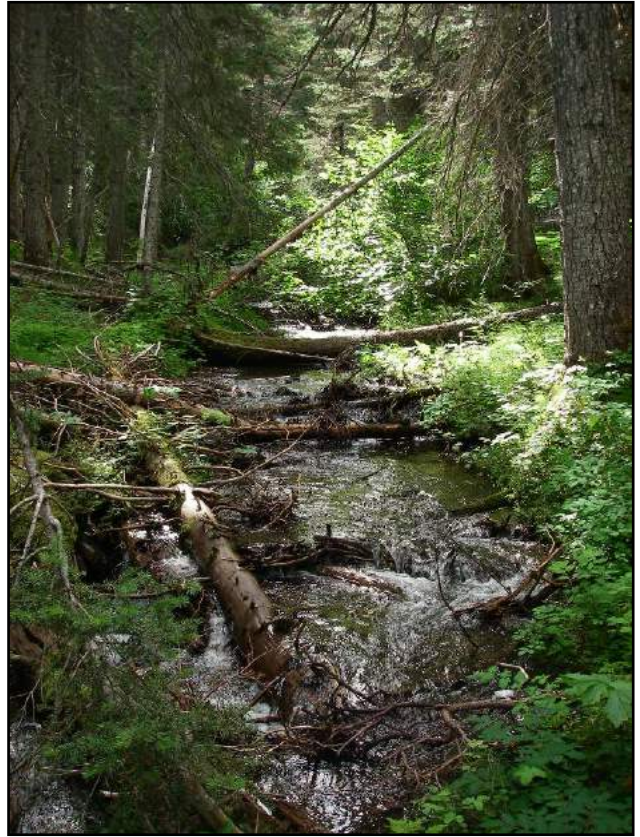
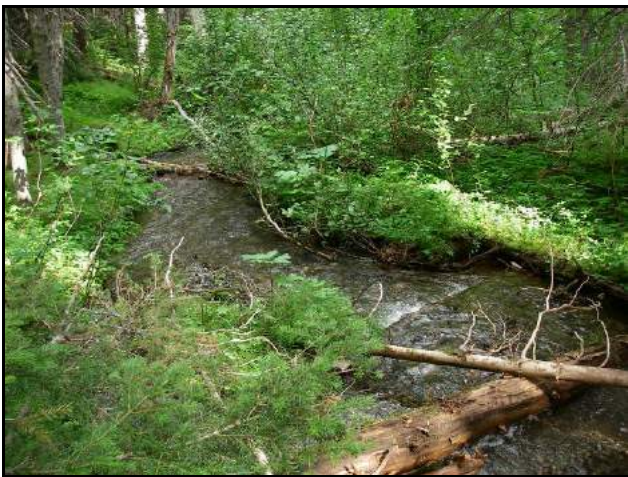
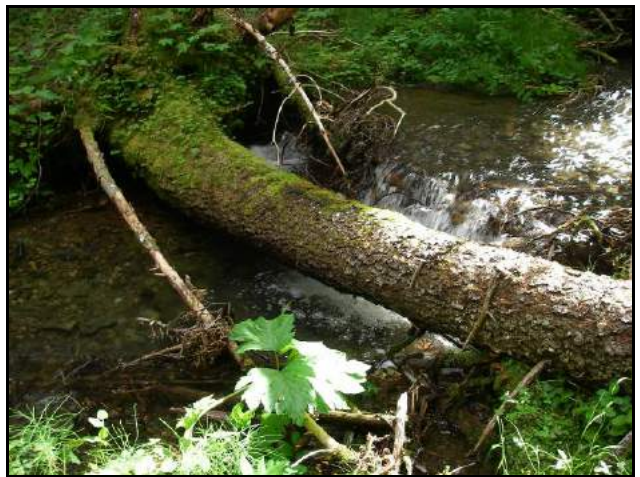
PHOTOS				
Photo		Foc Lg	Dir	Comments
R:	105	F: 4353	STD	X deep pool us at rc
COMMENTS				
Section		Comments		
CHANNEL		S3 default - excellent stream, critical habitat. Low stable banks, somewhat confined by stable valley walls

Site 233 – Upstream riffle section

Site 233 – Upstream step-pool section

Site 233 – Downstream view

Site 233 – Across view, showing deep pool

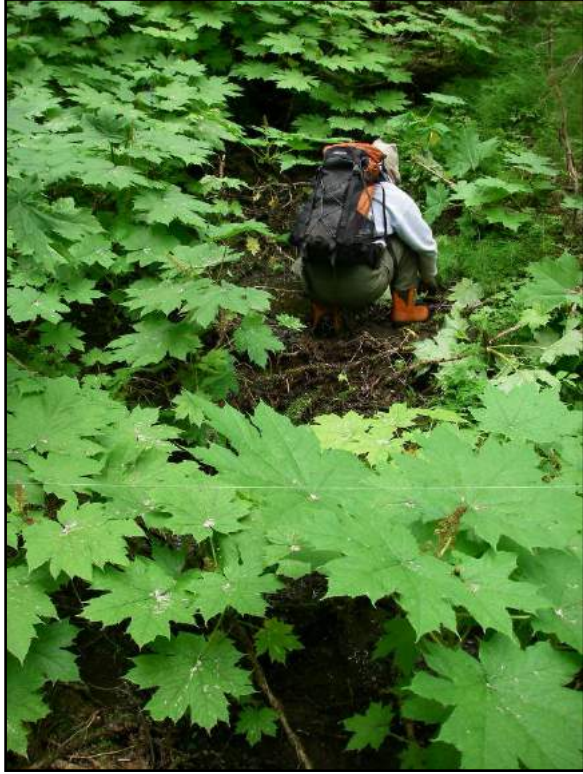
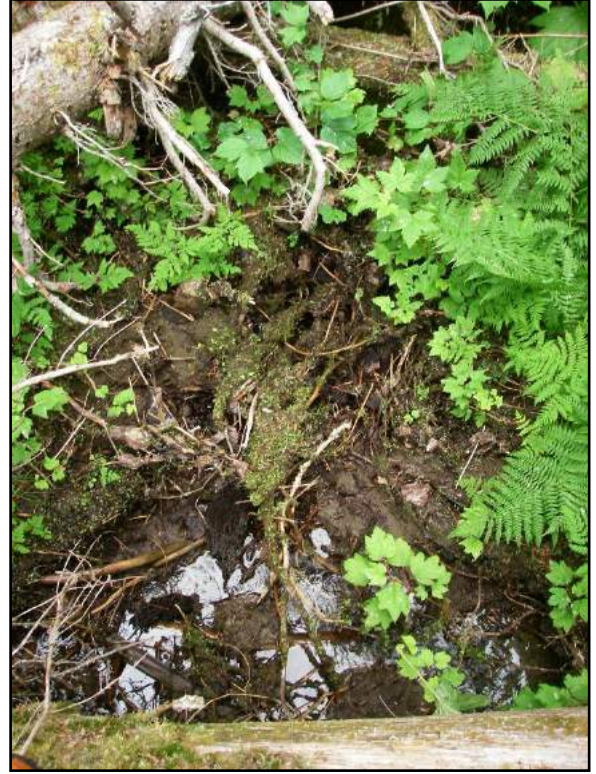
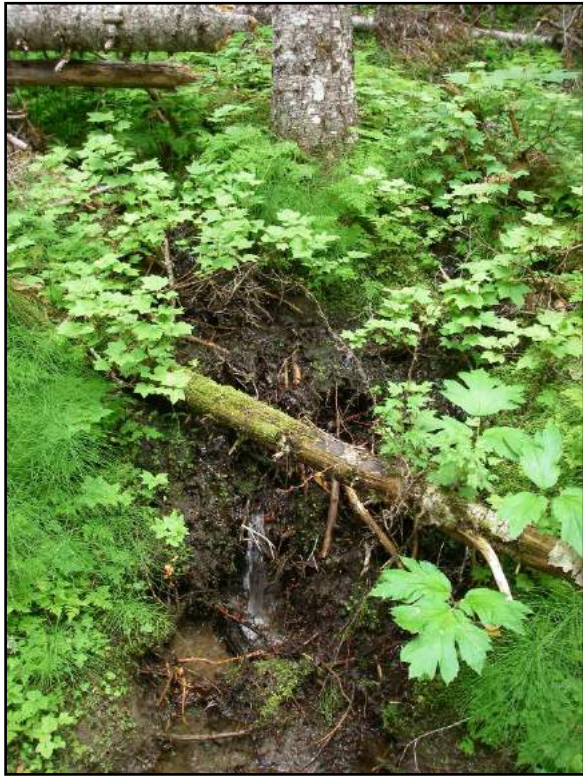
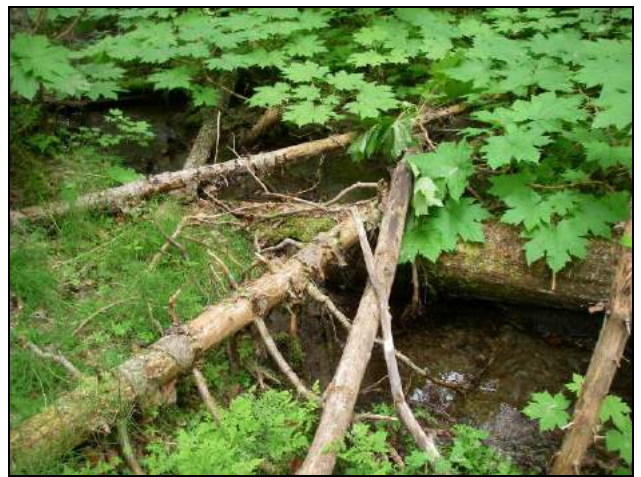
PHOTOS					
Photo		Foc Lg	Dir	Comments	
R:	101	F: 4354	STD	U	marginal flow us of rc
R:	101	F: 4355	STD	D	almost a seepage at rc
R:	101	F: 4356	STD	U	seepage barrier
R:	101	F: 4357	STD	D	decent habitat ~20m ds of rc
COMMENTS					
Section		Comments			
CHANNEL		S6 - small stream w/marginal habitat, a bit of scour @ rc but v. seepage like. Then there's a stretch of decent habitat ~20m long. Outlet has an overland flow barrier (drops 1.5m over 2m, flows over moss and SWD)

Site 234 – Upstream view

Site 234 – Downstream view, almost a seepage

Site 234 – Upstream seepage barrier

Site 234 – Downstream good habitat

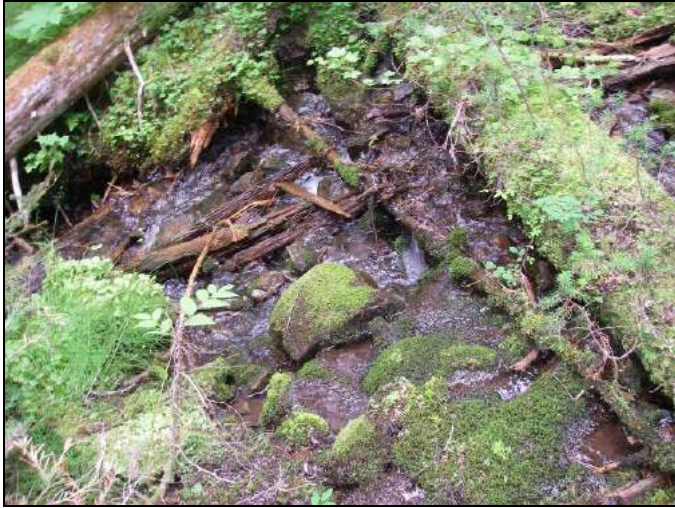
PHOTOS					
Photo		Foc Lg	Dir	Comments	
R:	101	F: 4358	STD	D	24% cascade barrier
R:	101	F: 4359	STD	D	@ rc
R:	101	F: 4360	STD	U	@ rc
COMMENTS					
Section			Comments		
CHANNEL			S6 - small stream w/good flow, abundant SWD at RC. Some decent pools, but generally shallow. 24% cascade barrier ~40m DS of RC

Site 235 – Downstream 25% cascade barrier

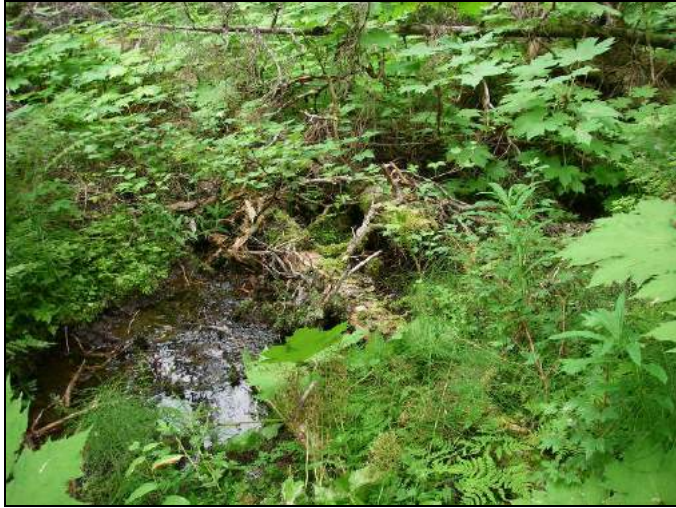
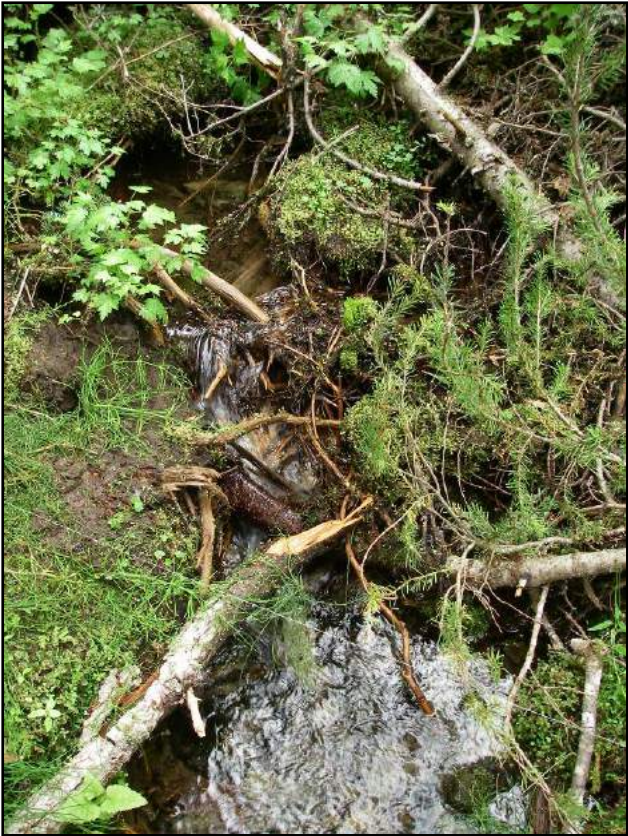
Site 235 – Downstream view

Site 235 – Upstream view

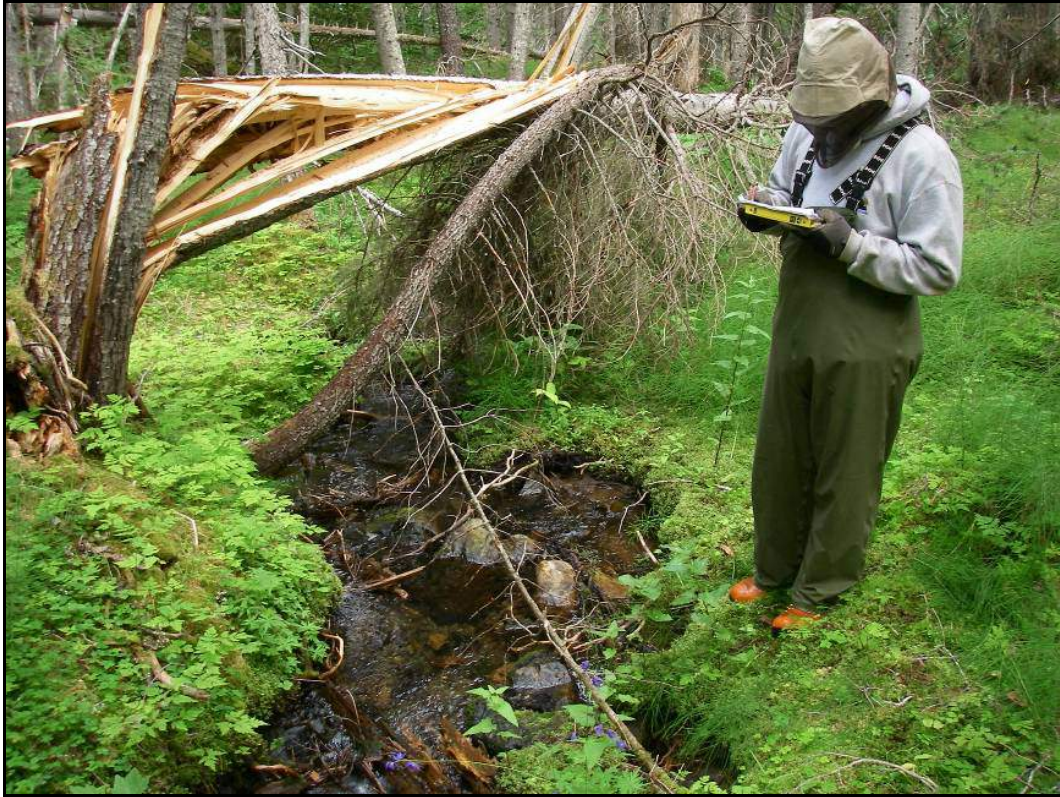
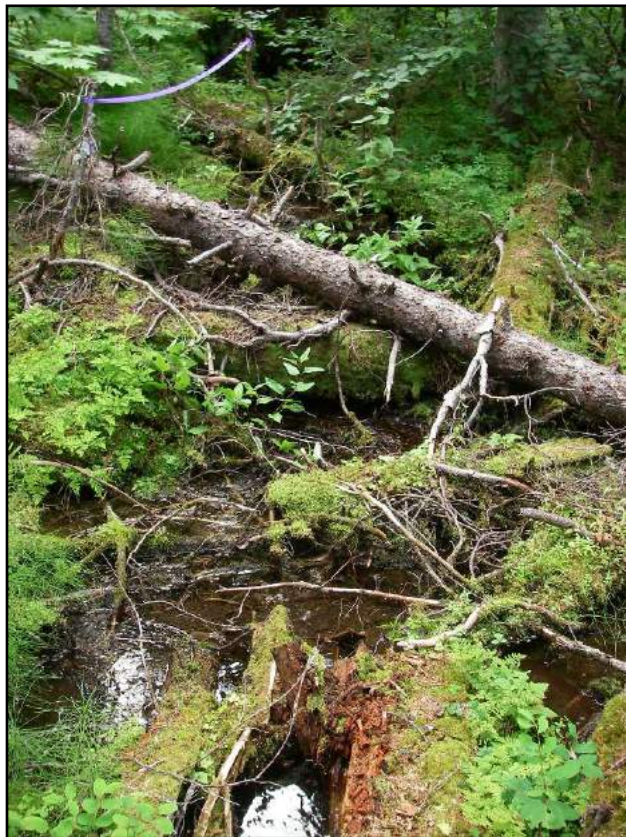
COMMENTS	
Section	Comments
CHANNEL	S6 - at RC due to marginal channelization 29% slope at rc, ~20m ds of rc maybe fb. US of road marginal w/several sections of overland and subsurface flow, mostly seepage, ~10m ds of RC several other streams enter and resulting stream is way better habitat

Site 237 – Downstream view, nice habitat

Site 237 – Upstream view, bad habitat

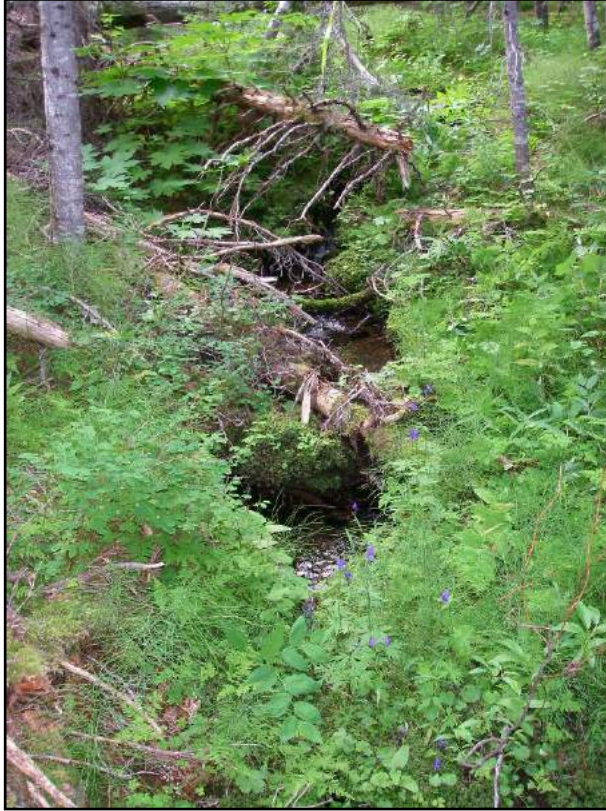
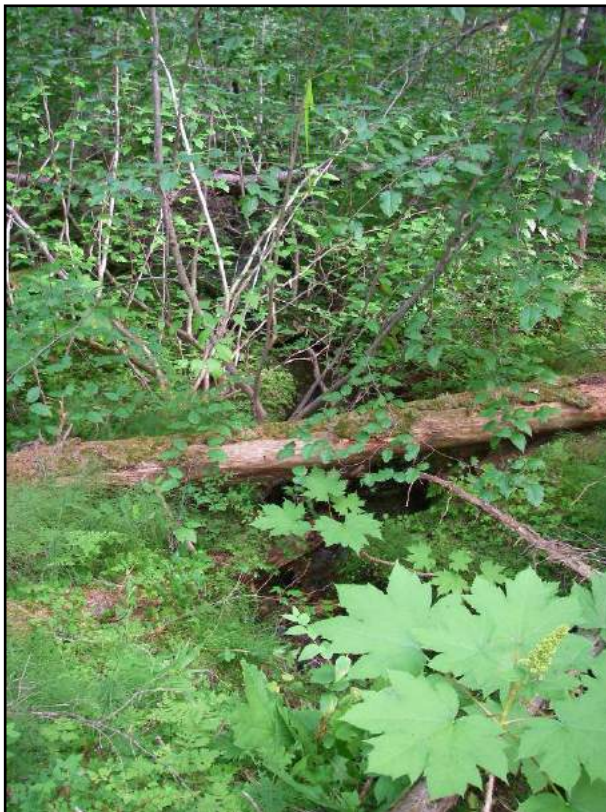
Photo	Foc Lg	Dir	Comments
R: 101 F: 4366	STD	U	defined channel us of rc
R: 101 F: 4367	STD	D	from rc

Site 239 – Upstream view, defined channel

Site 239 – Downstream view

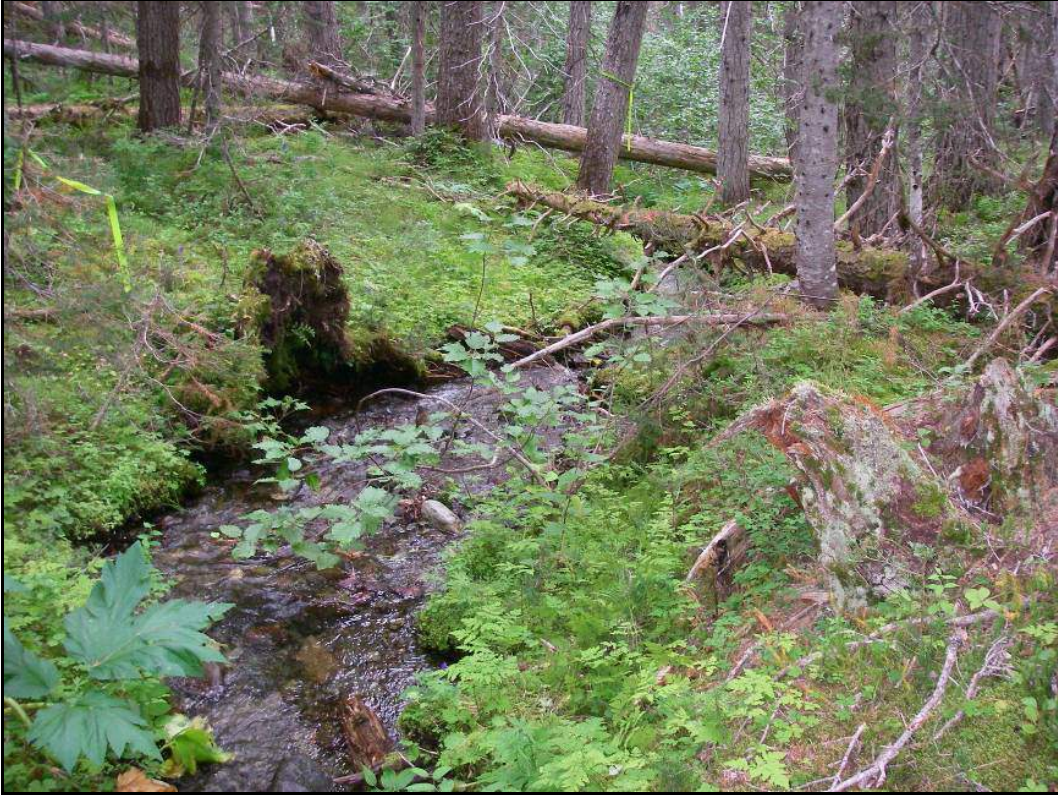
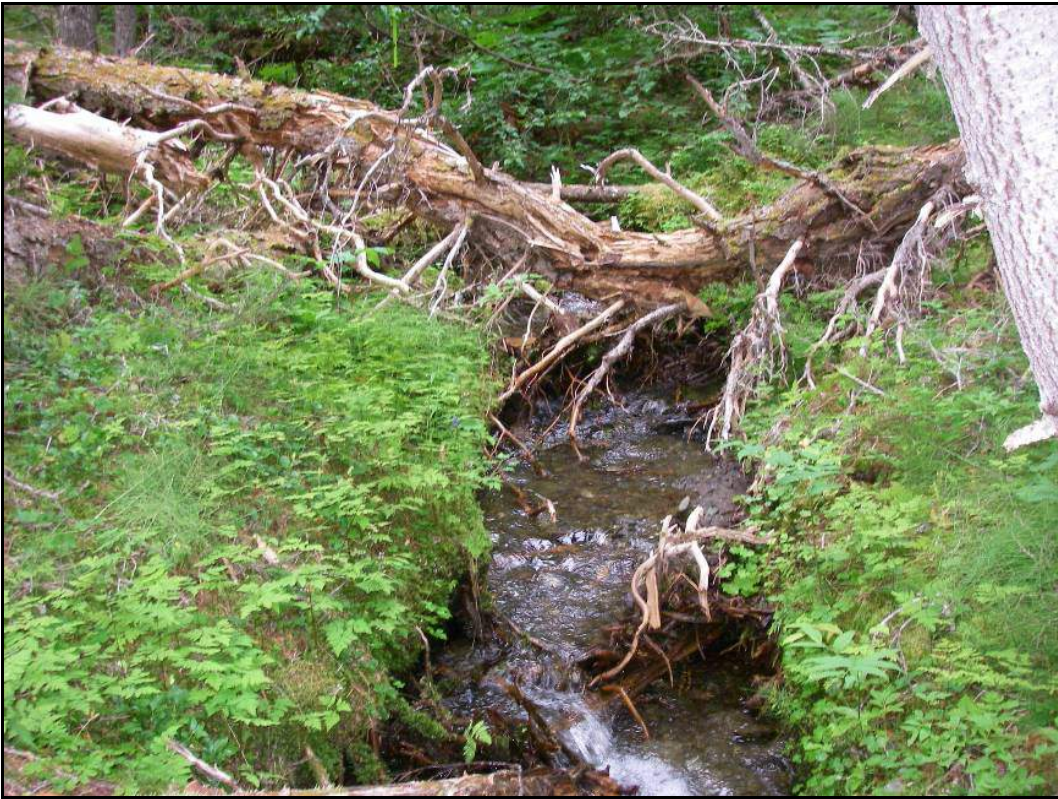
PHOTOS					
Photo		Foc Lg	Dir	Comments	
R:	102	F: 4368	STD	D	from rc
R:	102	F: 4369	STD	U	from rc
COMMENTS					
Section		Comments			
CHANNEL		S6 - marginal habitat, shallow but clear stream with good flow. Gradient barrier ds of rc 26% slope (feature)

Site 245 – Downstream view

Site 245 – Upstream view
