Schaft Creek Fisheries Baseline 2007

Rescan Tahltan Environmental Consultants
Vancouver, British Columbia

March 2008

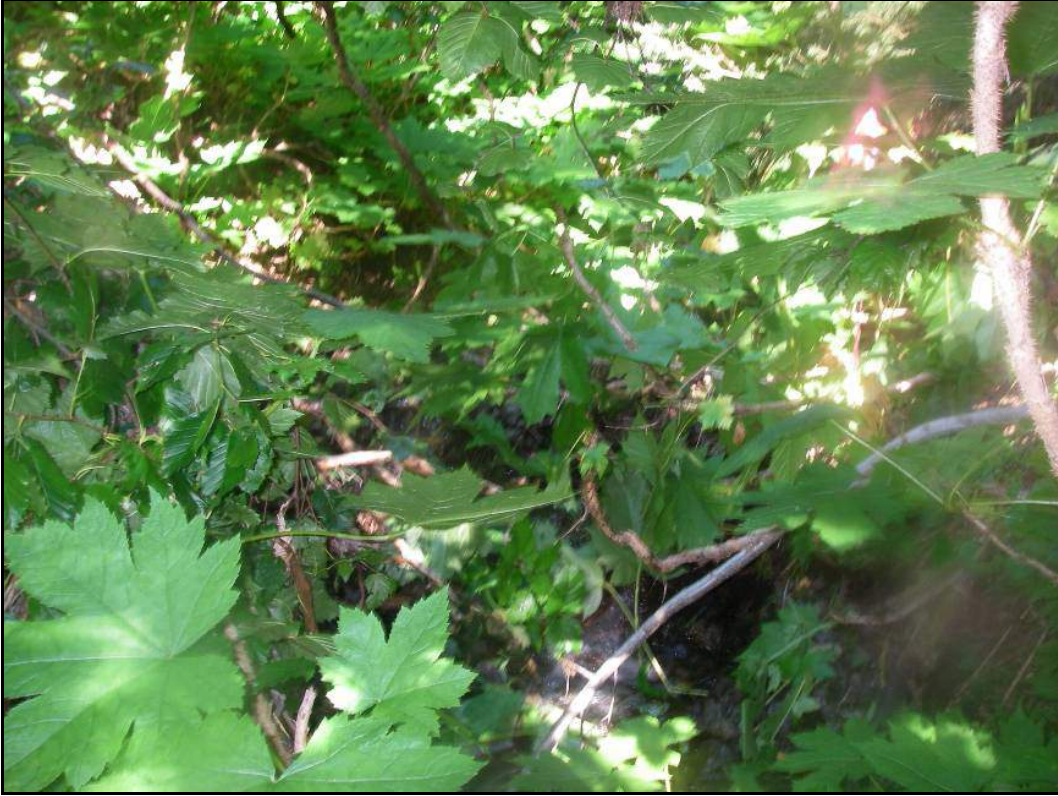
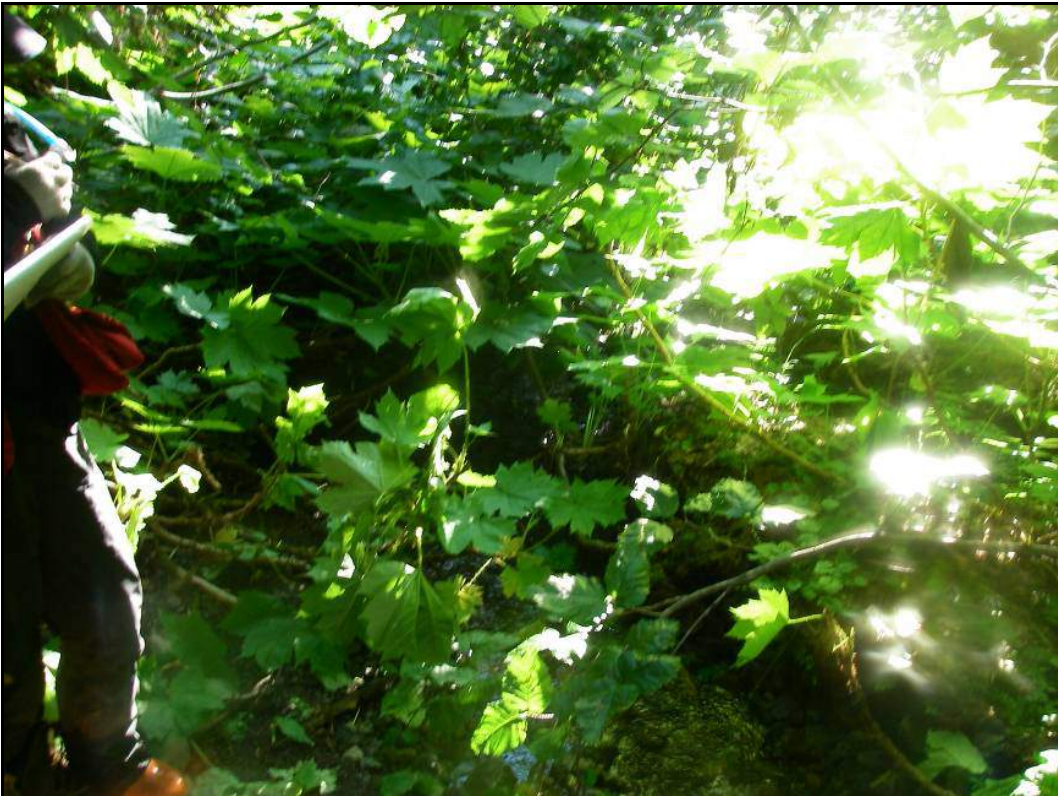
COMMENTS	
Section	Comments
CHANNEL	S6 - 26% barrier @ 1st crossing, marginal habitat, no pools, shallow. Same stream as site 245.

Site 246 – Upstream view

Site 246 – Downstream view

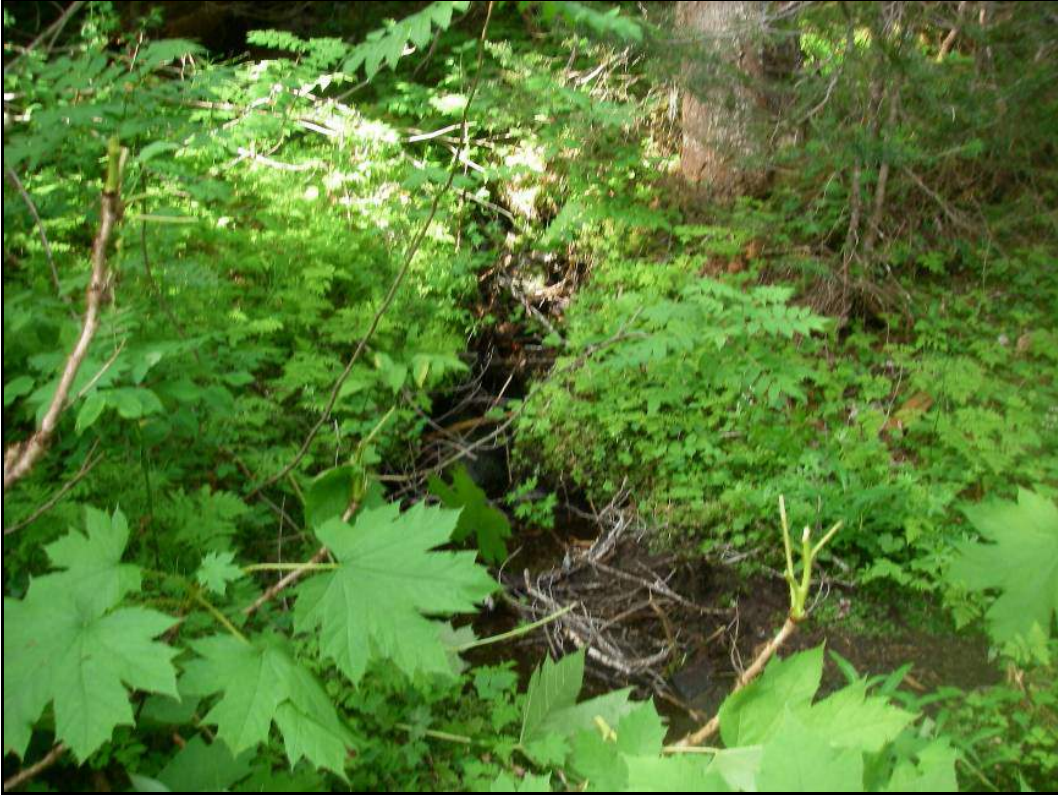
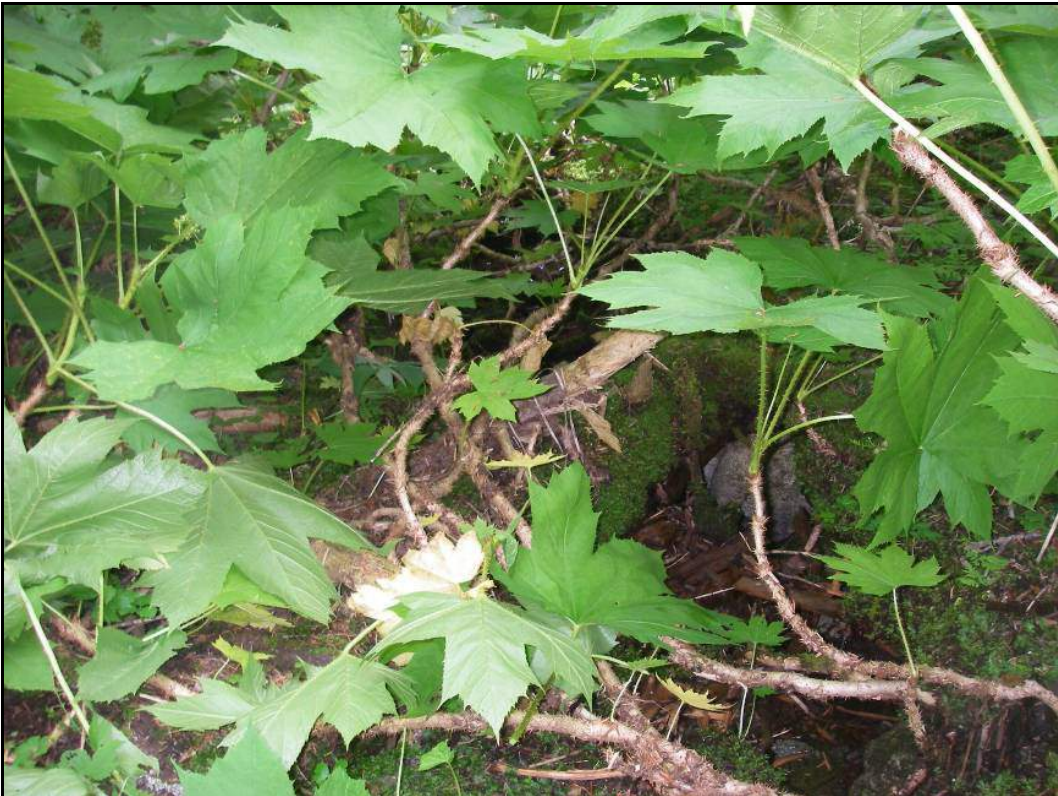
COMMENTS	
Section	Comments
CHANNEL	S6 - barely a stream, very narrow, defined channel with barely a trickle of flow. High gradient (27%)

Site 248 – Upstream view

Site 248 – Downstream view

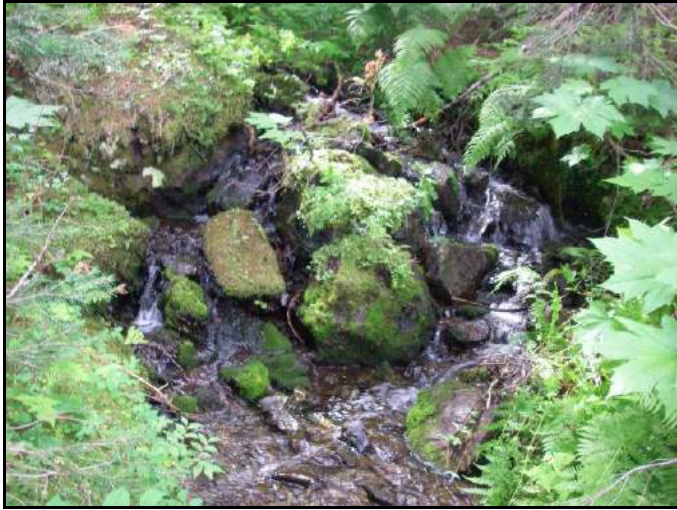
Photo	Foc Lg	Dir	Comments
R: 102 F: 4389	STD	U	cascade barrier ds of rc
R: 102 F: 4390	STD	U	@ rc
R: 102 F: 4392	STD	D	@ rc

Site 254 – Upstream cascade barrier

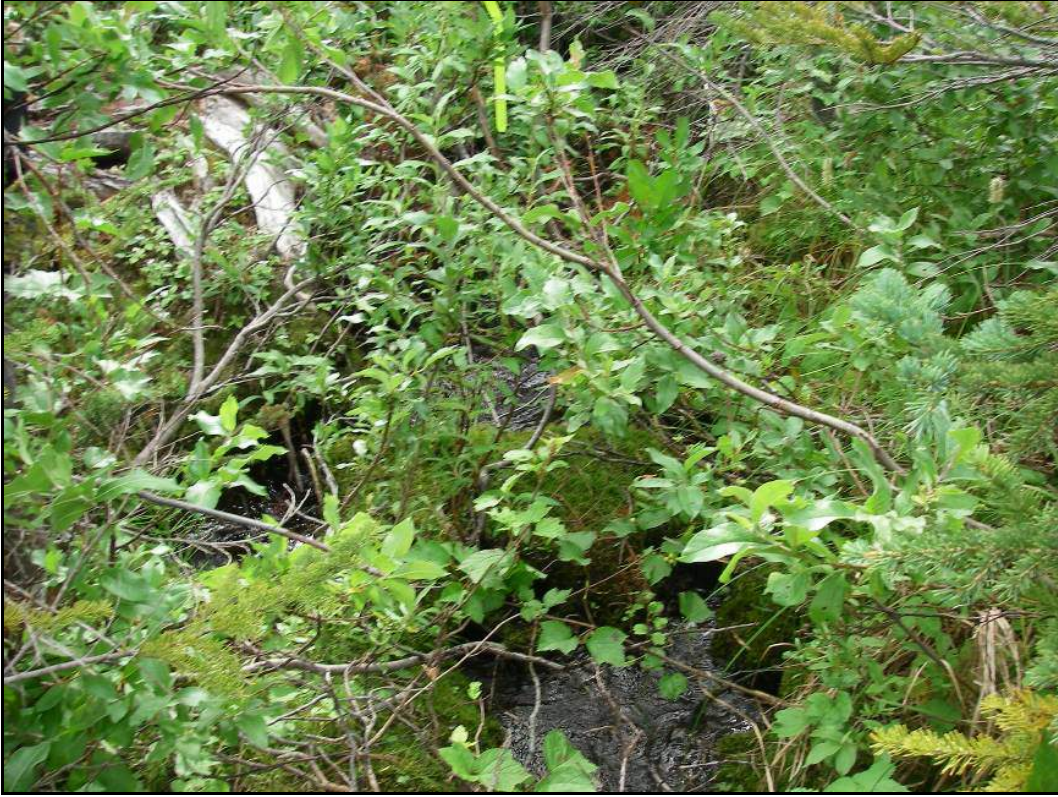
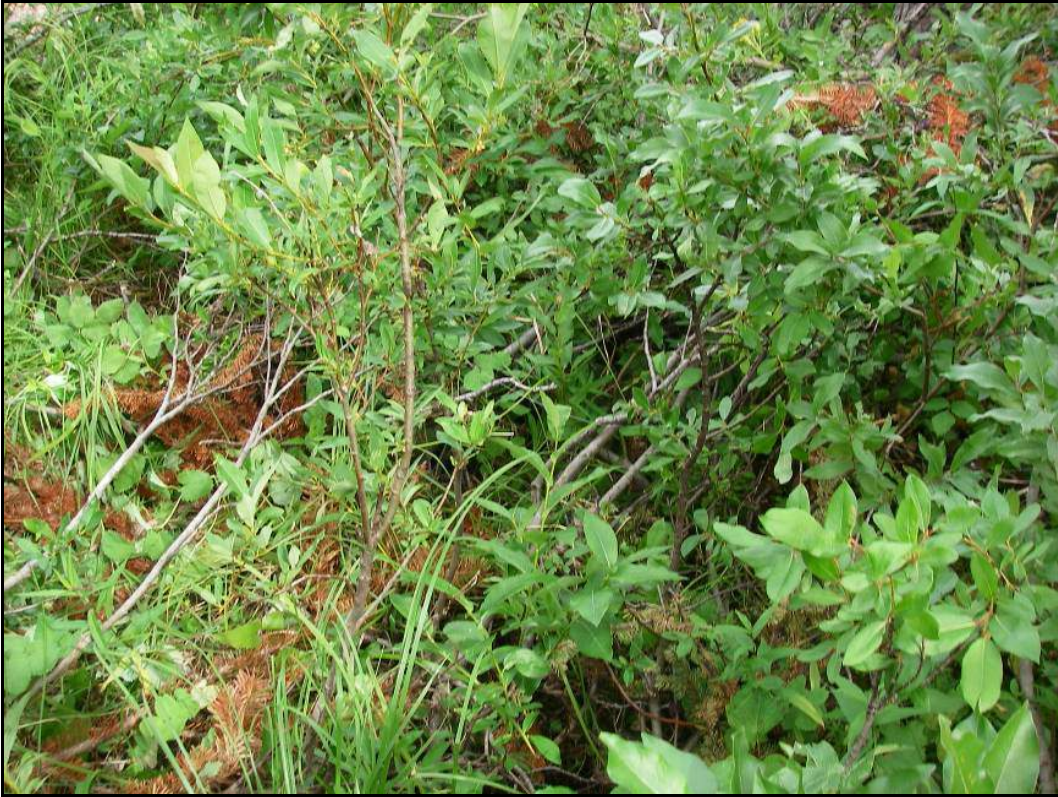
COMMENTS	
Section	Comments
CHANNEL	S6 - small stream @ bottow of av chute. Lots of SWD. Good flow, but shallow, no pools. Probably ds barrier. Road follows stream (actually on top of stream) for several M us of rc.

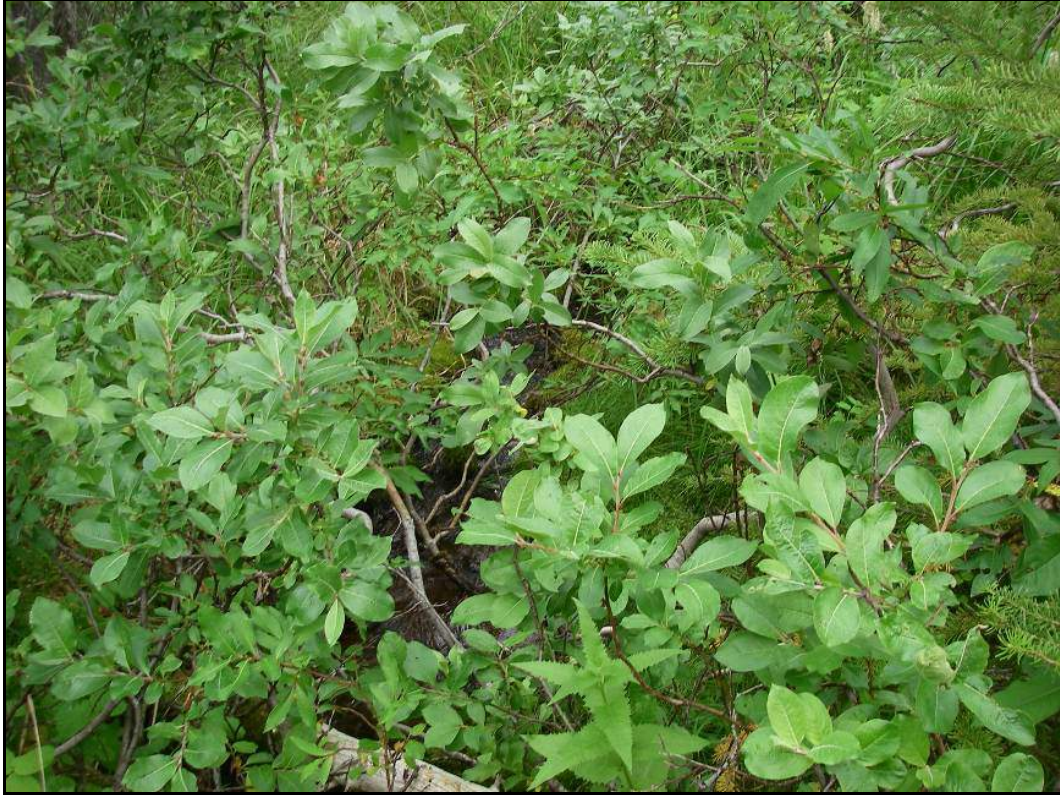
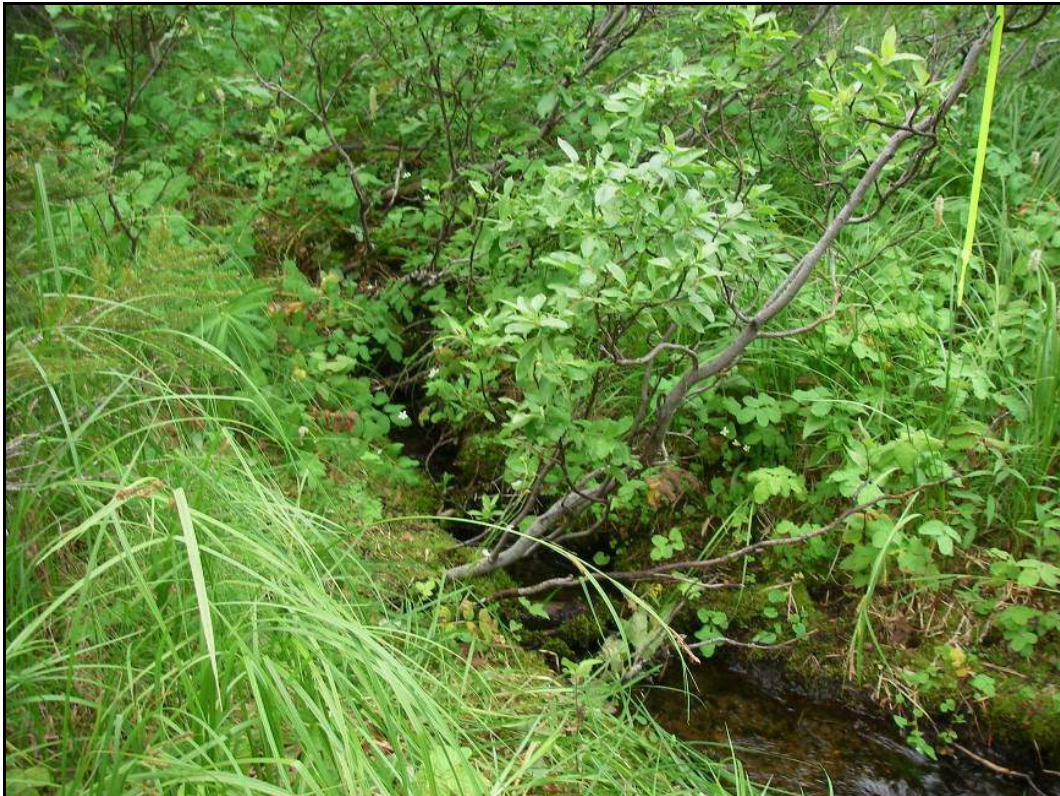
COMMENTS	
Section	Comments
SITE CARD	bedmaterial and LWD func. Missing on site card.
CHANNEL	S6 - small stream along edge of wetland. Multiple sections of underground flow, no pools. Marginal habitat.

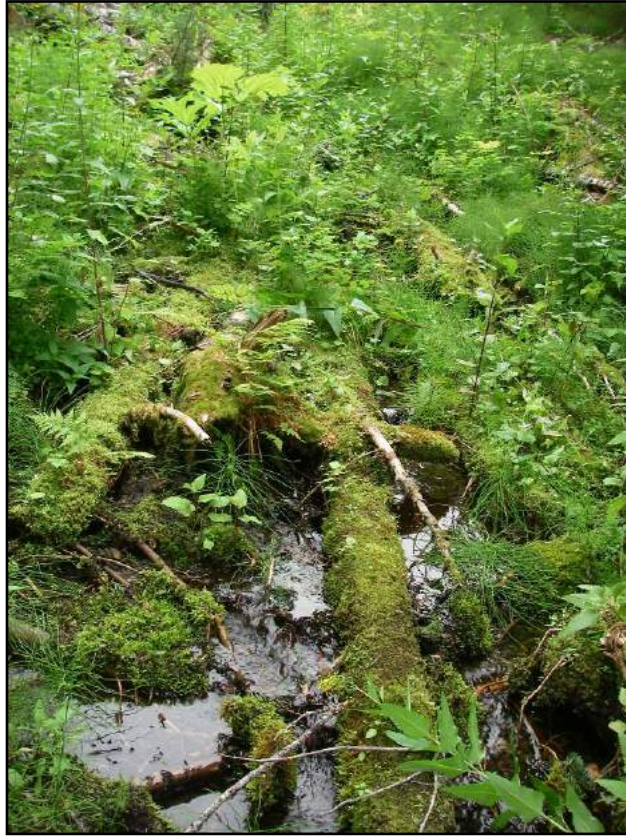
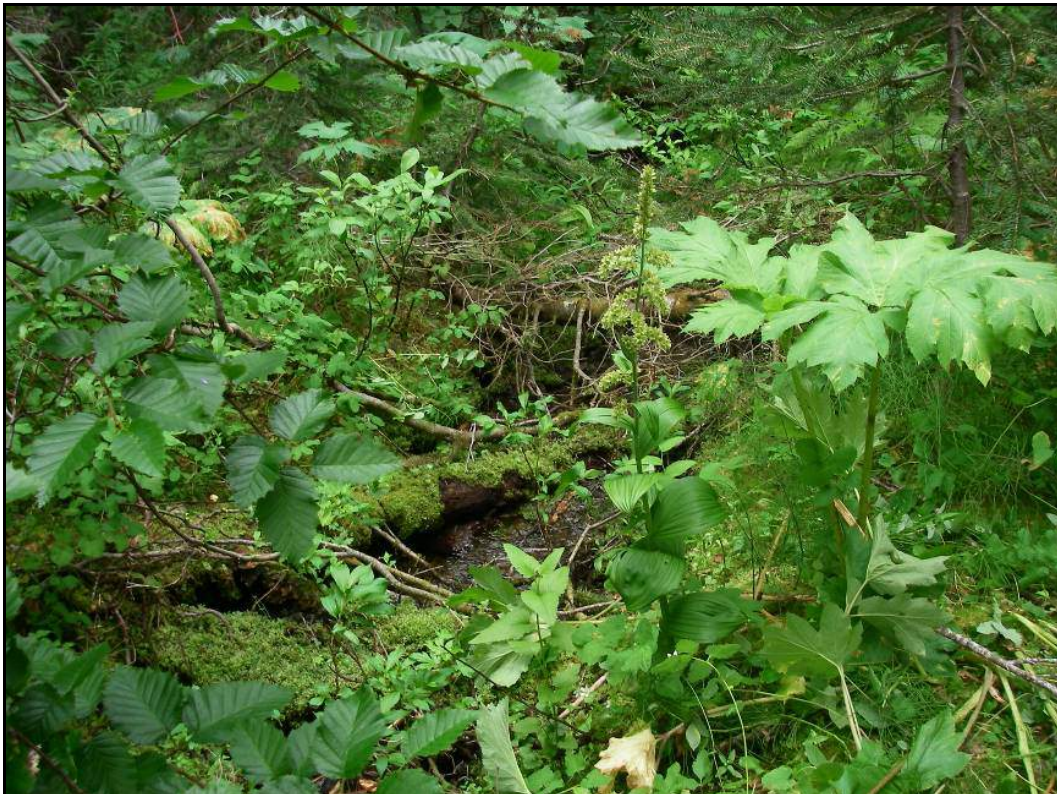
Section	Comments
CHANNEL	S6 - small stream comes from av chute and splits into 2 channels just us of rc. Shallow no pools, marginal habitat. Probably gradient barrier ds.

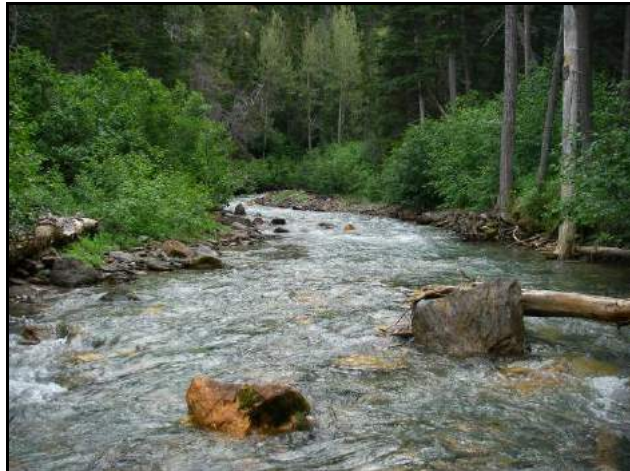
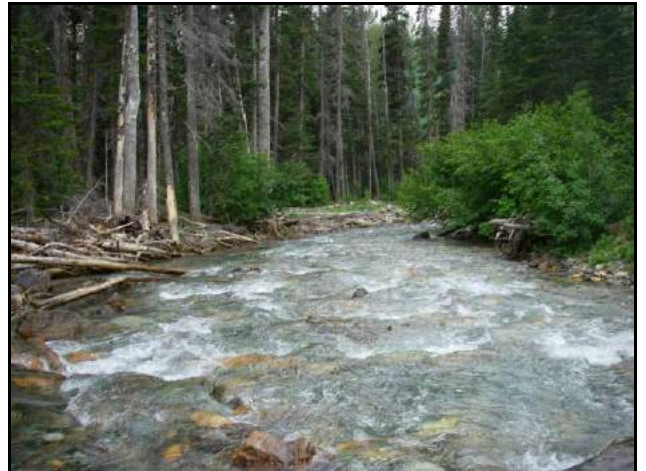
PHOTOS				
Photo		Foc Lg	Dir	Comments
R:	106	F:	392	STD X eroding bank LB
R:	106	F:	393	STD X abandoned channel
COMMENTS				
Section		Comments		
CHANNEL		S3 Default - adequate habitat probably not dense enough to have recovered fish via shocking. Important habitat value. Recommend moving bridge site us 40+m due to eroding banks on RB.

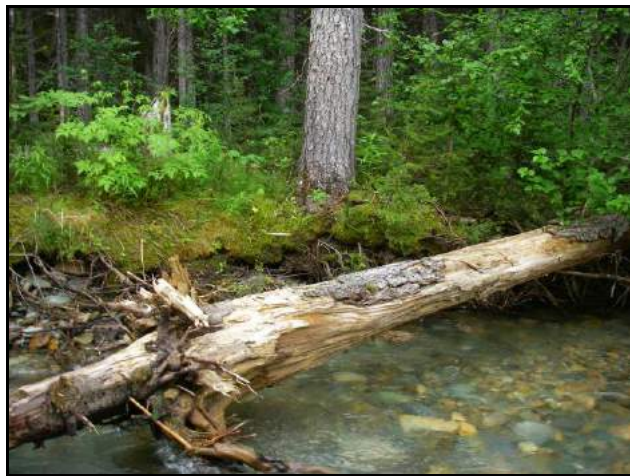
Site 300 – Erosion left bank

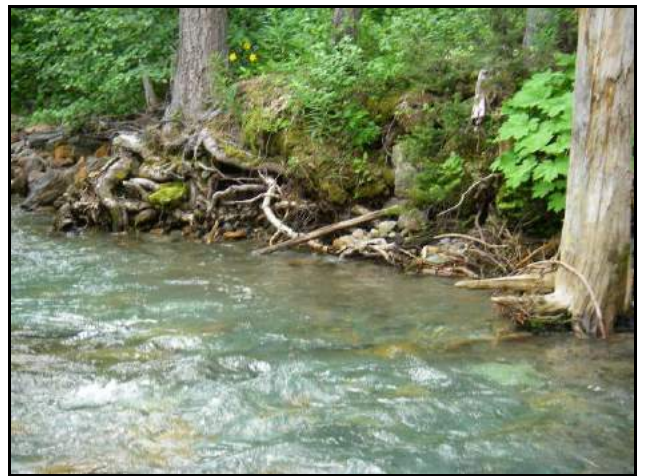
Site 300 – Erosion right bank

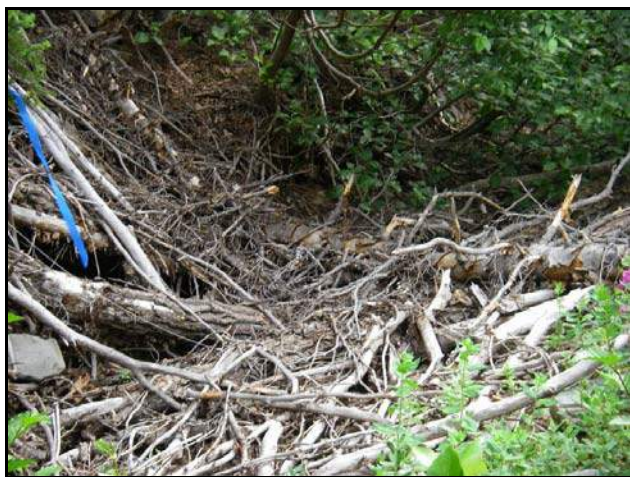
Site 300 – Abandoned channel

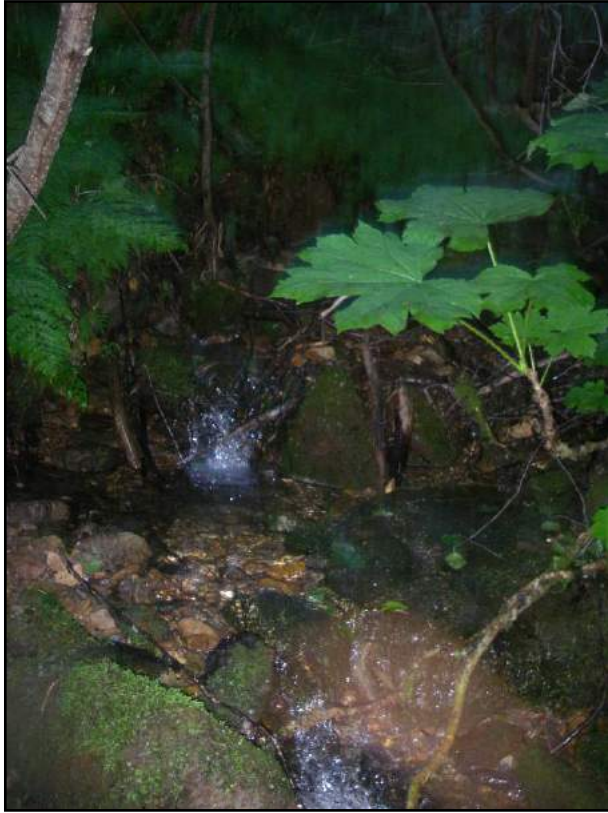
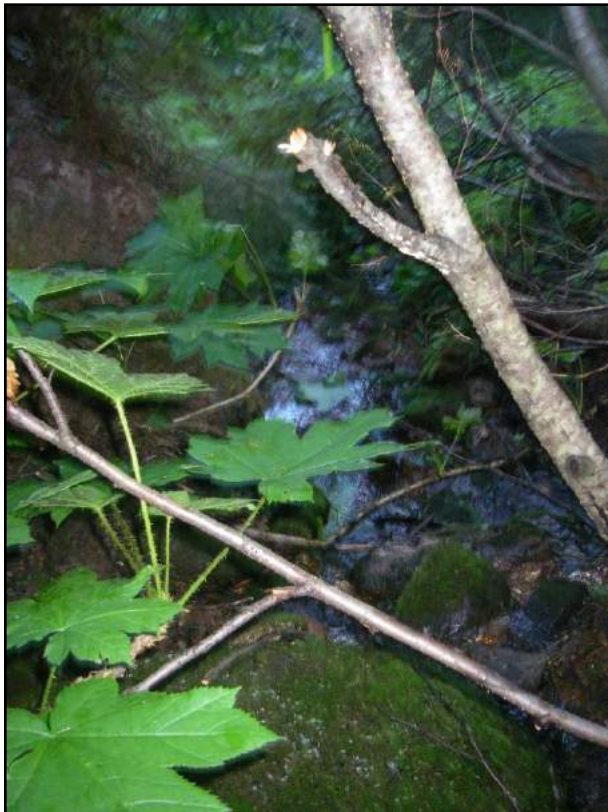
Photo	Foc Lg	Dir	Comments
R: 107 F: 411	STD	U	note extensive over veg.
R: 107 F: 412	STD	D

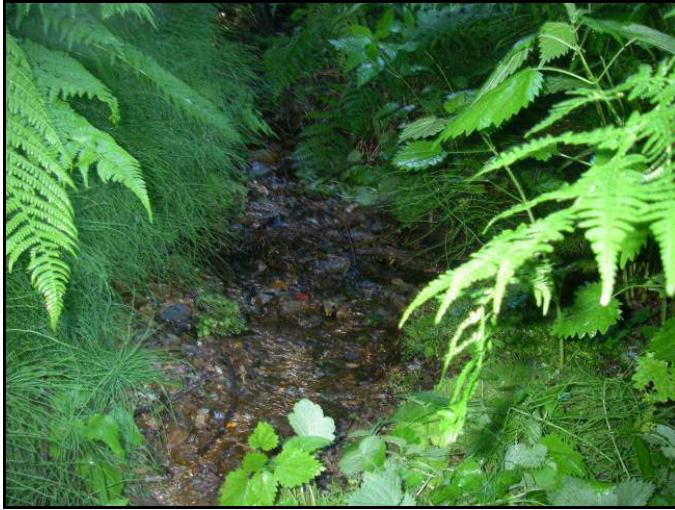
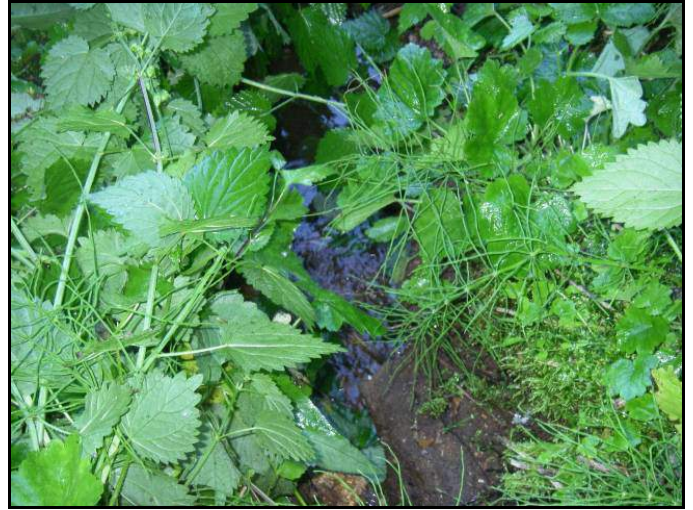
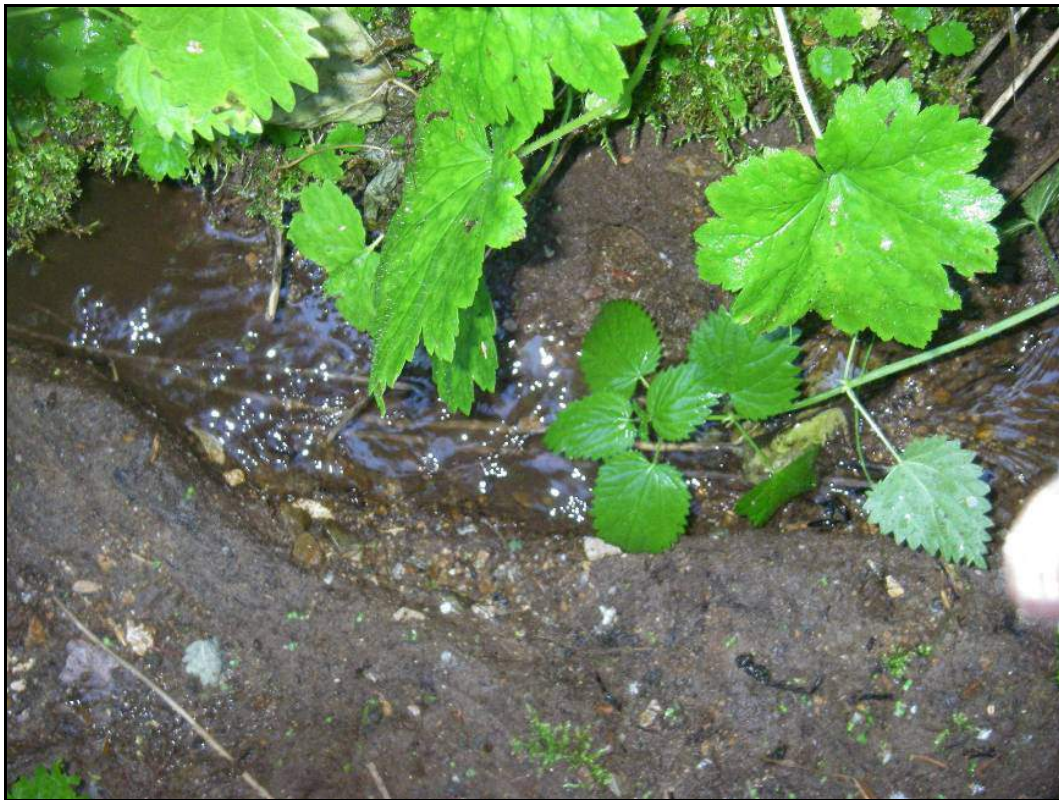
Photo	Foc Lg	Dir	Comments
R: 107 F: 413	STD	U	with pencil for scale
R: 107 F: 414	STD	D	
R: 107 F: 415	STD	X	showing lack of formal banks at road crossing

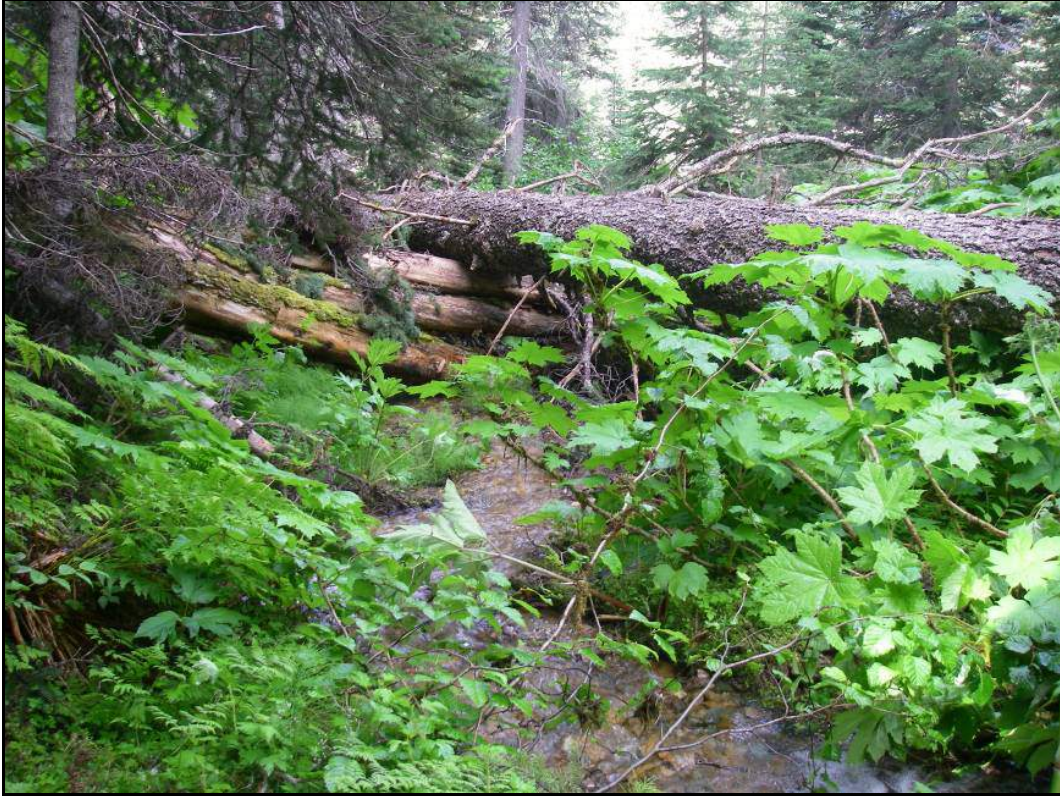
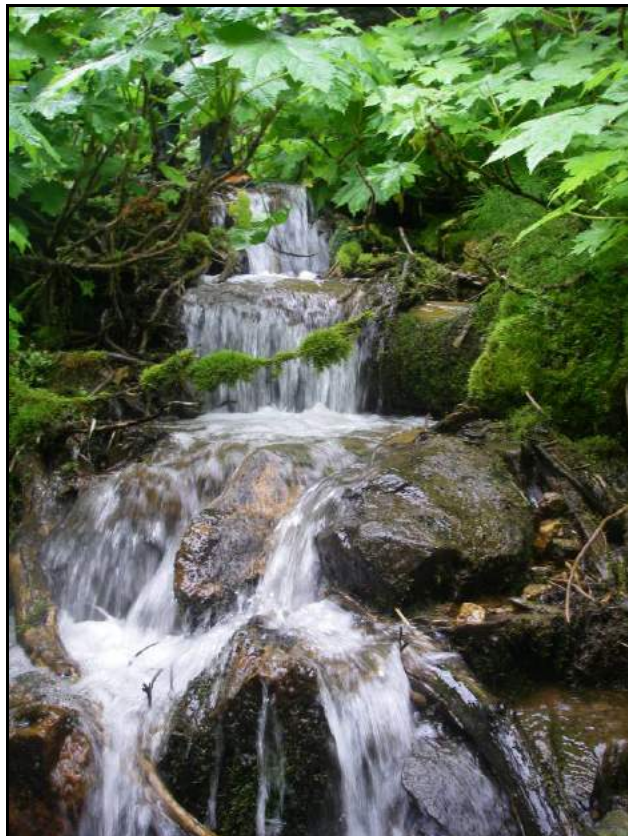
PHOTOS				
Photo		Foc Lg	Dir	Comments
R: 107	F: 420	STD	D	
R: 107	F: 421	STD	U	barriers possible
WILDLIFE				
Group		Observations		
BIR		songbird feathers		
MAM		moose scat		
COMMENTS				
Section		Comments		
CHANNEL		S4 - reach 2 exhibits good gravel substrate and good cover. The stream is wildly unconfined yet streamlike 100% ov for cover. Good flow nd many side channels. Important habitat values.

Site 312 – Upstream view, possible barrier

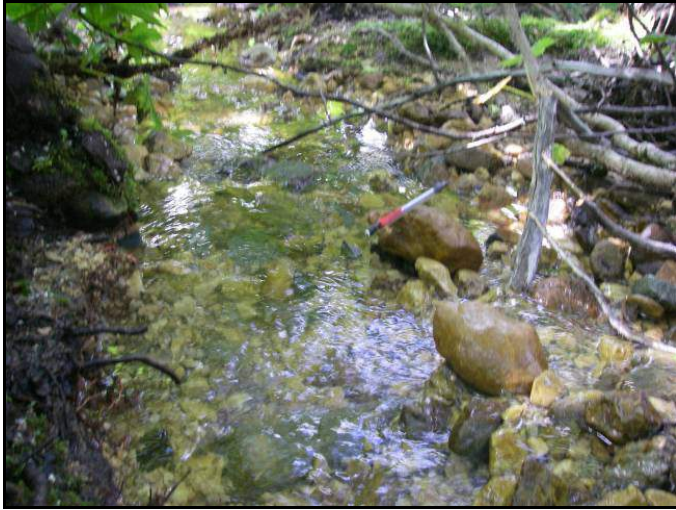
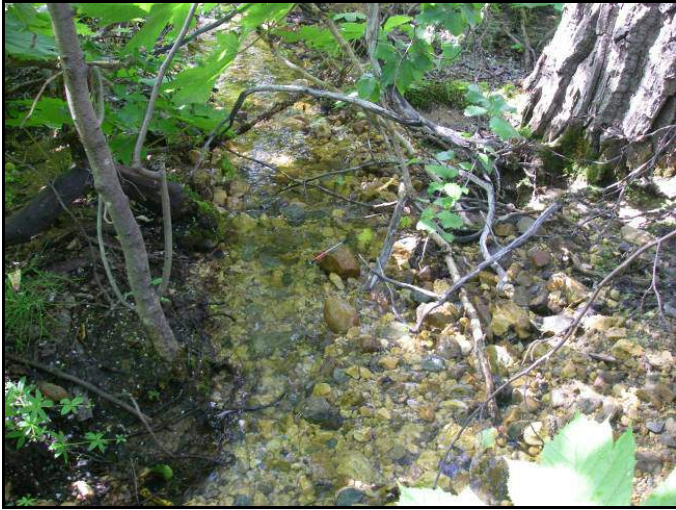
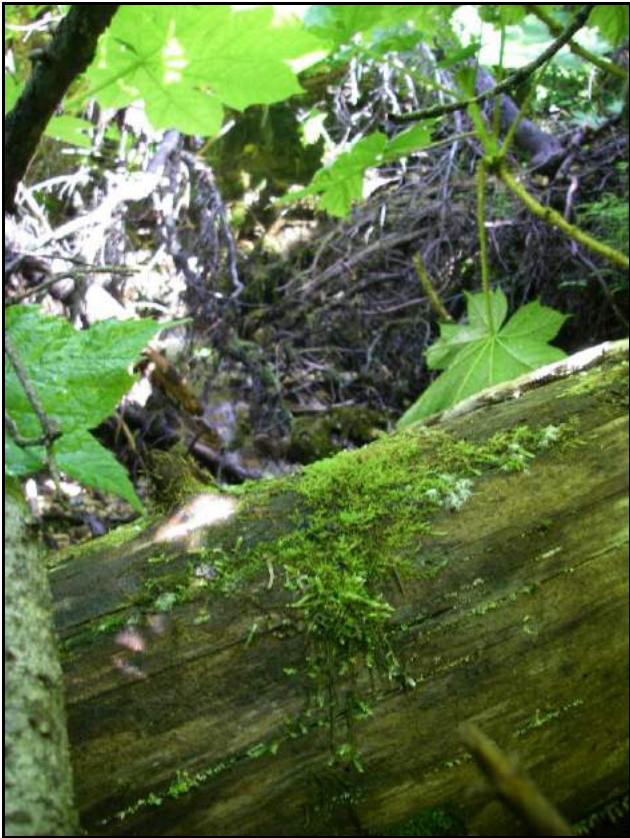
PHOTOS				
Photo		Foc Lg	Dir	Comments
R:	107	F:	426	STD U note 18% ov.
WILDLIFE				
Group		Observations		
MAM		moose scat		
MAM		dead vole		
COMMENTS				
Section		Comments		
CHANNEL		S6 - habitat value important, compromised by wetland adct to Mess Cr. Good gravels flow unconfined. Extensive devils club= rip veg.

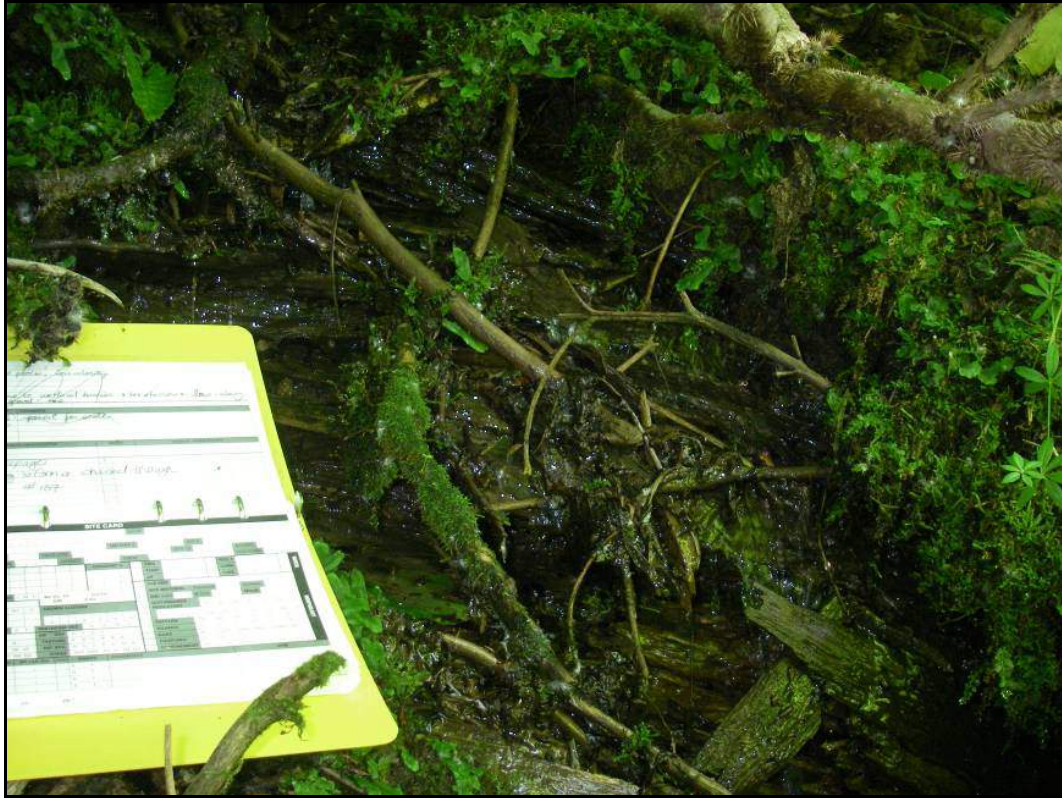
Section	Comments
CHANNEL	NCD - seepage starting to form a channel though.

Site 314 – Showing stream bed

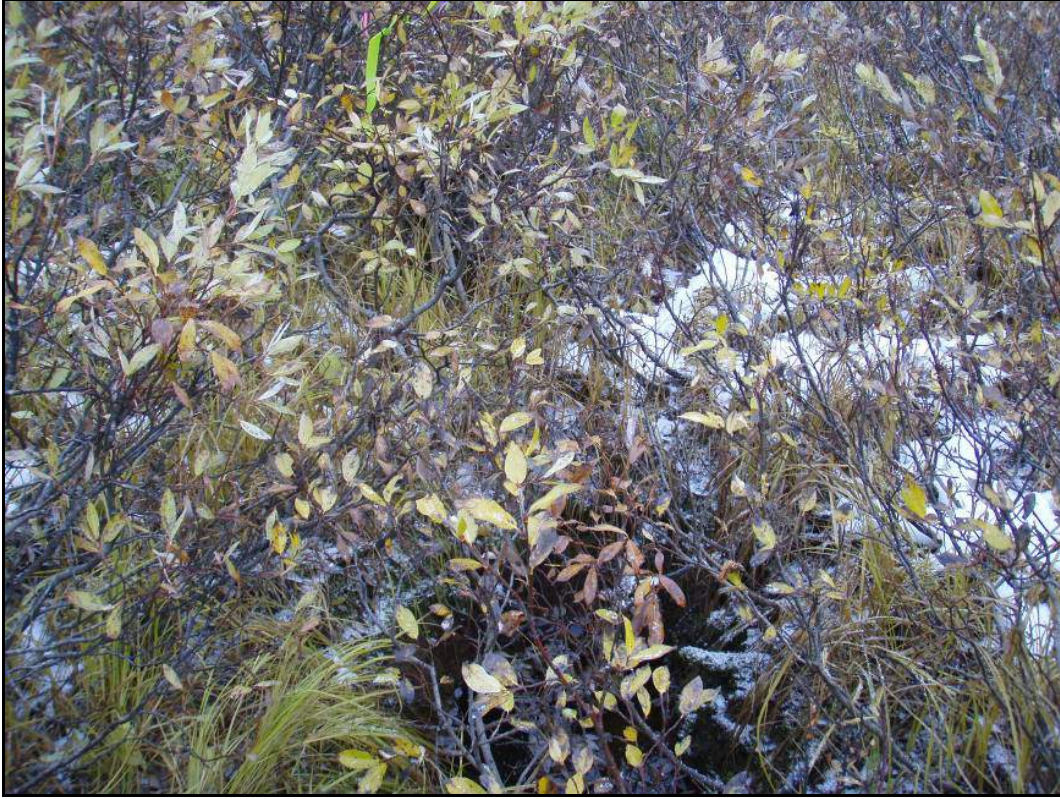
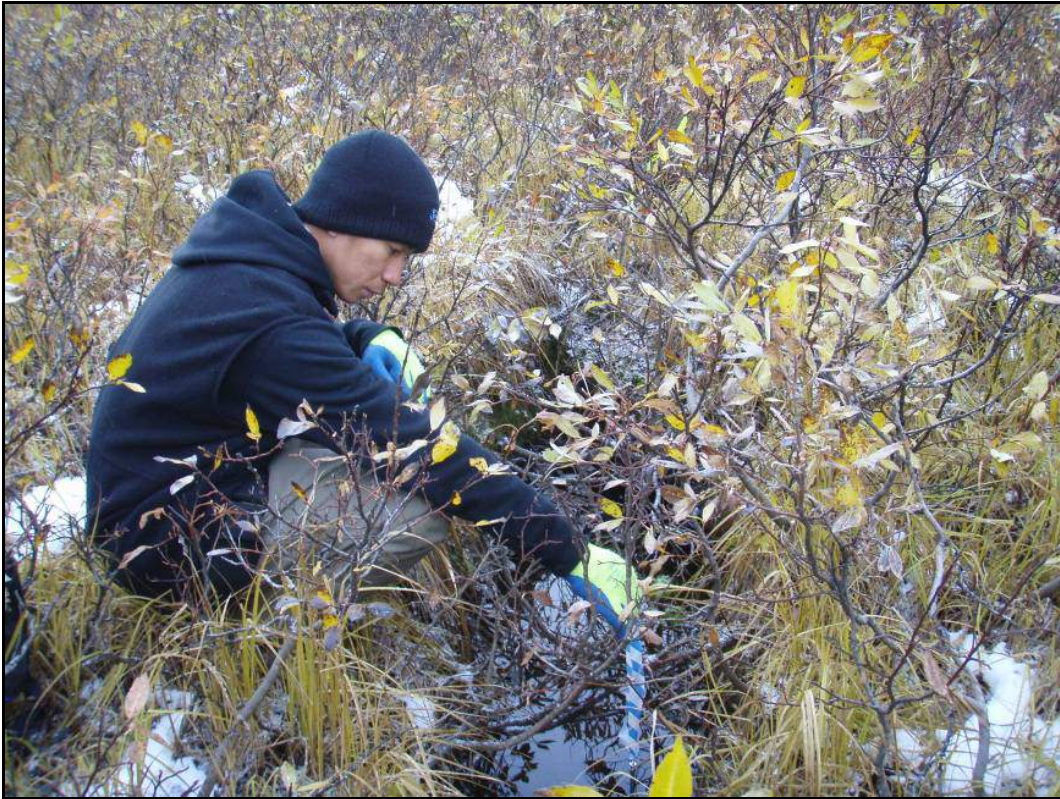
COMMENTS	
Section	Comments
CHANNEL	S6 - resample 0.5 degrees at sample time. Good channel with cover in wetland/marsh.

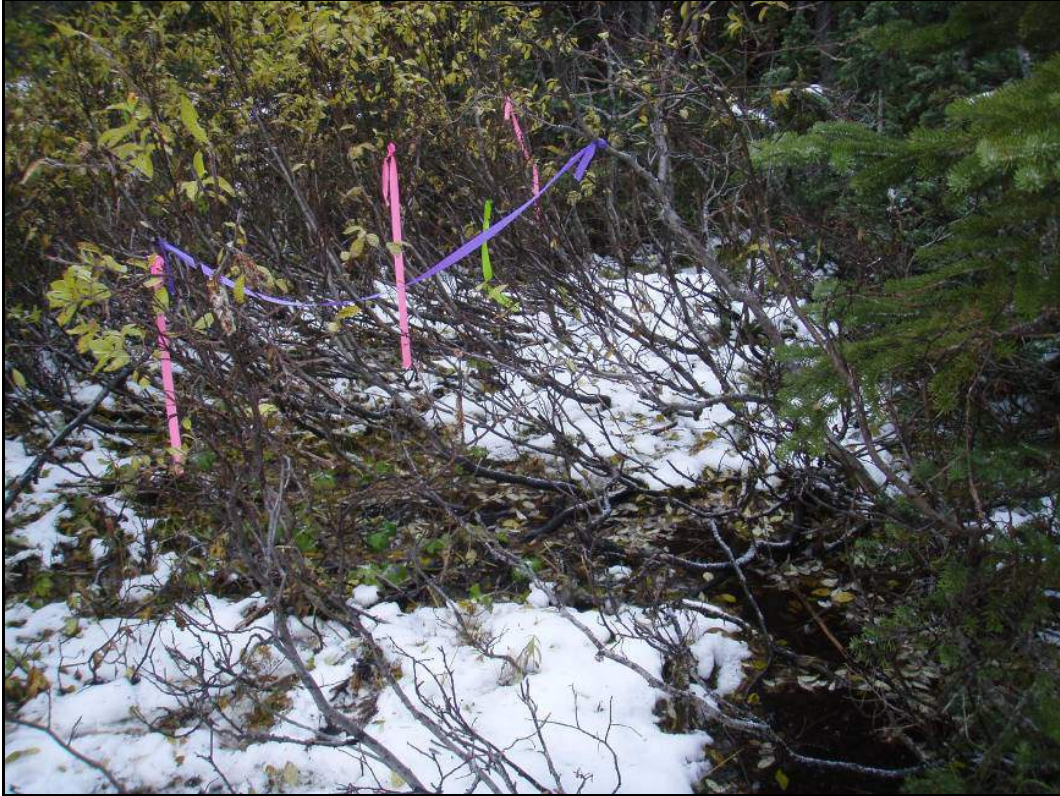
Site 322 – Downstream view

Section	Comments
CHANNEL	NCD - flows nto WL with M221. intermittent dry, no defined channel.
SITE CARD	NCD

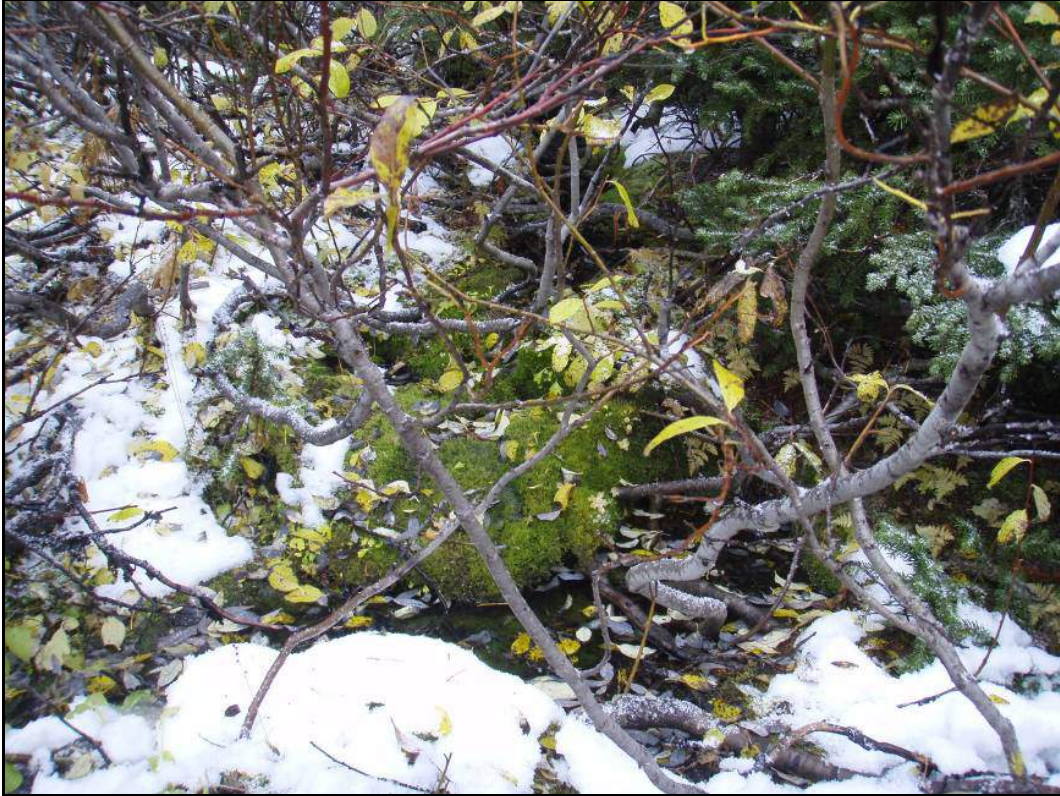
Site 323 – Upstream view

Section	Comments
CHANNEL	NCD - short reach with water and flow <100m
SITE CARD	NCD

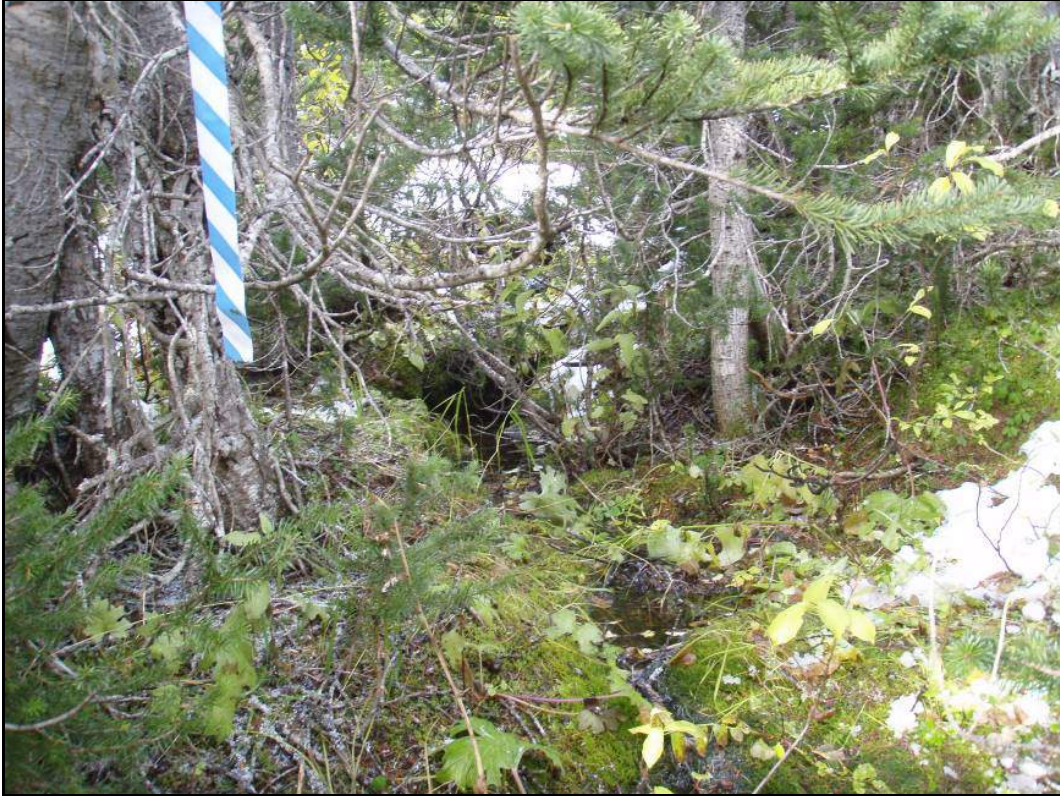
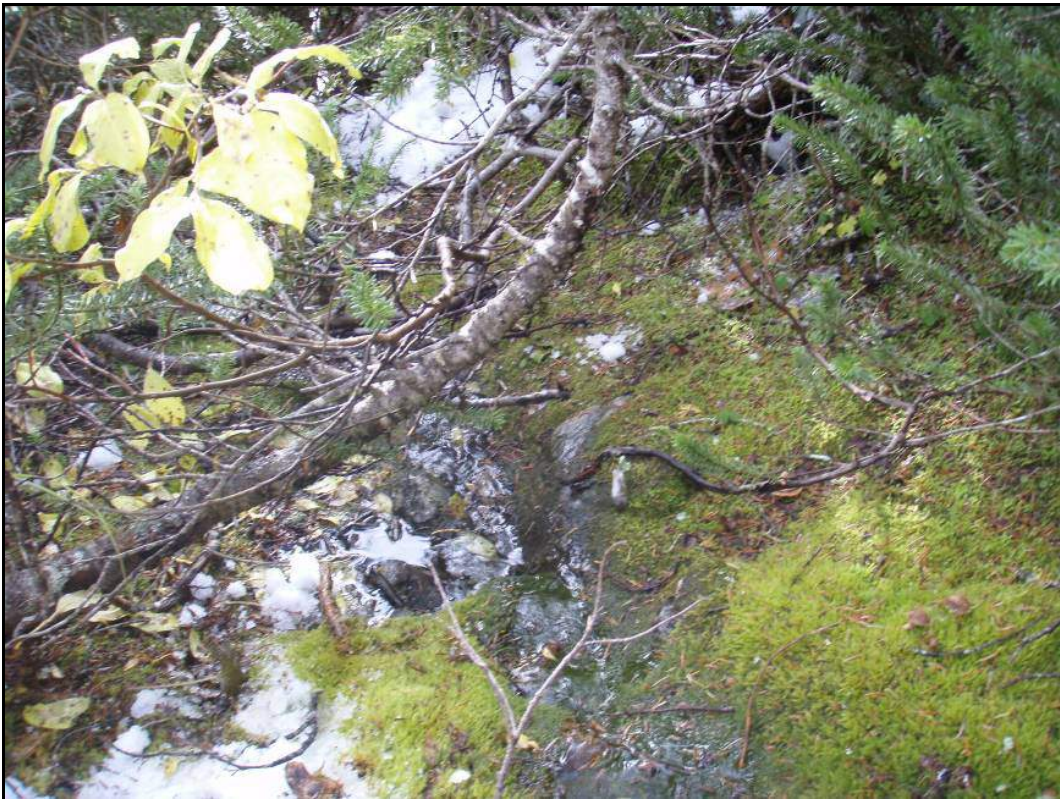
Name	Comments
OverWinter Habitat	poor - shallow pools
Rearing Habitat	poor - shallow pools
Spawning Habitat	poor - few fines, poor gravel mix

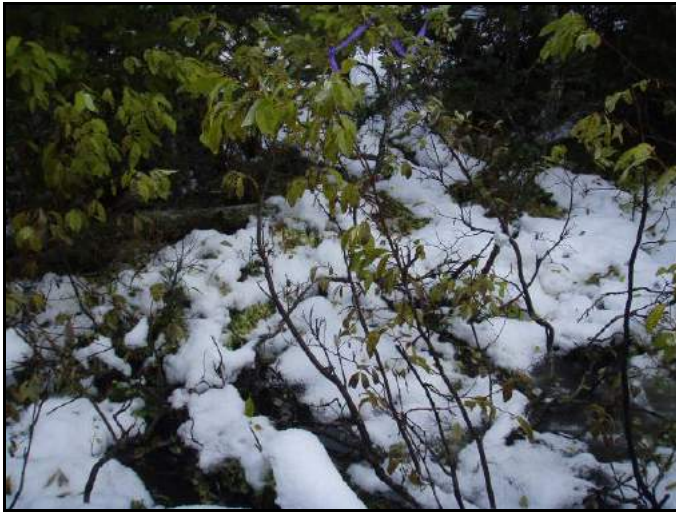
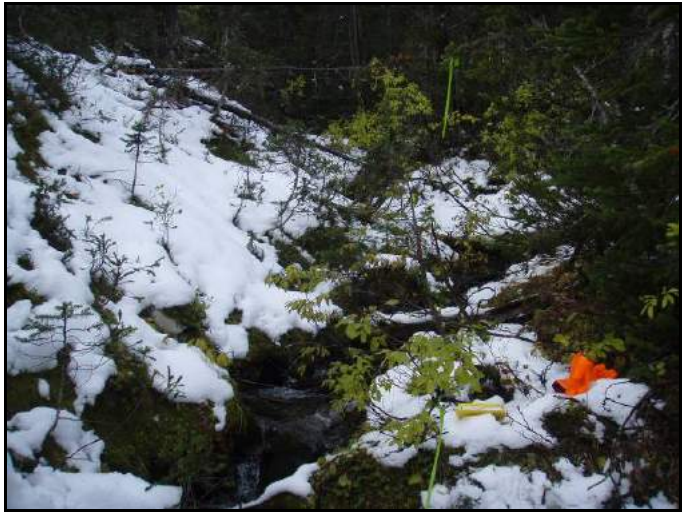
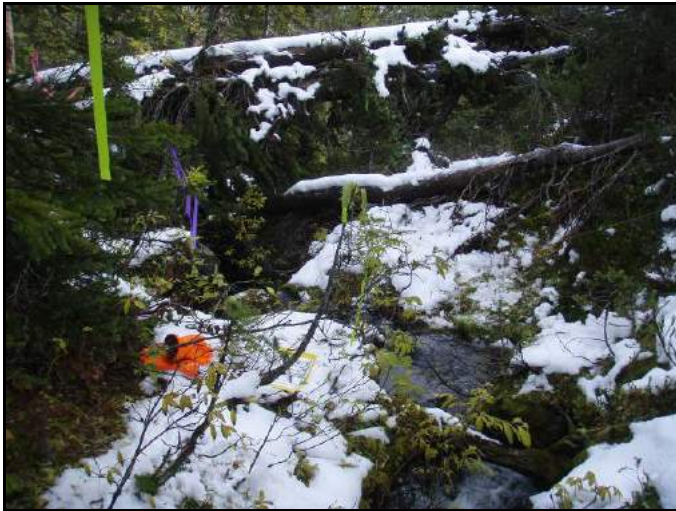
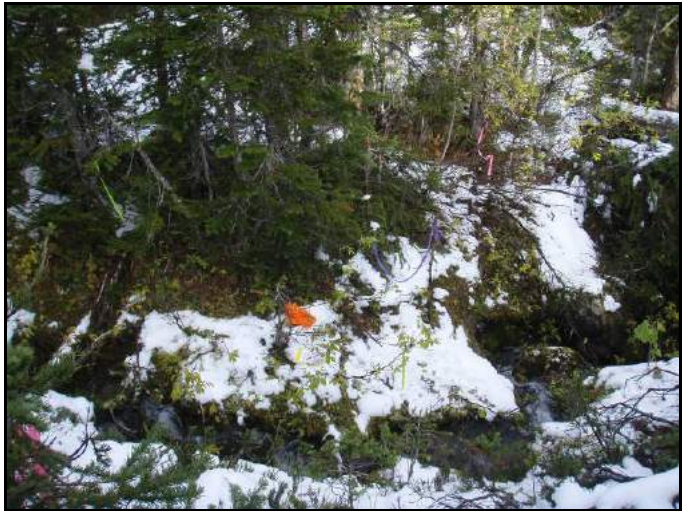
Name	Comments
OverWinter Habitat	good - cover, pools, flow
Rearing Habitat	good - abundant cover
Spawning Habitat	good - nice mix of fines
