Schaft Creek Fisheries Baseline 2007

Rescan Tahltan Environmental Consultants
Vancouver, British Columbia

March 2008

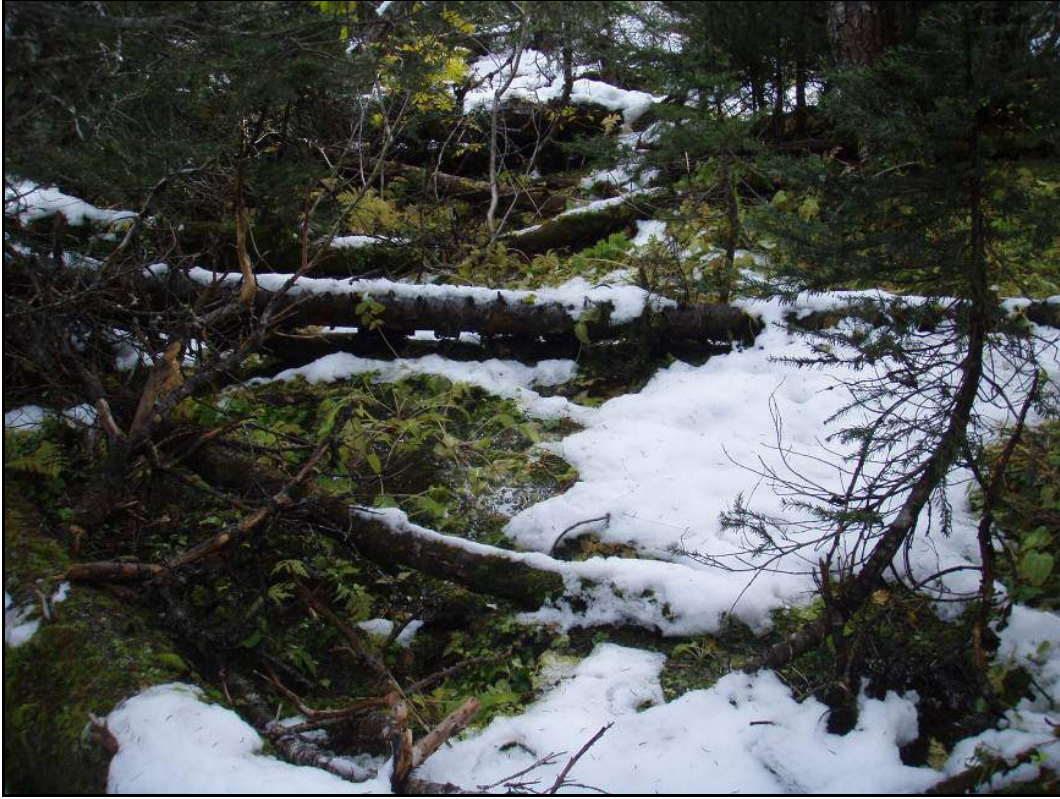
Site 328 – Downstream view

Section	Comments
SITE CARD	NCD
CHANNEL	NCD - McElhanney notes as seepage

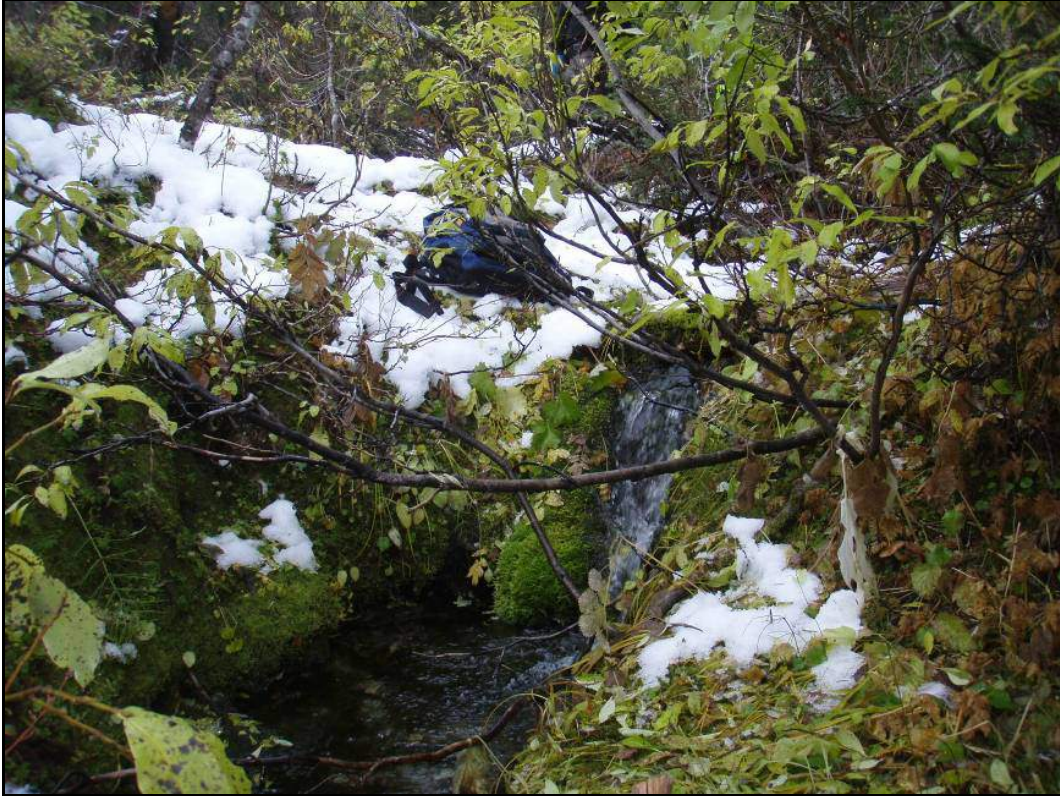
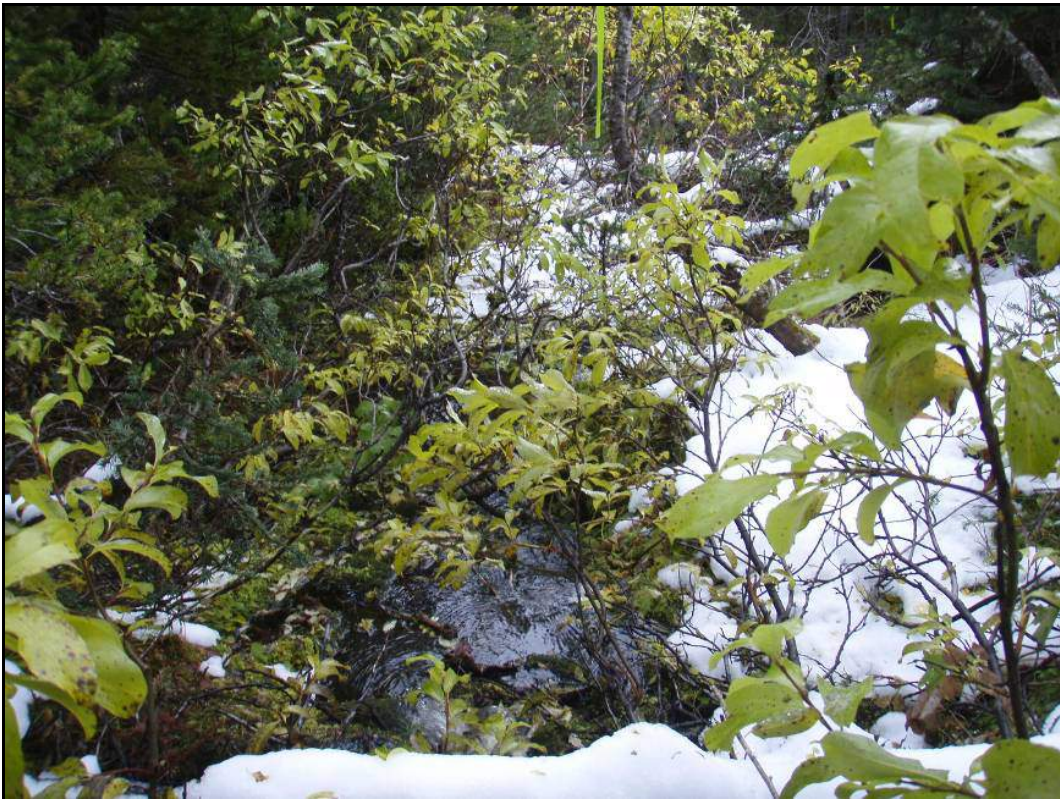
Site 329 – Upstream view

PHOTOS					
Photo			Foc Lg	Dir	Comments
R:	DIG	F: 1394	STD	U	
R:	DIG	F: 1395	STD	D	
COMMENTS					
Section		Comments			
CHANNEL		S6 - >35% at mouth into S Mess lk.

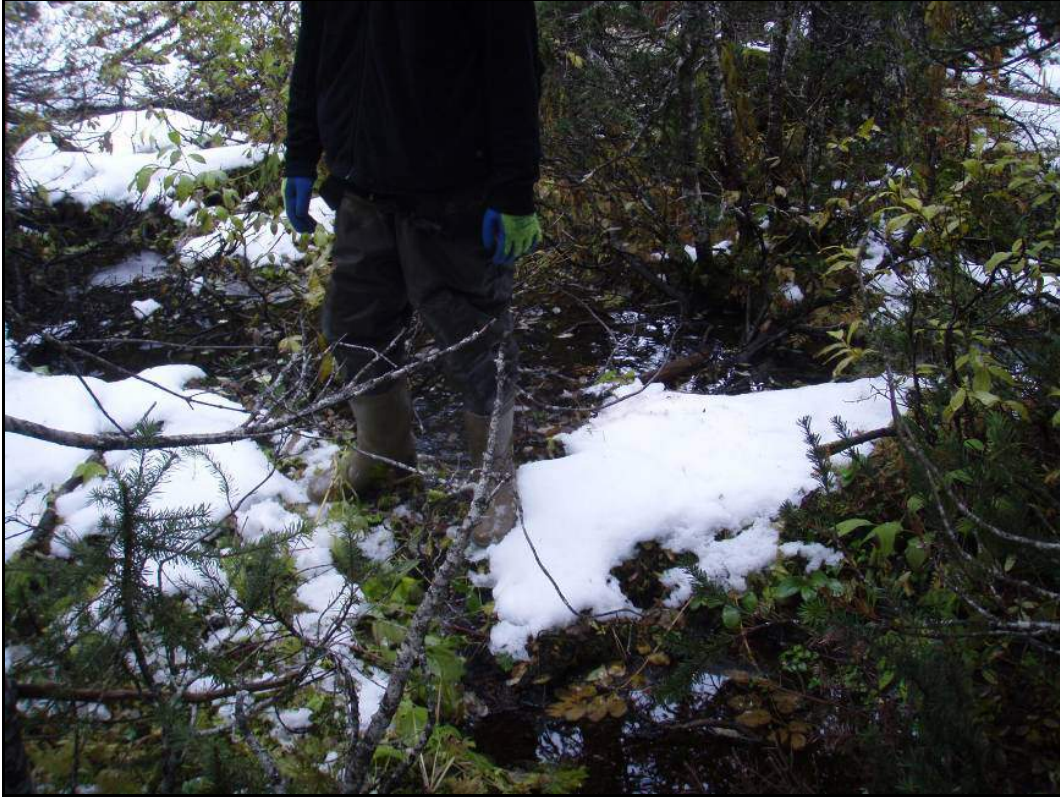
Site 330 – Upstream view of NCD

Section	Comments
CHANNEL	NCD - "overland flow". No defined channel scour or continual reach.
SITE CARD	NCD

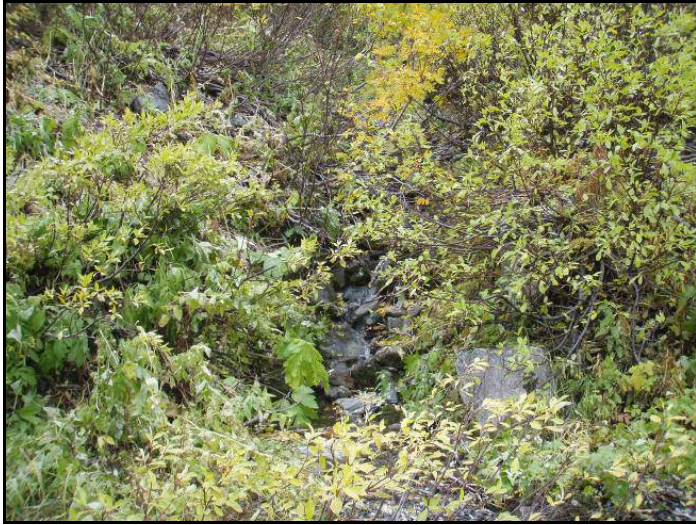
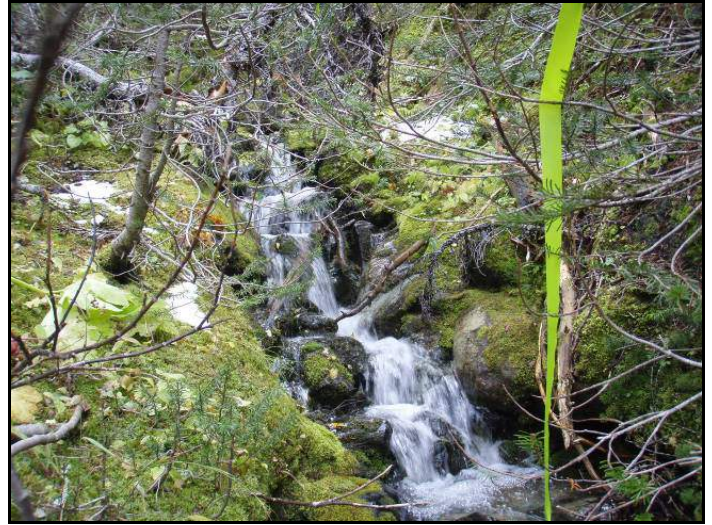
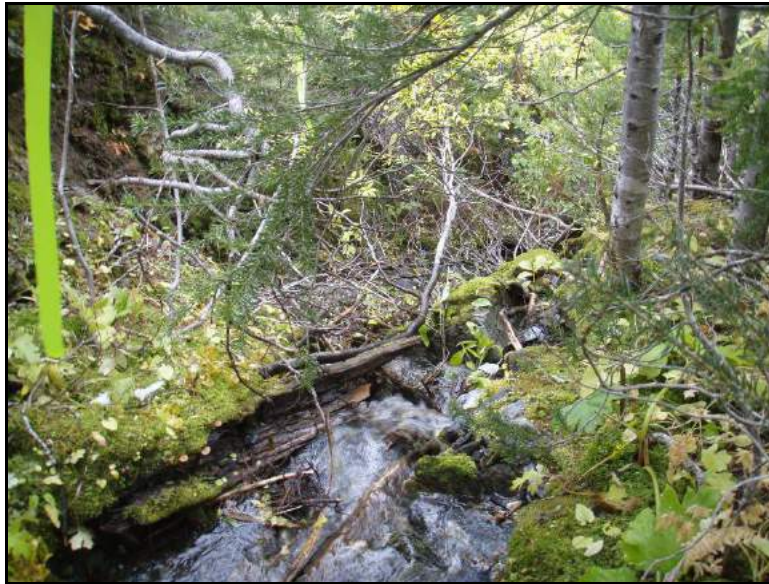
Site 332 – Upstream view

COMMENTS	
Section	Comments
CHANNEL	S6 - ~35% gradient along entire reach. 2m drops at line. Other wise step pool. Barrier at mouth.

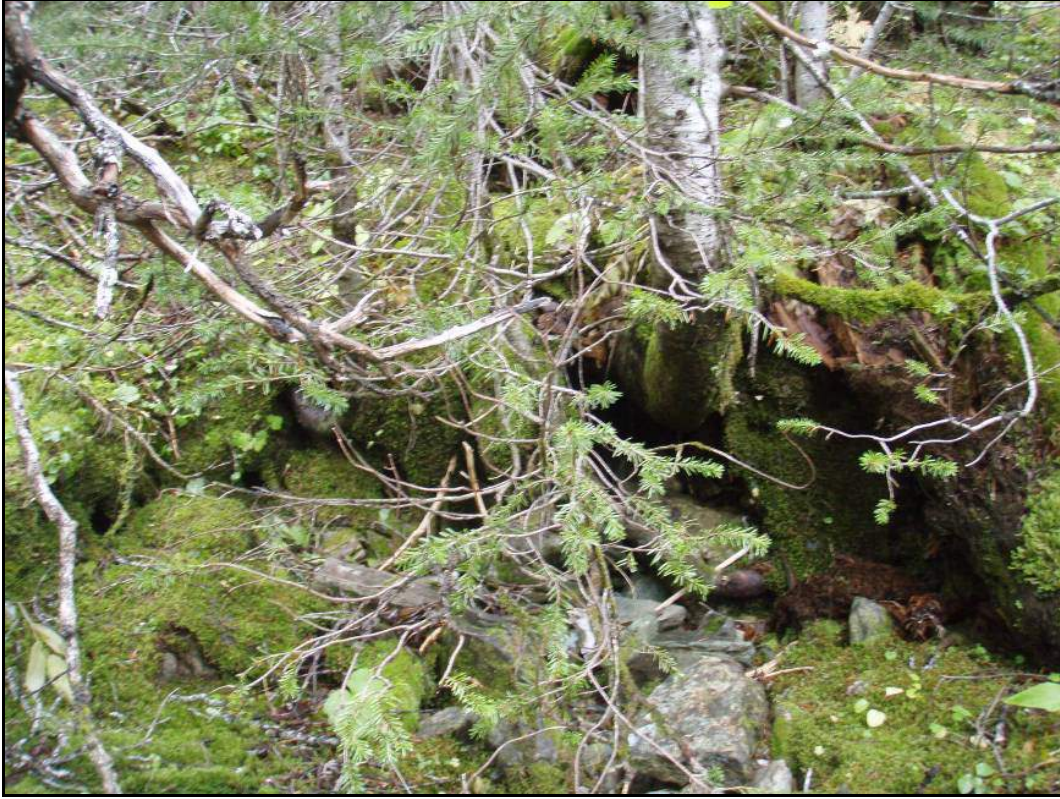
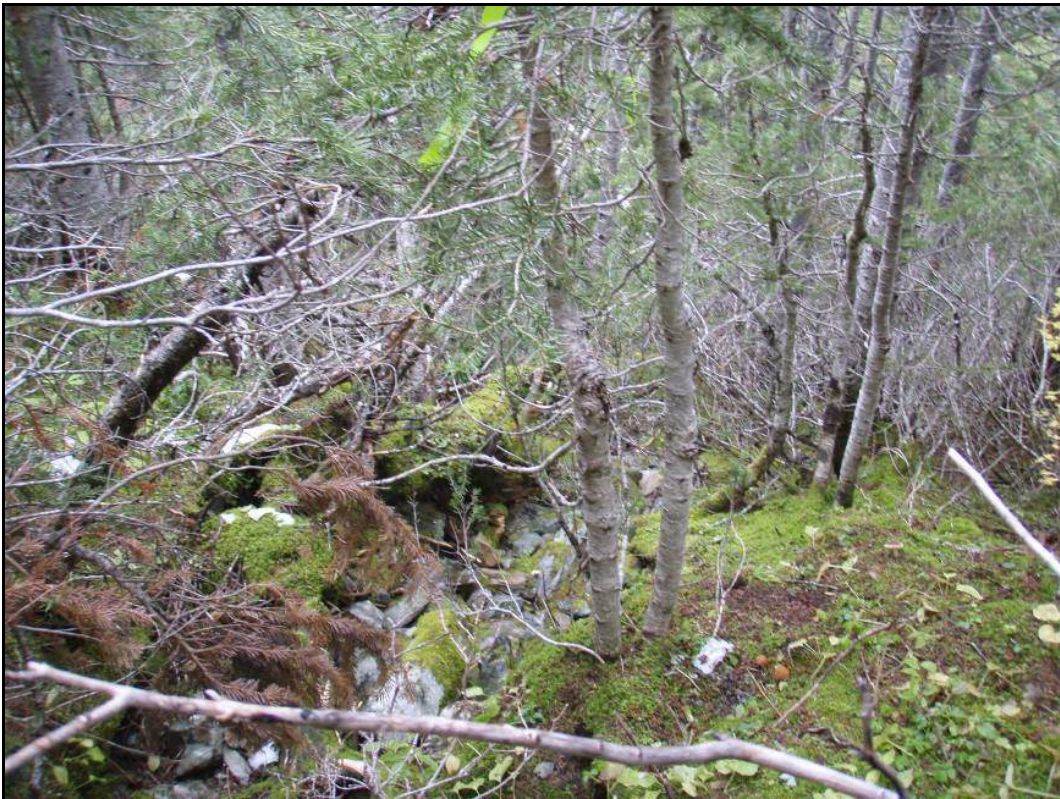
Site 333 – Upstream view

Section	Comments
CHANNEL	S6 - 75% gradient.

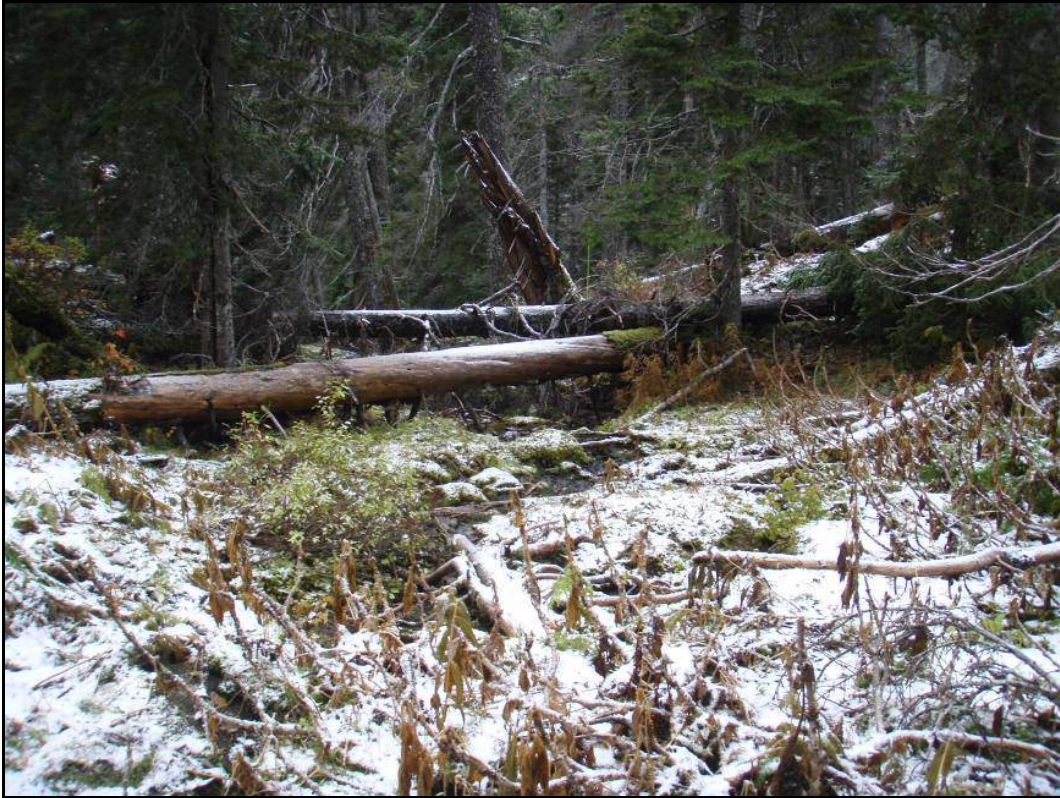
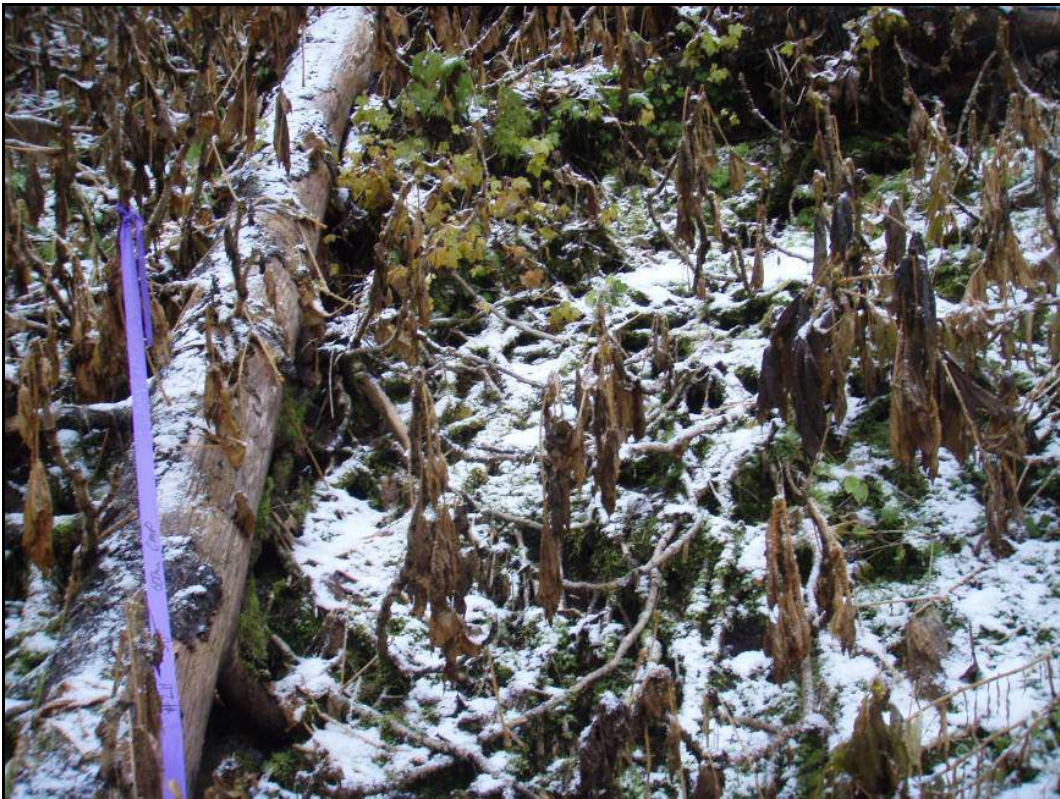
Site 335 – Upstream view

COMMENTS	
Section	Comments
CHANNEL	S6 - dry channel no fish habitat.

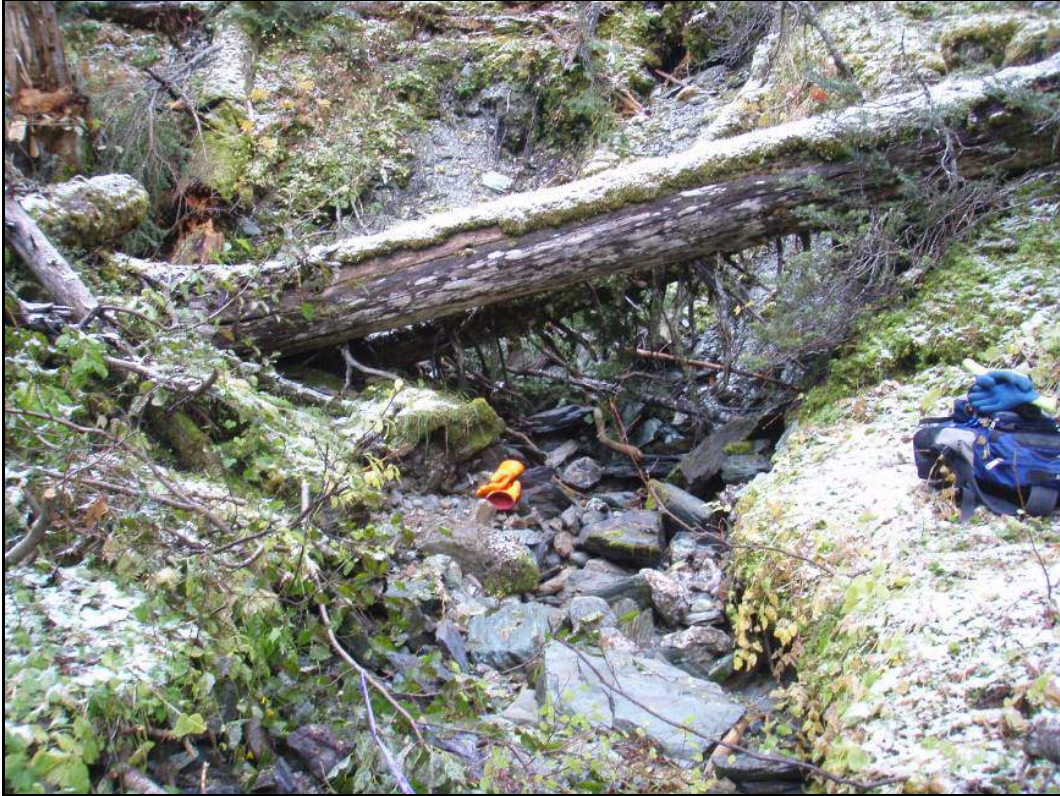
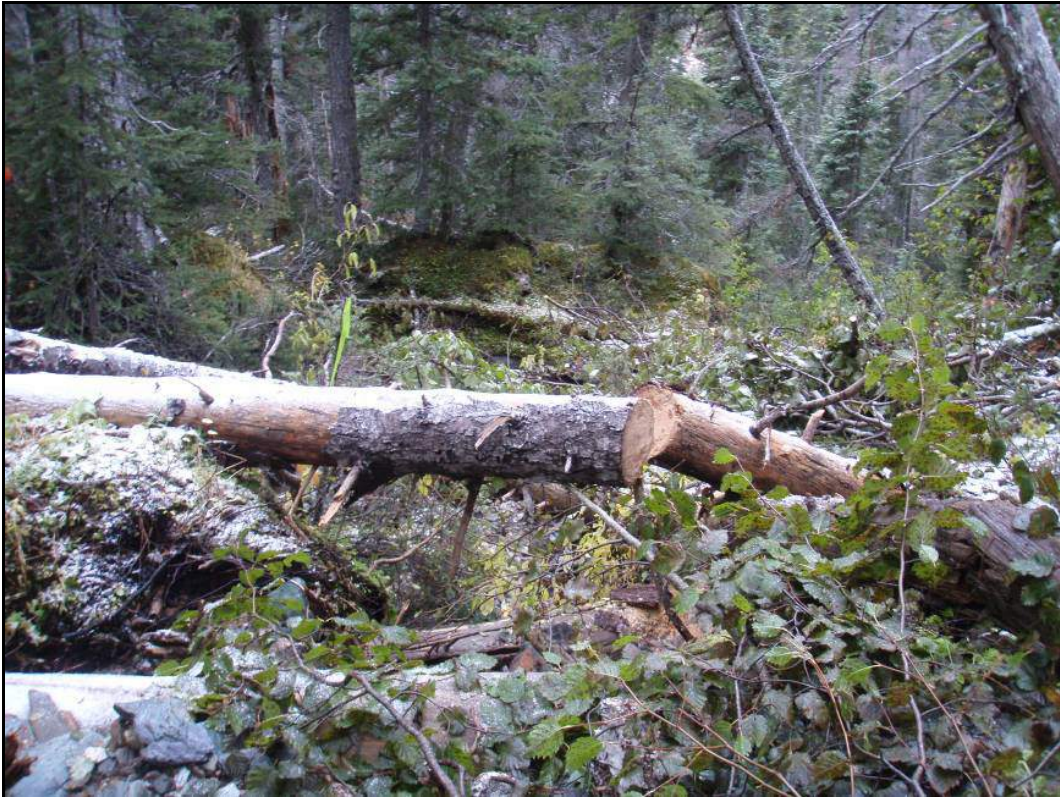
Site 336 – Upstream view

COMMENTS	
Section	Comments
CHANNEL	S6 - steep dry channel.

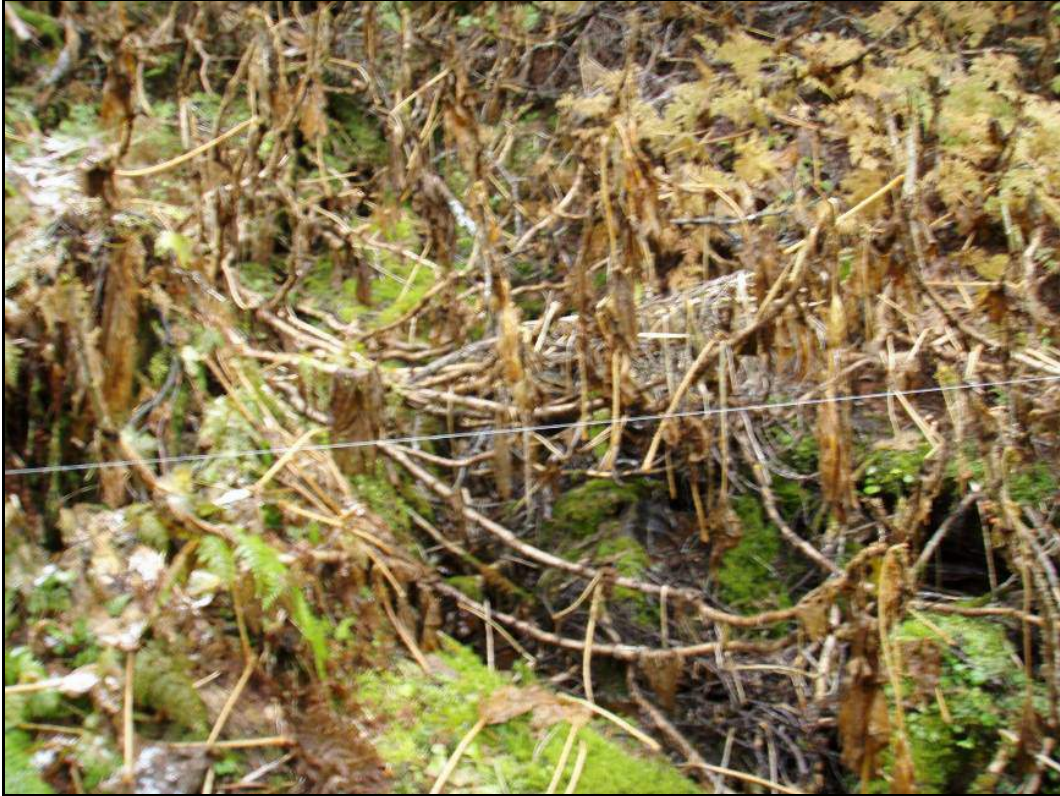
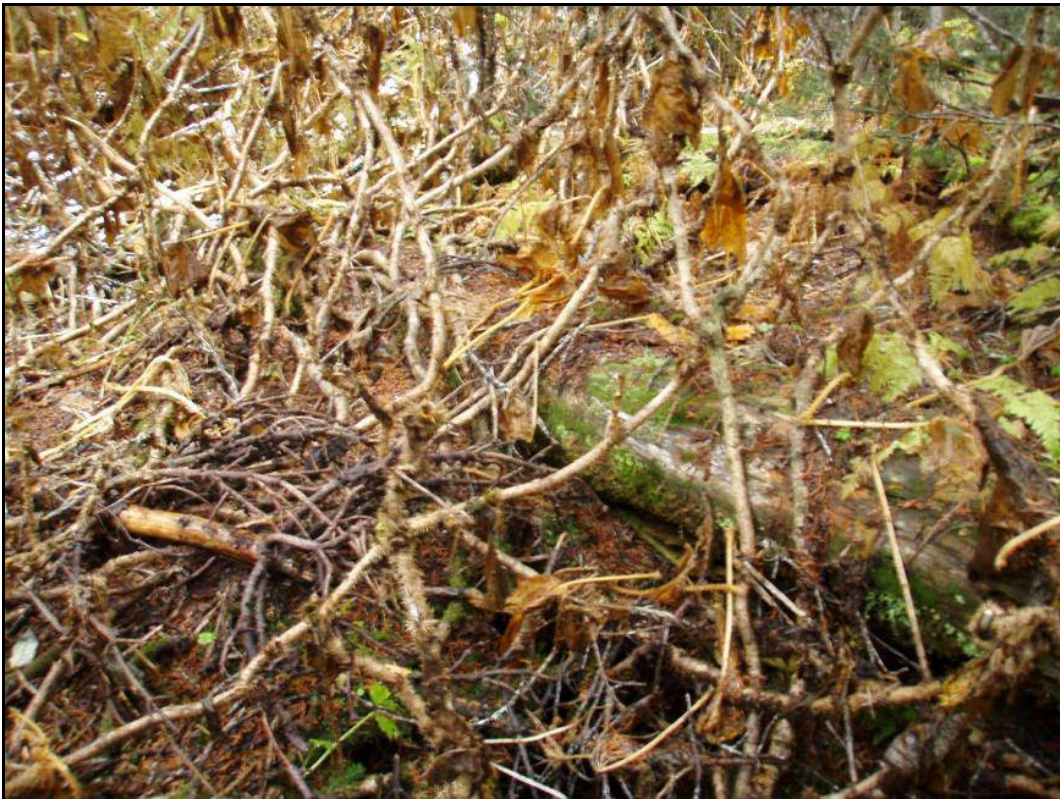
Site 338 – Upstream view

COMMENTS	
Section	Comments
CHANNEL	S6 - steep channel.

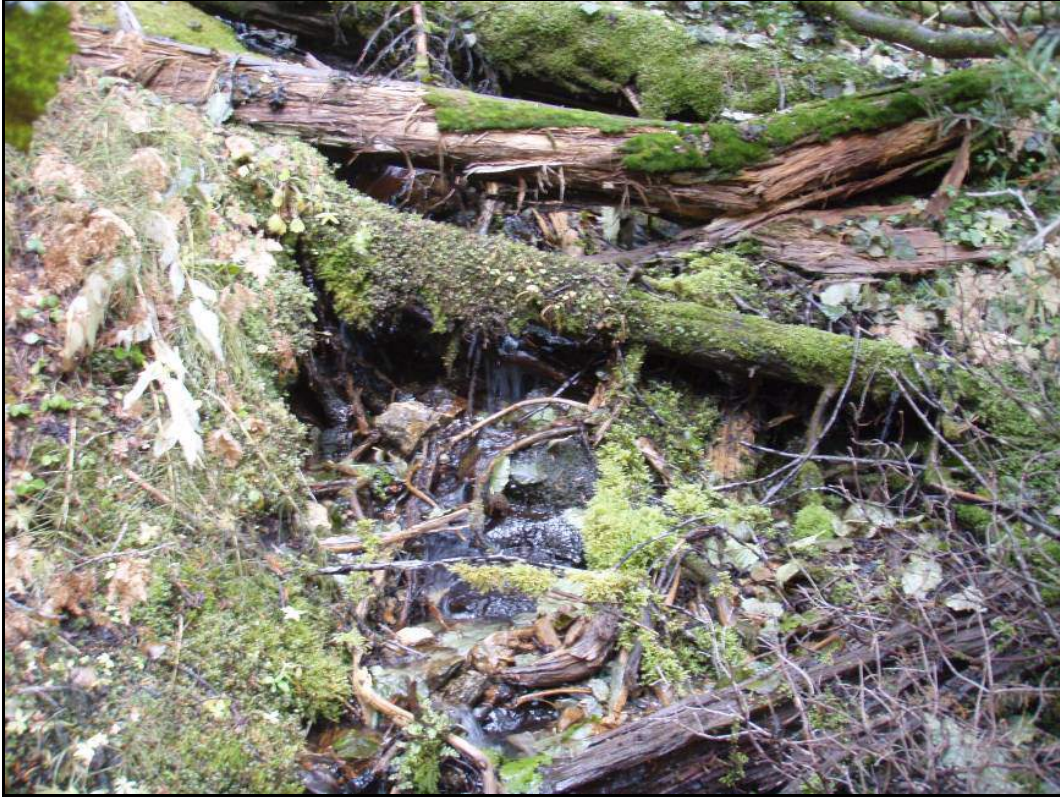
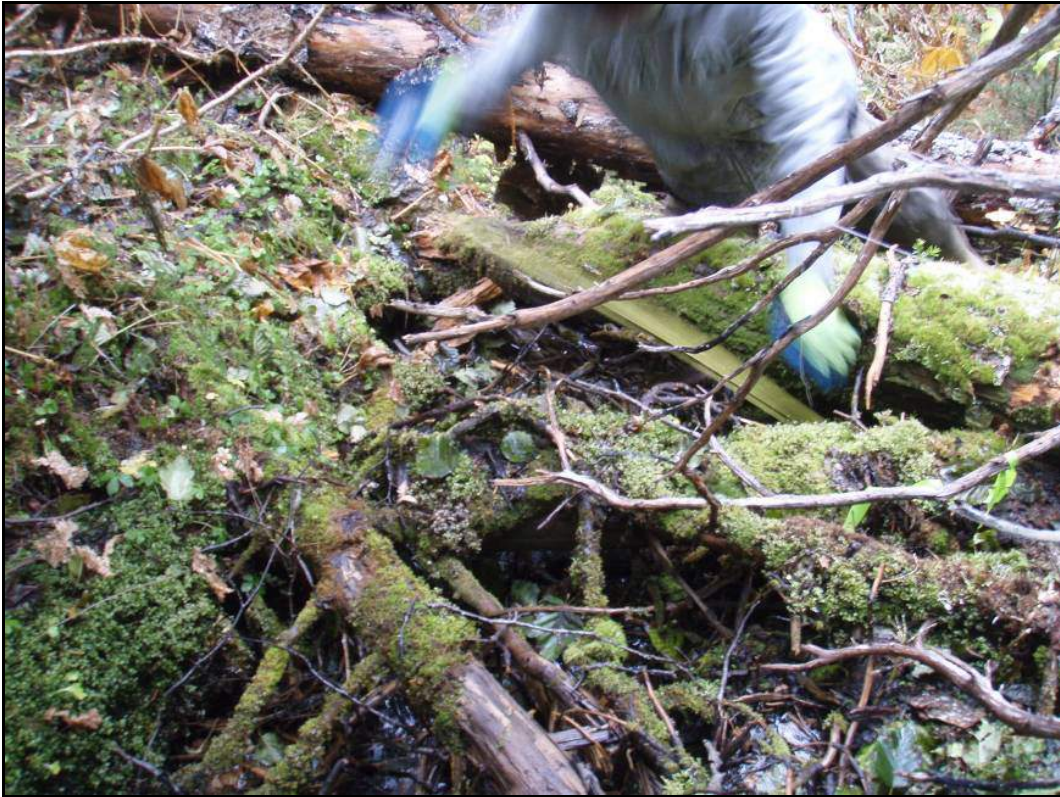
Site 341 – Upstream view

COMMENTS	
Section	Comments
CHANNEL	S6 - steep gradient. In valley wall, tributary to Tish Cr.

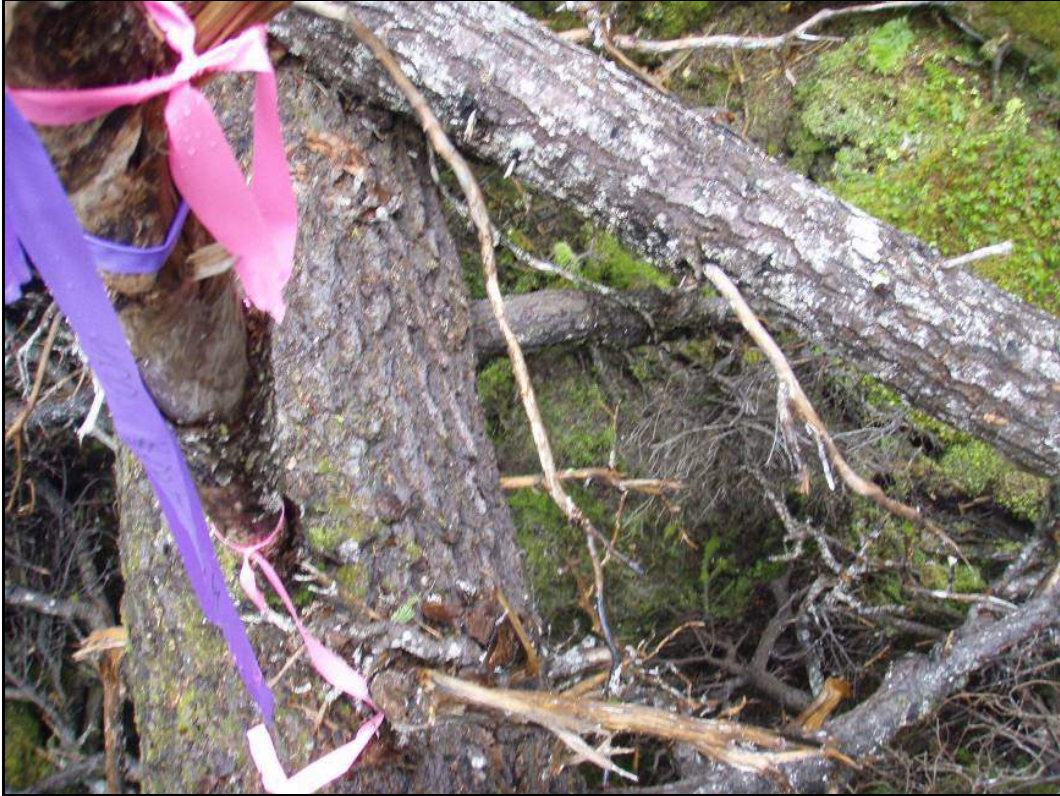
Site 344 – Downstream view

Section	Comments
CHANNEL	NCD - >70% slope ds.
SITE CARD	NCD

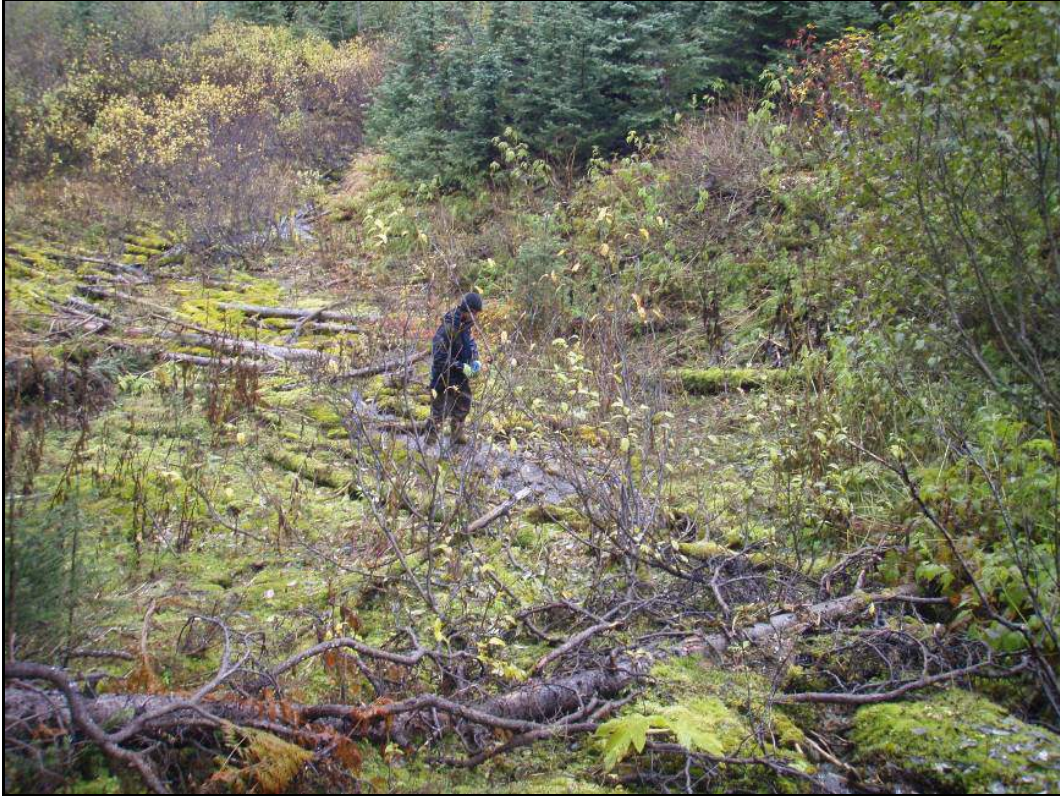
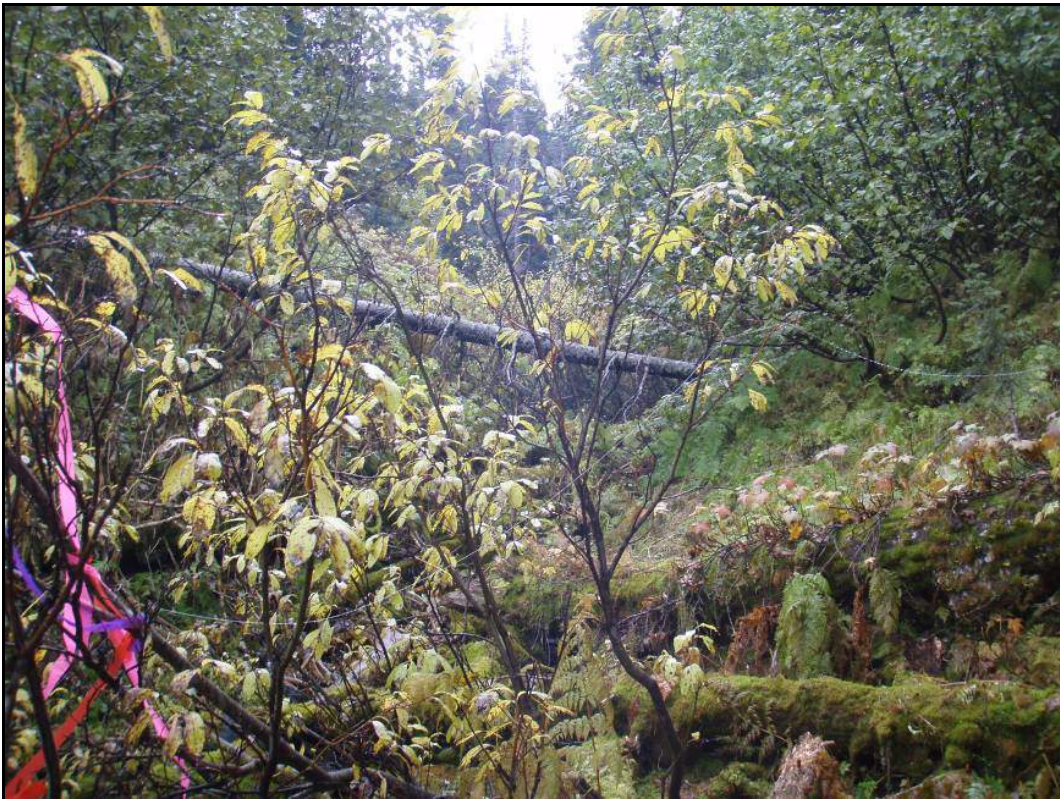
Site 346 – Downstream view

COMMENTS	
Section	Comments
CHANNEL	S6 - up from crossing, S4 down from crossing. Sampling required. Marginal fish habitat.

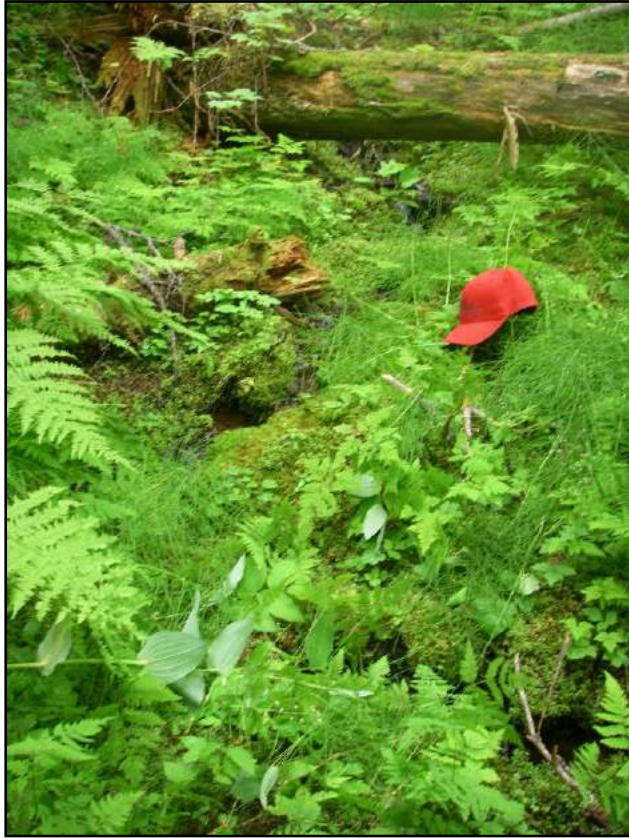
Site 400 – Upstream view

Section	Comments
CHANNEL	NCD - ~60m ds goes subsurface for ~10m along 30% grade. Returns ds in aw grade section. ~20% w/ defined channel @ rd crossing, cw-2m
SITE CARD	NCD

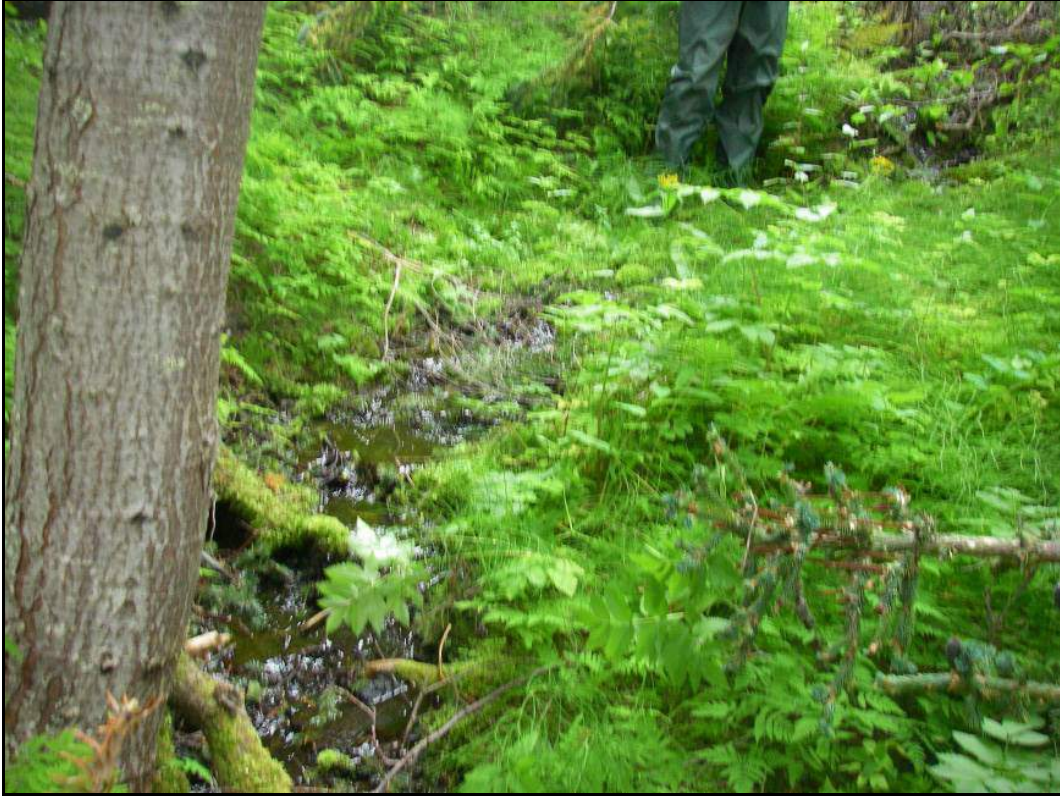
Site 401 – Upstream view

Photo	Foc Lg	Dir	Comments
R: 100 F: 3	STD	U	taken ~10m ds rd crossing
R: 100 F: 4	STD	D	taken ~10m ds rd crossing

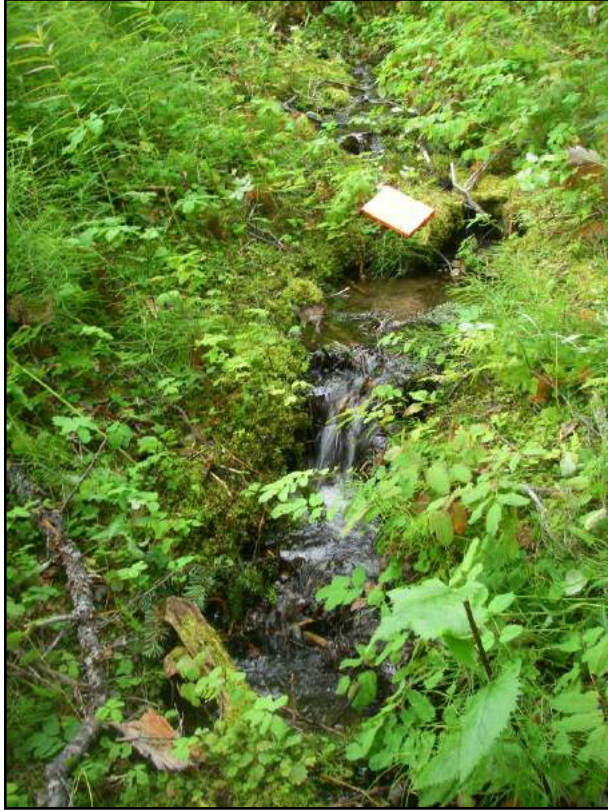
Site 402 – Upstream view

COMMENTS	
Section	Comments
CHANNEL	S6 - good flow in channel. Steady open channel, branched from another channel located ~20m from rd crossing. Multiple braids from main channel through slide area. Good gravels for spawning, limited rearing. Site 403 on another branch from same stream us
SITE CARD	some measurements missing (ph, additional stream widths)

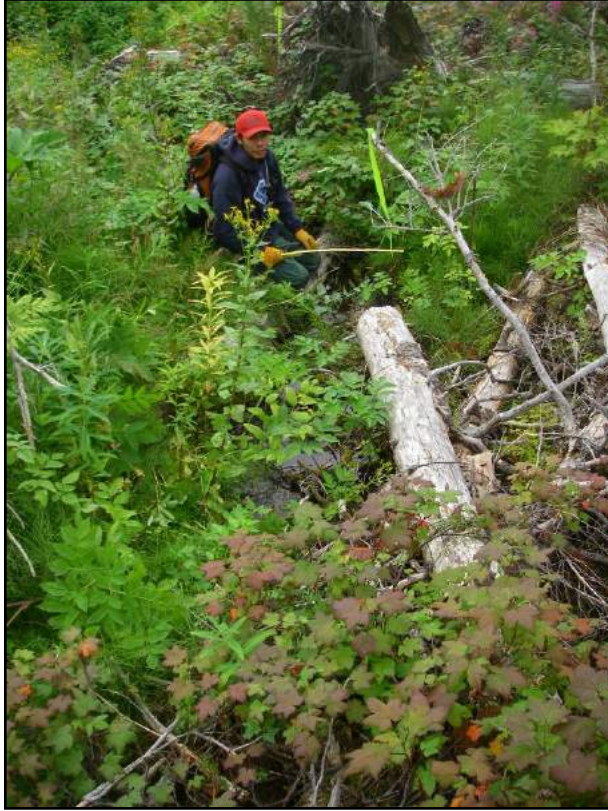
Site 404 – Downstream view

Section	Comments
CHANNEL	S6 - still in slide area, above road crossing spreads into flat mud area and goes subsurface.

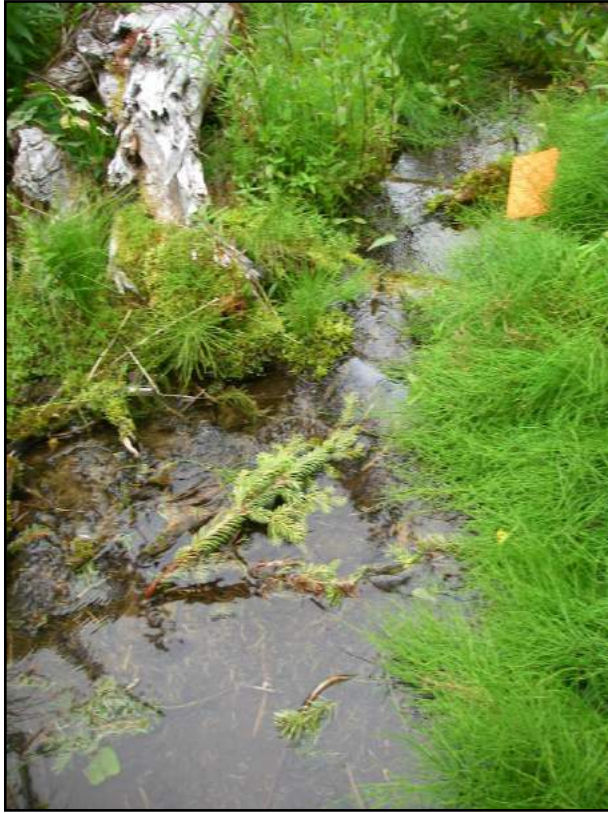
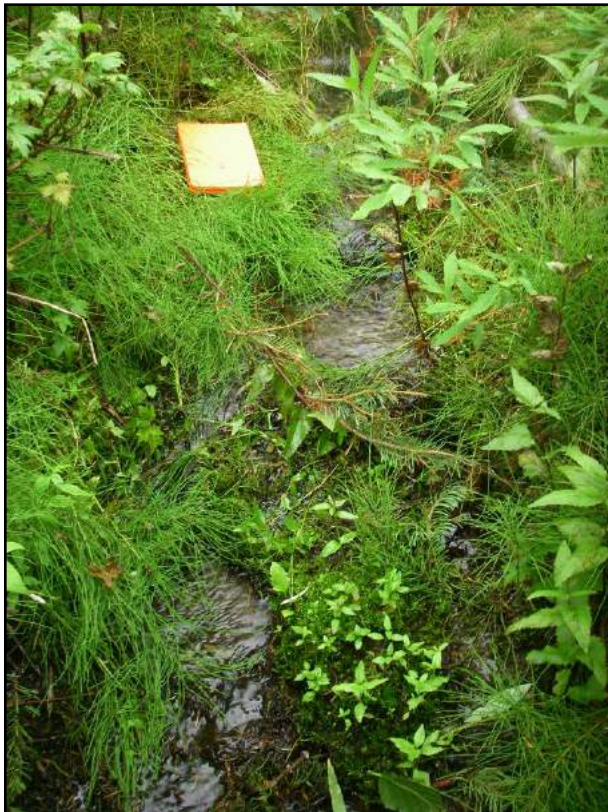
Site 405 – Downstream view

Section	Comments
CHANNEL	NCD - goes subsurface ~20m us rd crossing. Flows for 30m then goes under large mass woody debris and spreads out.
SITE CARD	NCD

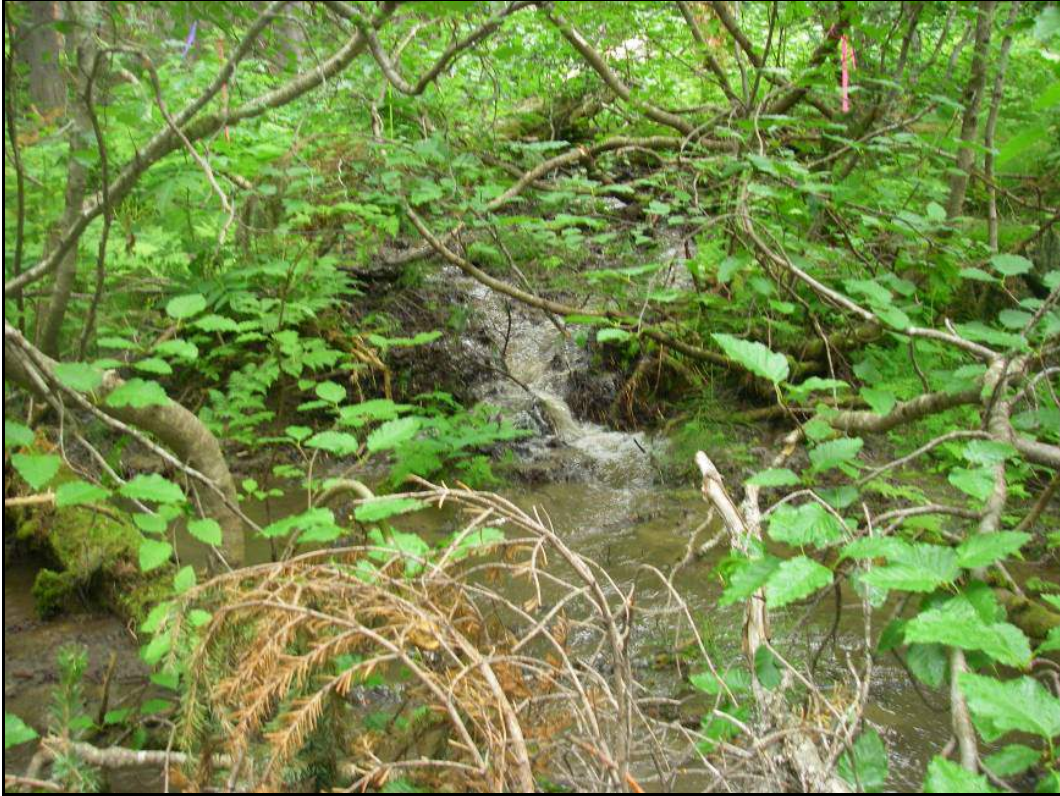
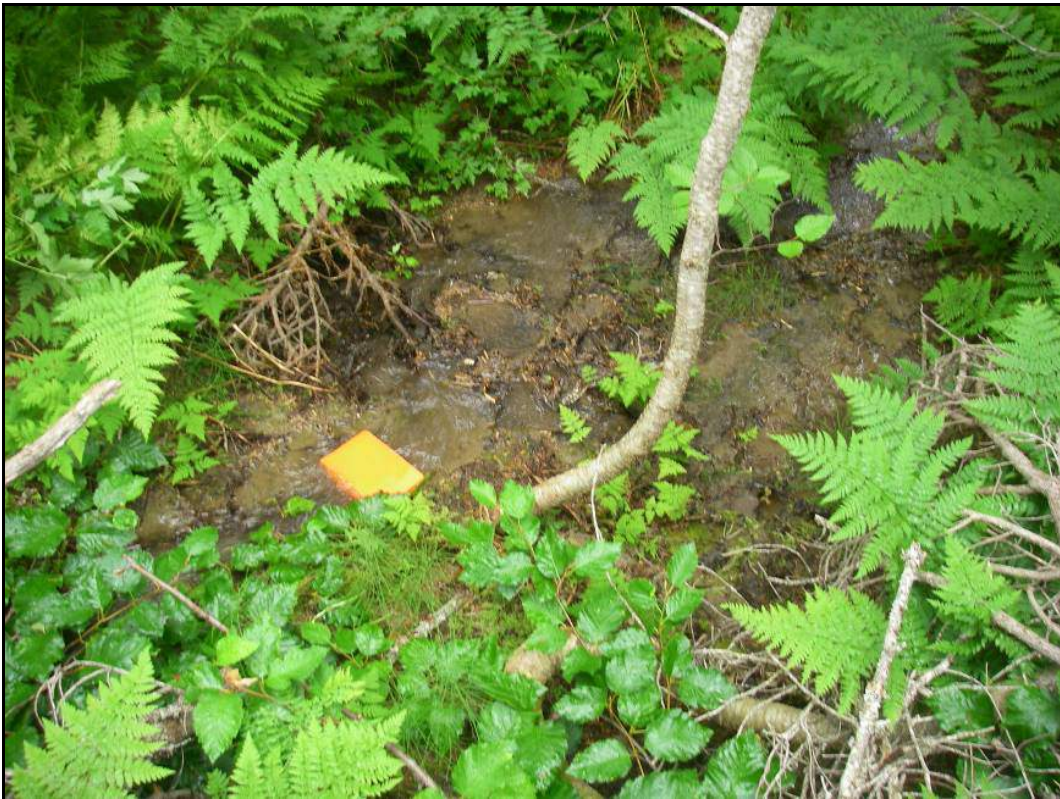
Site 407 – Upstream view

COMMENTS	
Section	Comments
CHANNEL	S6 - heavy avulsions rarely confined, only 2 measurements possible in site area. Gravel and fines, shallow pools. In slide area still, though some mature trees still standing.

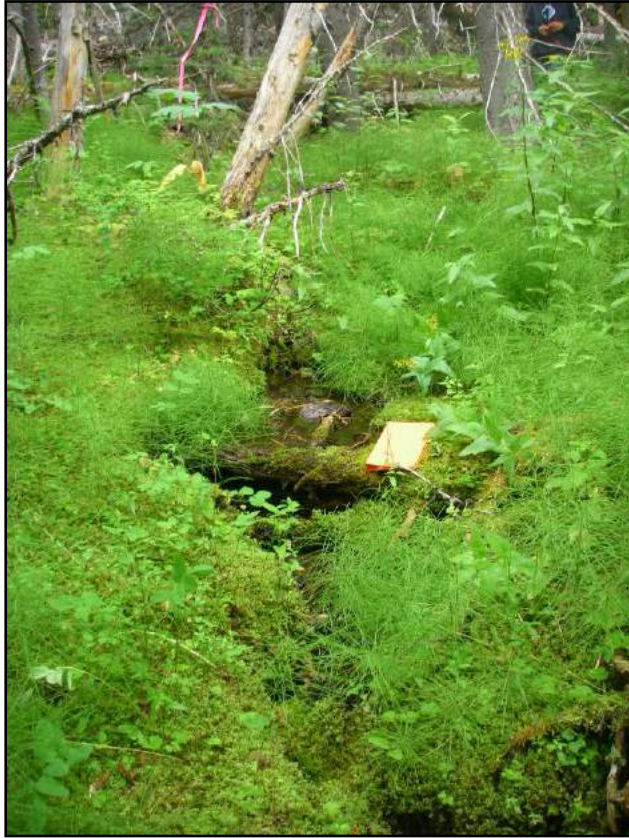
Site 408 – Upstream view

Section	Comments
CHANNEL	NCD - goes subsurface at road crossing for 2m, then again 30m ds for another 3m, continues w/intermittent surface flow ds.
SITE CARD	NCD

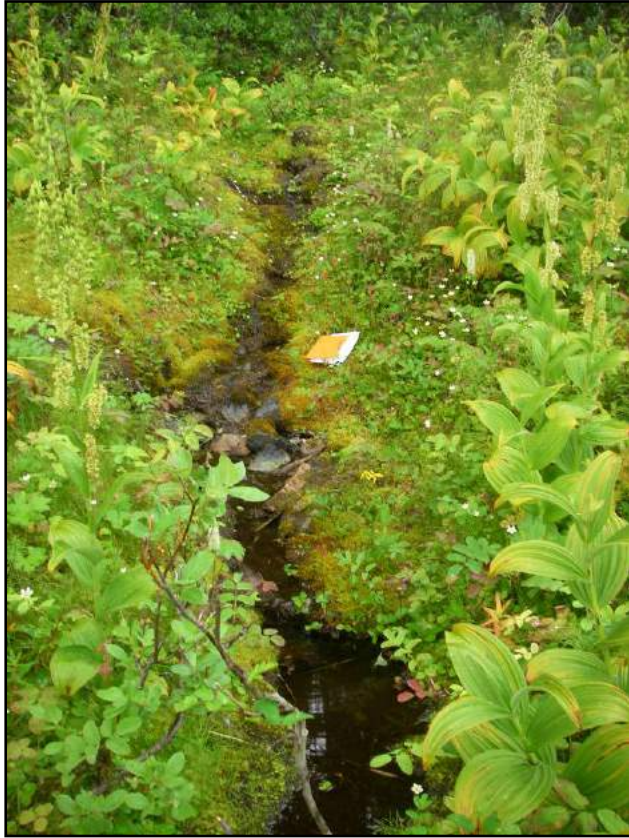
Site 411 – Upstream view

Section	Comments
CHANNEL	NCD - seeps out of ground at rd crossing, open channel for ~45m ds then intermittent subsurface through soil. ~10m ds site, and ww=20cm.
SITE CARD	NCD

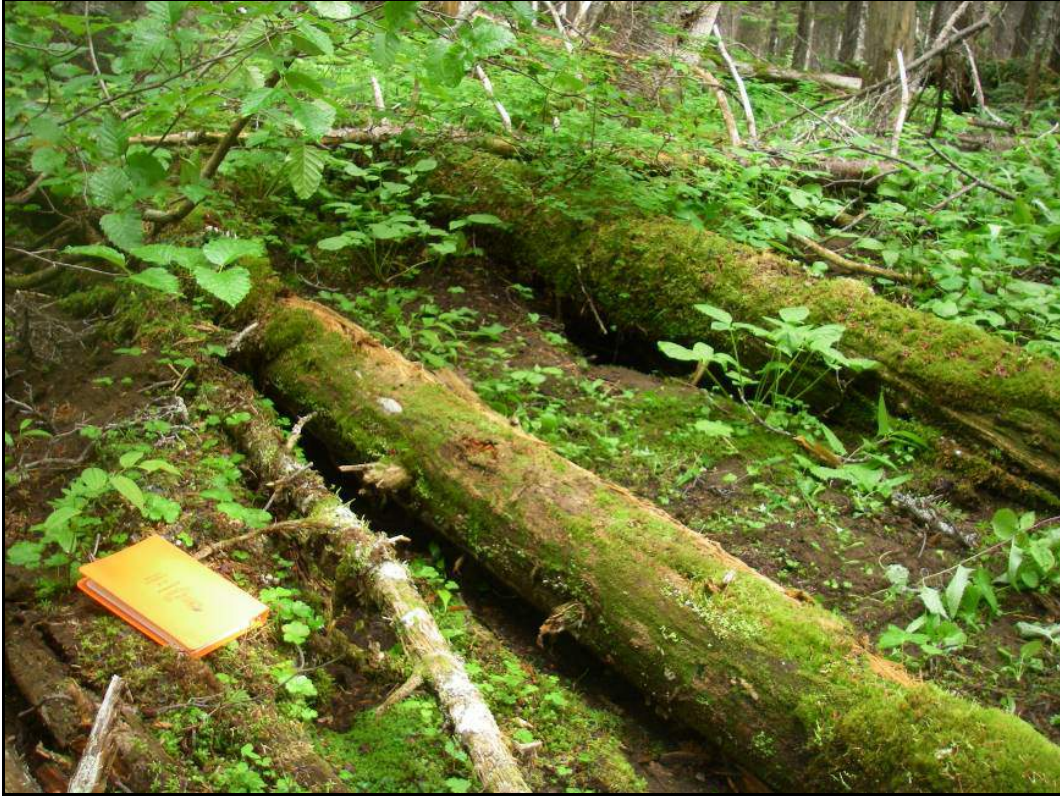
Site 412 – Across view of dry channel

Section	Comments
CHANNEL	NCD - dry at time of survey. Scoured siols indicate wide seepage that frequently goes subsurface.
SITE CARD	NCD
