Schaft Creek Fisheries Baseline 2007

Rescan Tahltan Environmental Consultants
Vancouver, British Columbia

March 2008

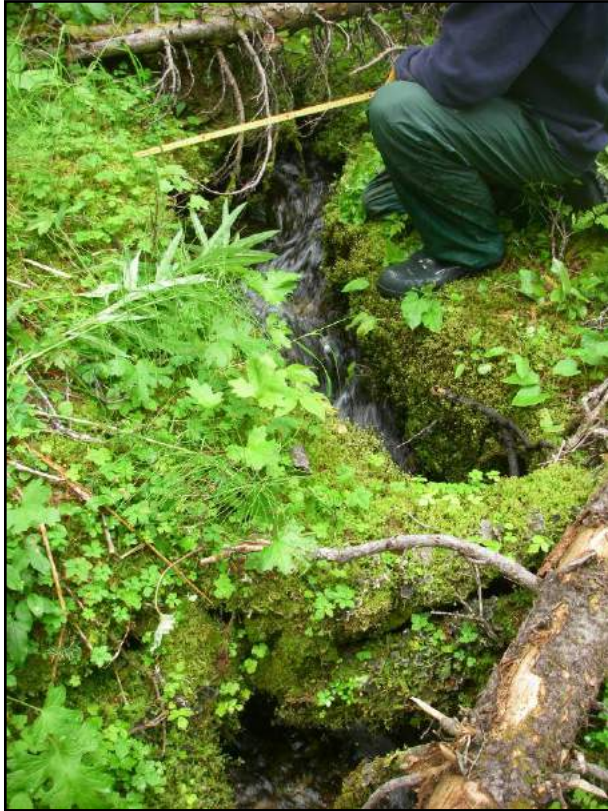
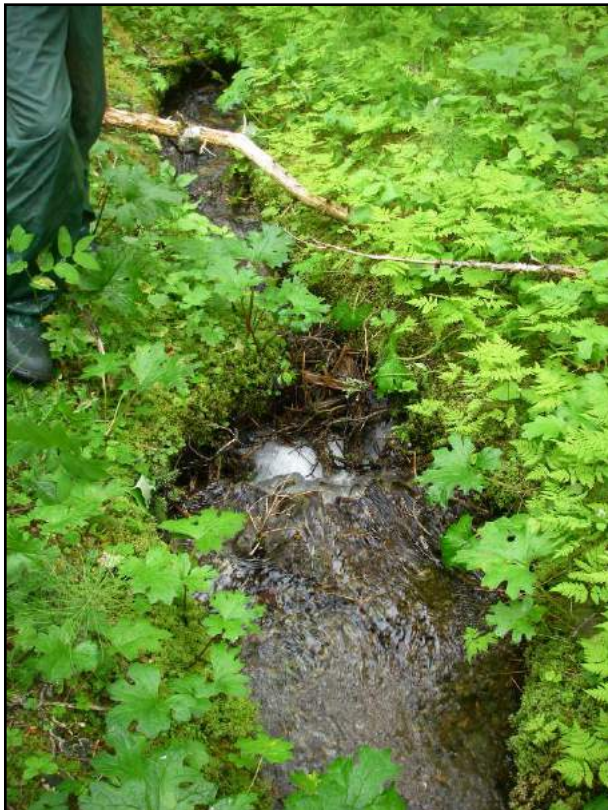
Site 413 – Upstream view

COMMENTS	
Section	Comments
CHANNEL	S6 - channel had good flow at time of survey. Frequently runs below surface but w/enough power to have an underground channel. Still may be migratory barrier. Good clean gravels suitable for spawning, good LWD cover.

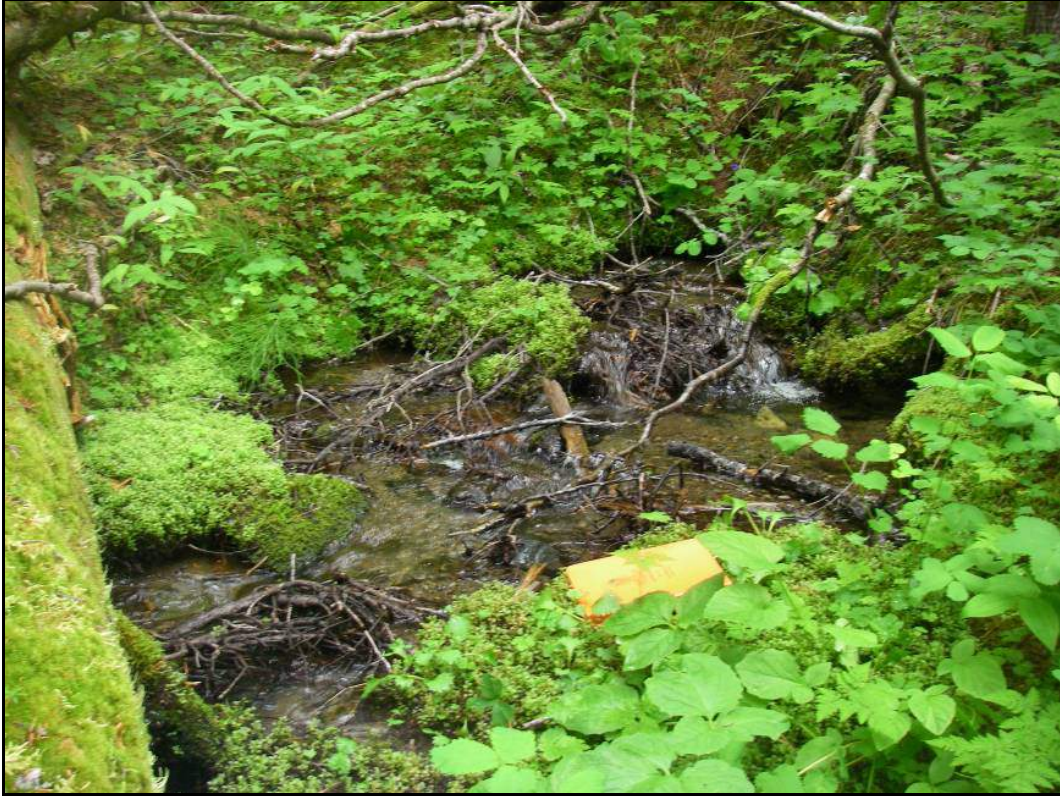
Site 414 – Upstream view

Section	Comments
CHANNEL	NCD - subsurface above rd for ~5m, comes out 4m ds from rd crossing, flows for 10m then intermittent/subsurface flow.
SITE CARD	NCD

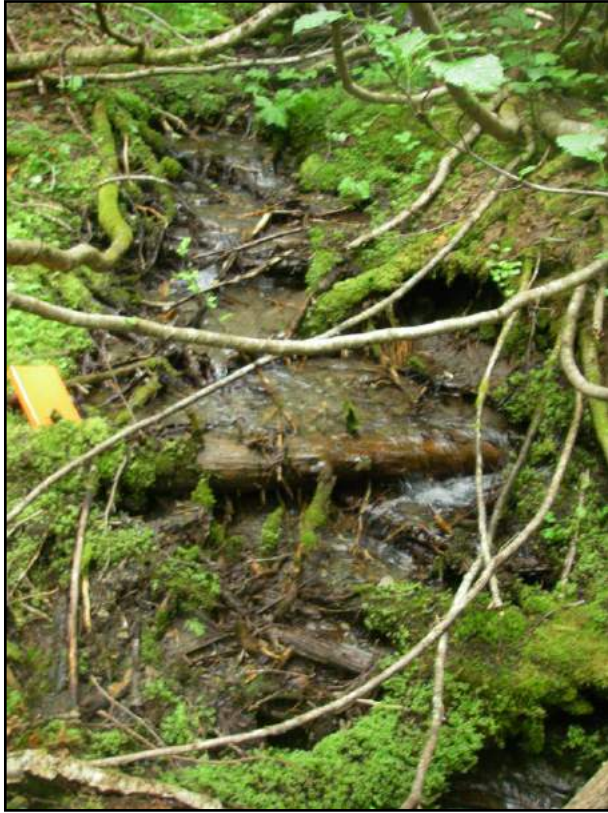
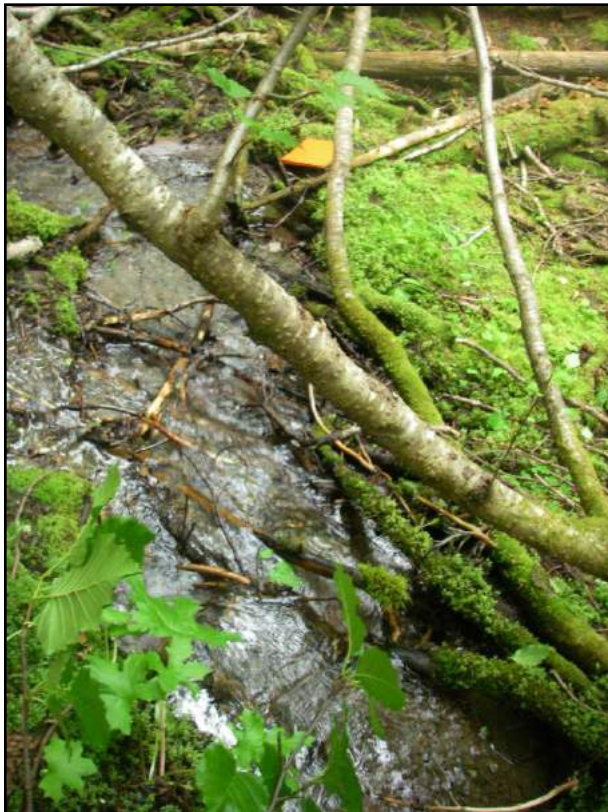
Site 415 – Upstream view

COMMENTS	
Section	Comments
CHANNEL	S6 - some gradient 20+%, frequently goes under root systems of trees and shrubs. Fair spawning gravels dominate. Cover high, poor for holding, but abundant LWD and SWD. Mig access poor. No defined step pools us rd crossing creek is spread out and branches

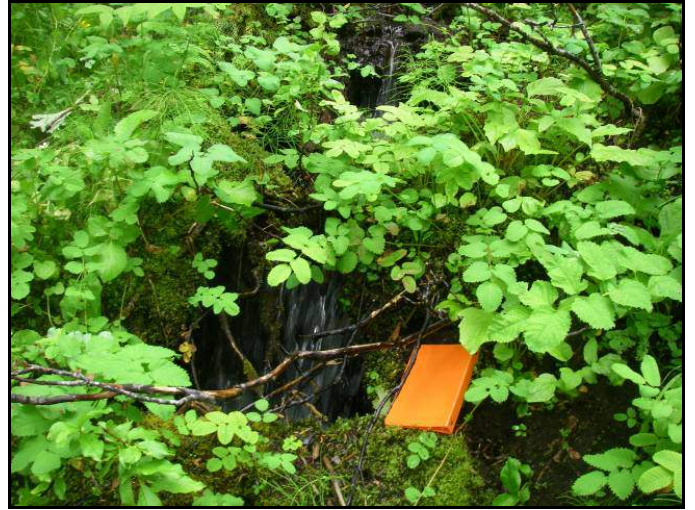
HABITAT QUALITY						
Name			Comments			
OverWinter Habitat			good			
Spawning Habitat			good			
Rearing Habitat			good			
PHOTOS						
Photo		Foc Lg		Dir		Comments
R:	100	F:	27	STD		U
R:	100	F:	28	STD		D
R:	100	F:	29	STD		NS feature
COMMENTS						
Section			Comments			
CHANNEL			S6 - 25m ds crossing creek goes underground for 7m. Under moss and tree roots over low gradient. Likely barrier to us mig. Though good flows may provide underground connectivity. Good pools, gravel and LWD cover. Several high drops ~.4 barrier to us mig.			
SITE CARD			morphology not recorded

Site 416 – Feature falls

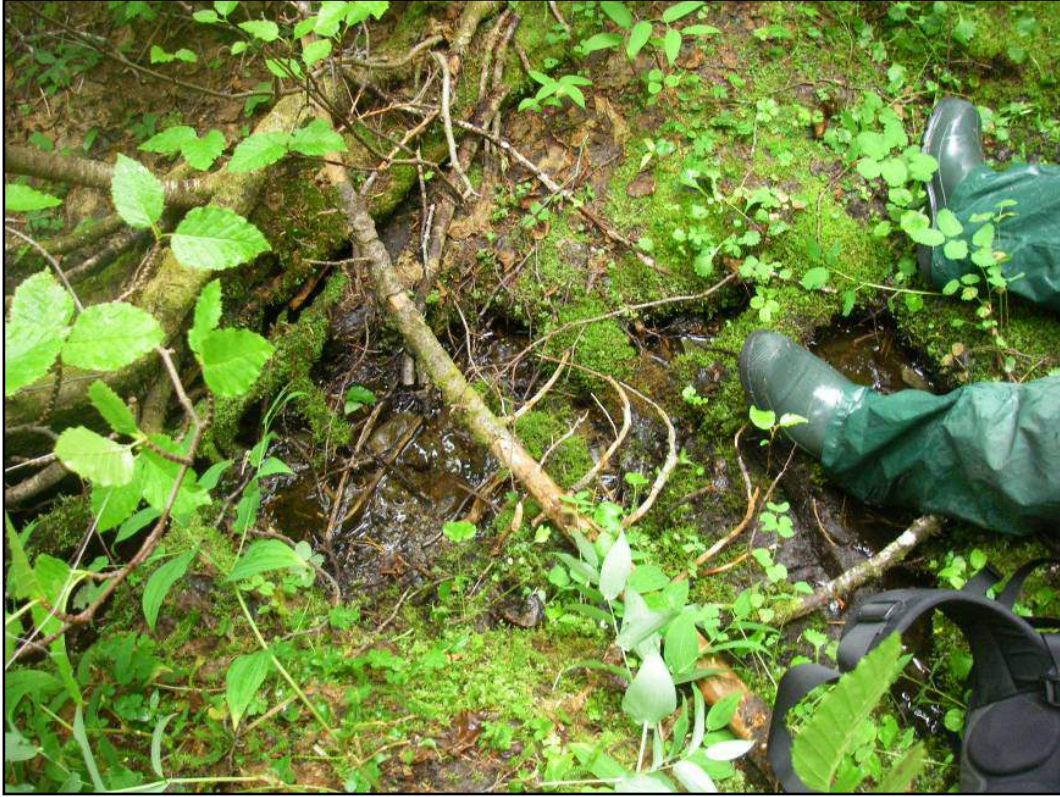
Site 417 – Across view

Section	Comments
CHANNEL	NCD - seep goes into ground at crossing
SITE CARD	NCD

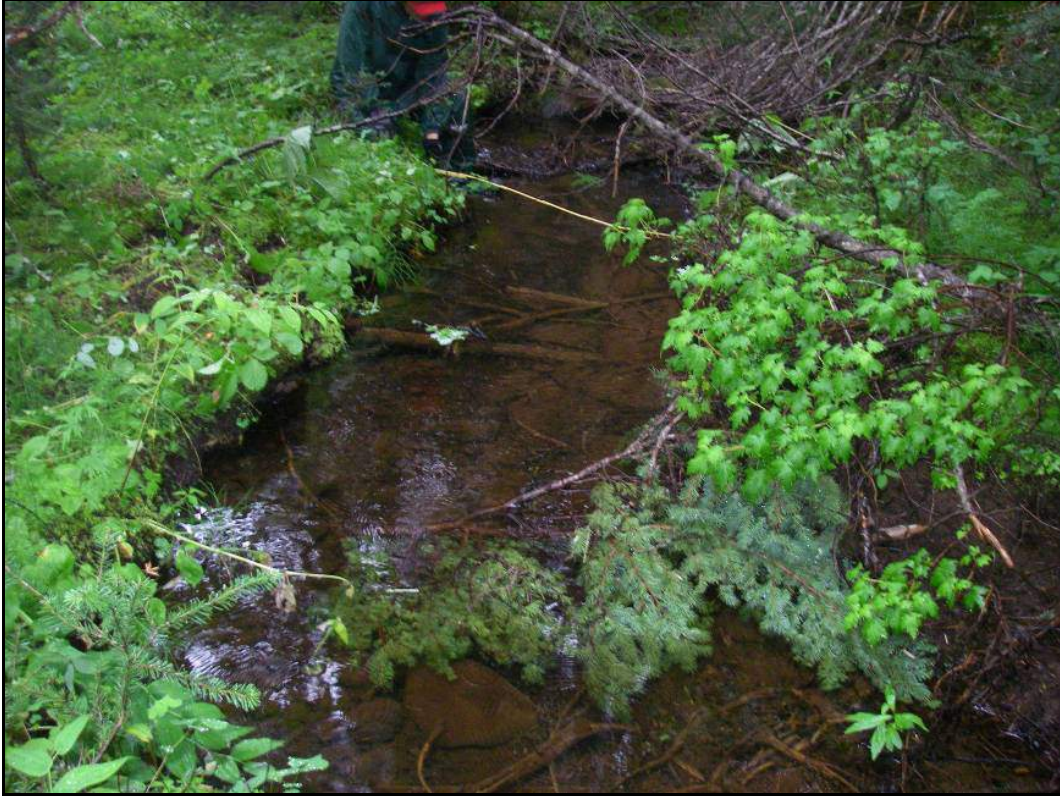
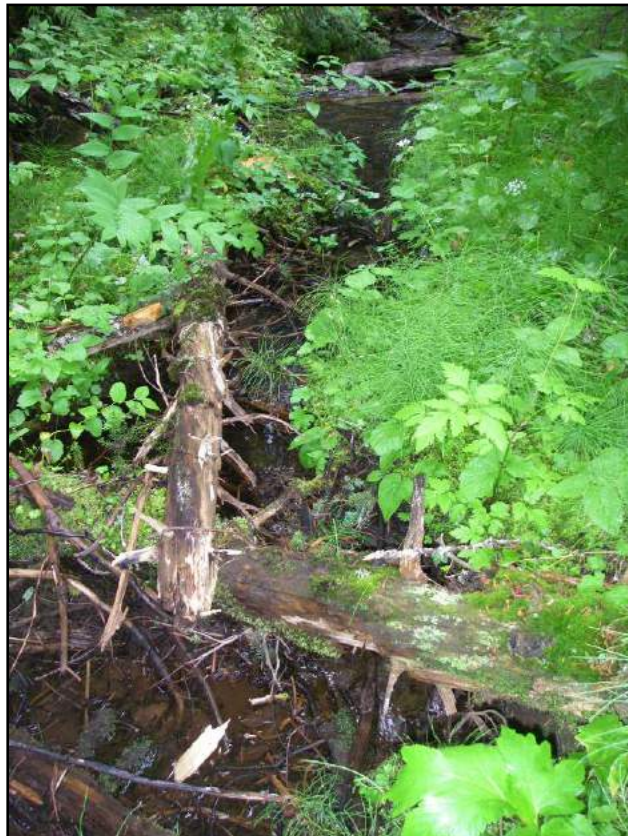
Site 419 – Upstream view

HABITAT QUALITY						
Name		Comments				
OverWinter Habitat		good				
Rearing Habitat		good				
Spawning Habitat		good				
PHOTOS						
Photo		Foc Lg		Dir	Comments	
R:	101	F:	2	STD	U	taken at road crossing
R:	101	F:	3	STD	D	taken at road crossing
COMMENTS						
Section		Comments				
CHANNEL		S4 default - followed ~350m to where it enters large creek, branched to 2 channels before confluence, barriers to juvenile and possible adults. Banks undercut, frequent pockets clean gravel, low gradient, grade at rd xing 3% below, 2% above

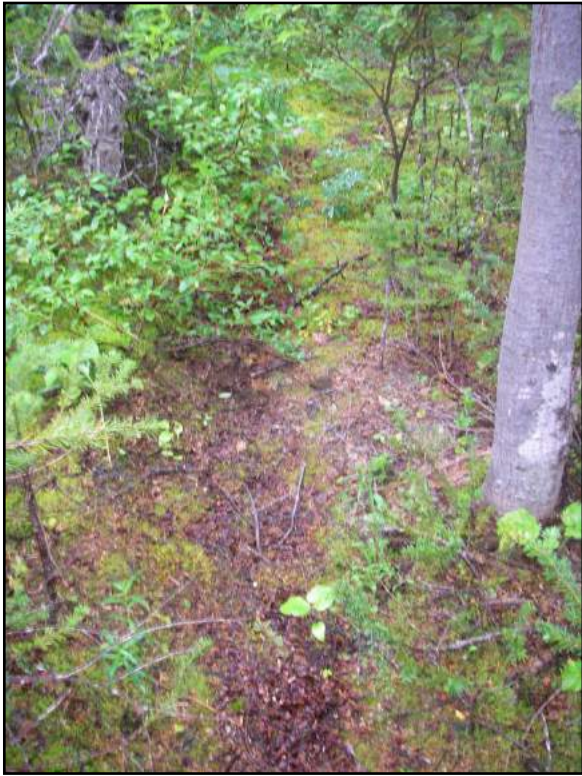
Site 420 – Goat trail along and crossing creek

Group	Observations
MAM	goat trail and wool in branches noted along route

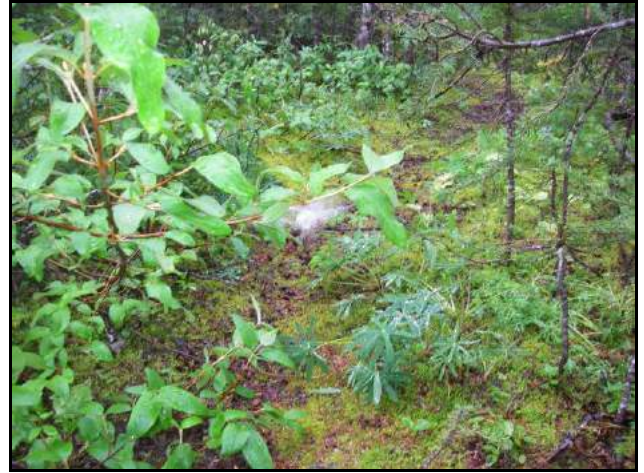
Site 420 – Wool in branches

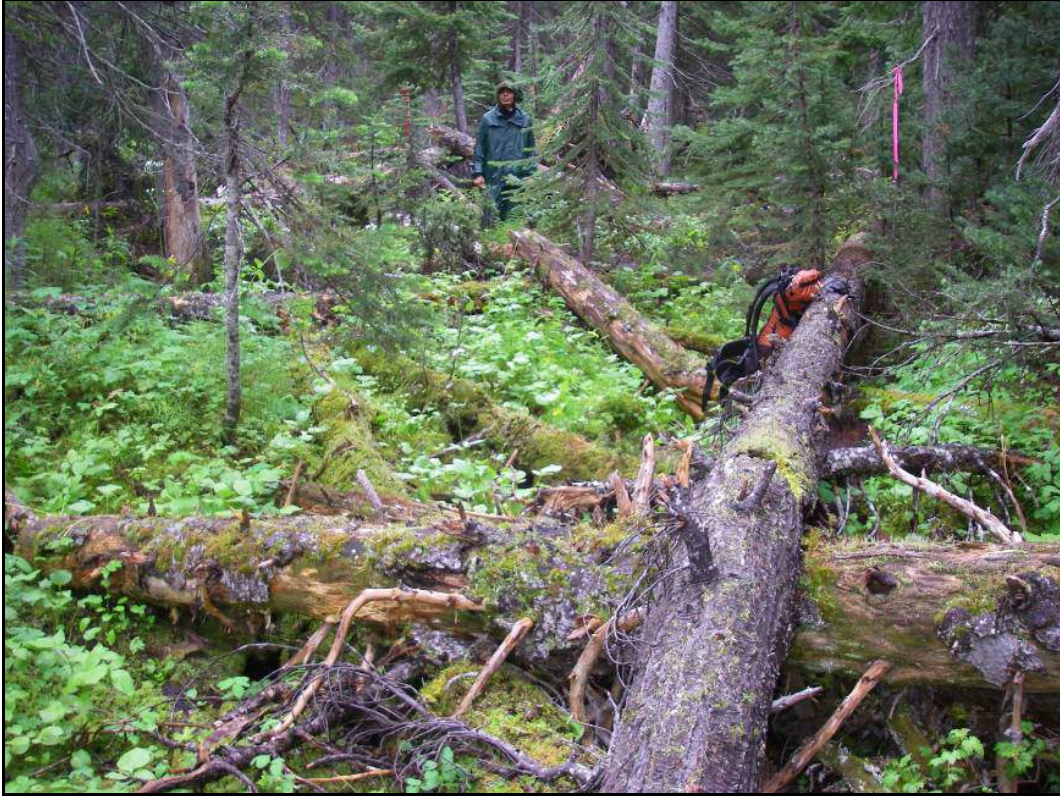
Site 422 – Upstream view, wide swale with wet depression

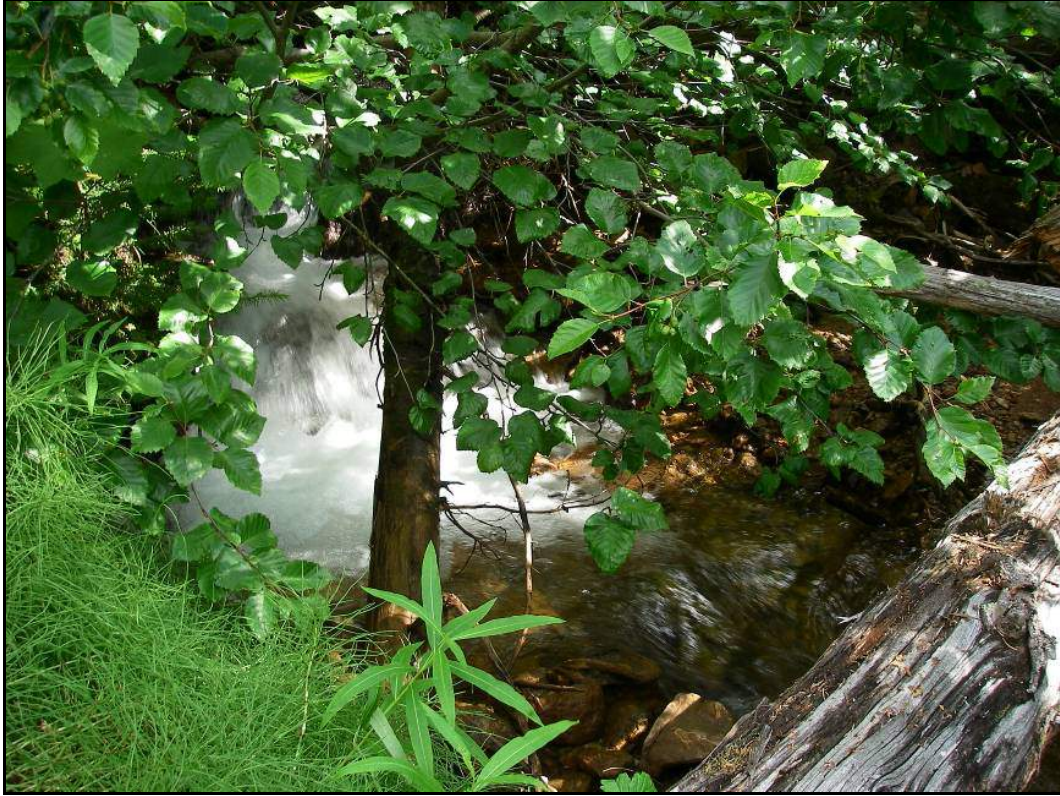
Section	Comments
CHANNEL	NCD - seepage with some overland flow at rc.
SITE CARD	NCD

Site 999 – Upstream view, subsurface and overland flow
