Schaft Creek Project

Draft Preliminary Groundwater

Baseline Report

Rescan Tahltan Environmental Consultants
Vancouver, British Columbia

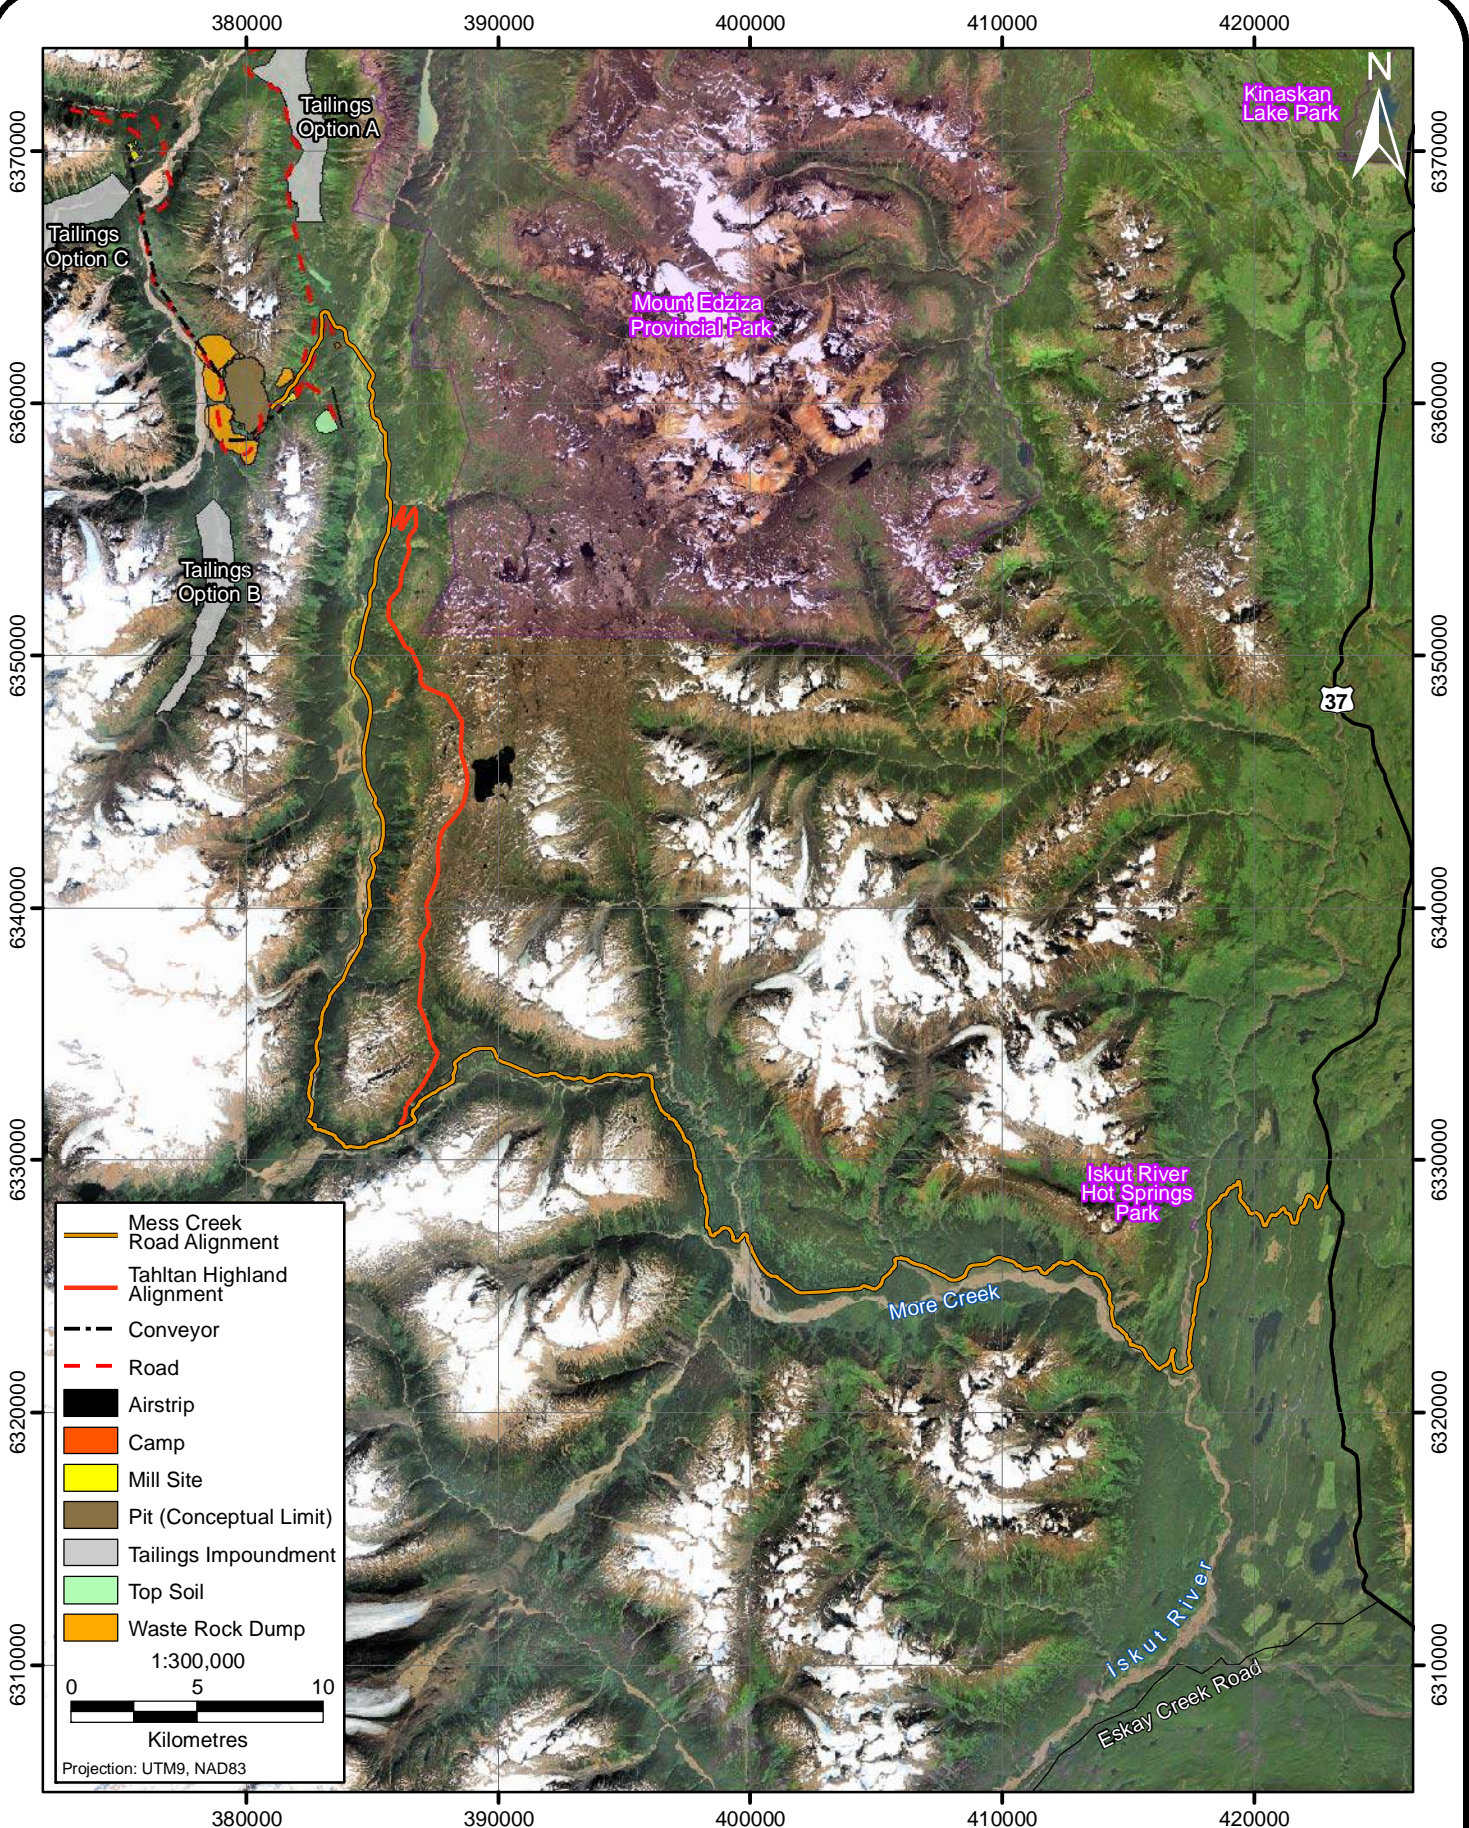
Mess Creek Road Alignment
	Tahltan Highland Alignment
	Conveyor
	Road
	Airstrip
	Camp
	Mill Site
	Pit (Conceptual Limit)
	Tailings Impoundment
	Top Soil
	Waste Rock Dump

Copper Fox has recently released a scoping level engineering and economic report for Schaft Creek. The mine and associated infrastructure are presented in Figure 1.1-3. The current mine plan has ore milled from an open pit at a rate of 65,000 tonnes/day. The Schaft deposit will be mined with large truck/shovel operations and typical drill and blast techniques. An explosives manufacturing facility will be constructed on-site to support blasting activities. The mine plan includes 719 million tonnes of minable ore over a 31 year mine life. The Project is estimated to generate up to 1,200 jobs during the construction phase of the project and approximately 500 permanent jobs during the life of the mine.

Over the life of the mine, the Schaft Creek Project will generate over 700 million tonnes of tailings. There are three tailings facilities being considered (Figure 1.1-3). The three options will undergo an alternatives assessment that will include engineering, construction and operating costs, geotechnical, geohazards, environmental and social considerations.

The Project will generate over a billion tonnes of waste rock. Waste rock dumps are proposed around the perimeter of the pit (Figure 1.1-3). This includes the flat area between the proposed pit and Schaft Creek.

A new airfield will be constructed to the east of the pit (Figure 1.1-3). The Project will be a fly-in, fly-out operation. The new landing strip will be capable of handling a Boeing 737. Other facilities include a terminal building, fuelling, maintenance and control facilities.

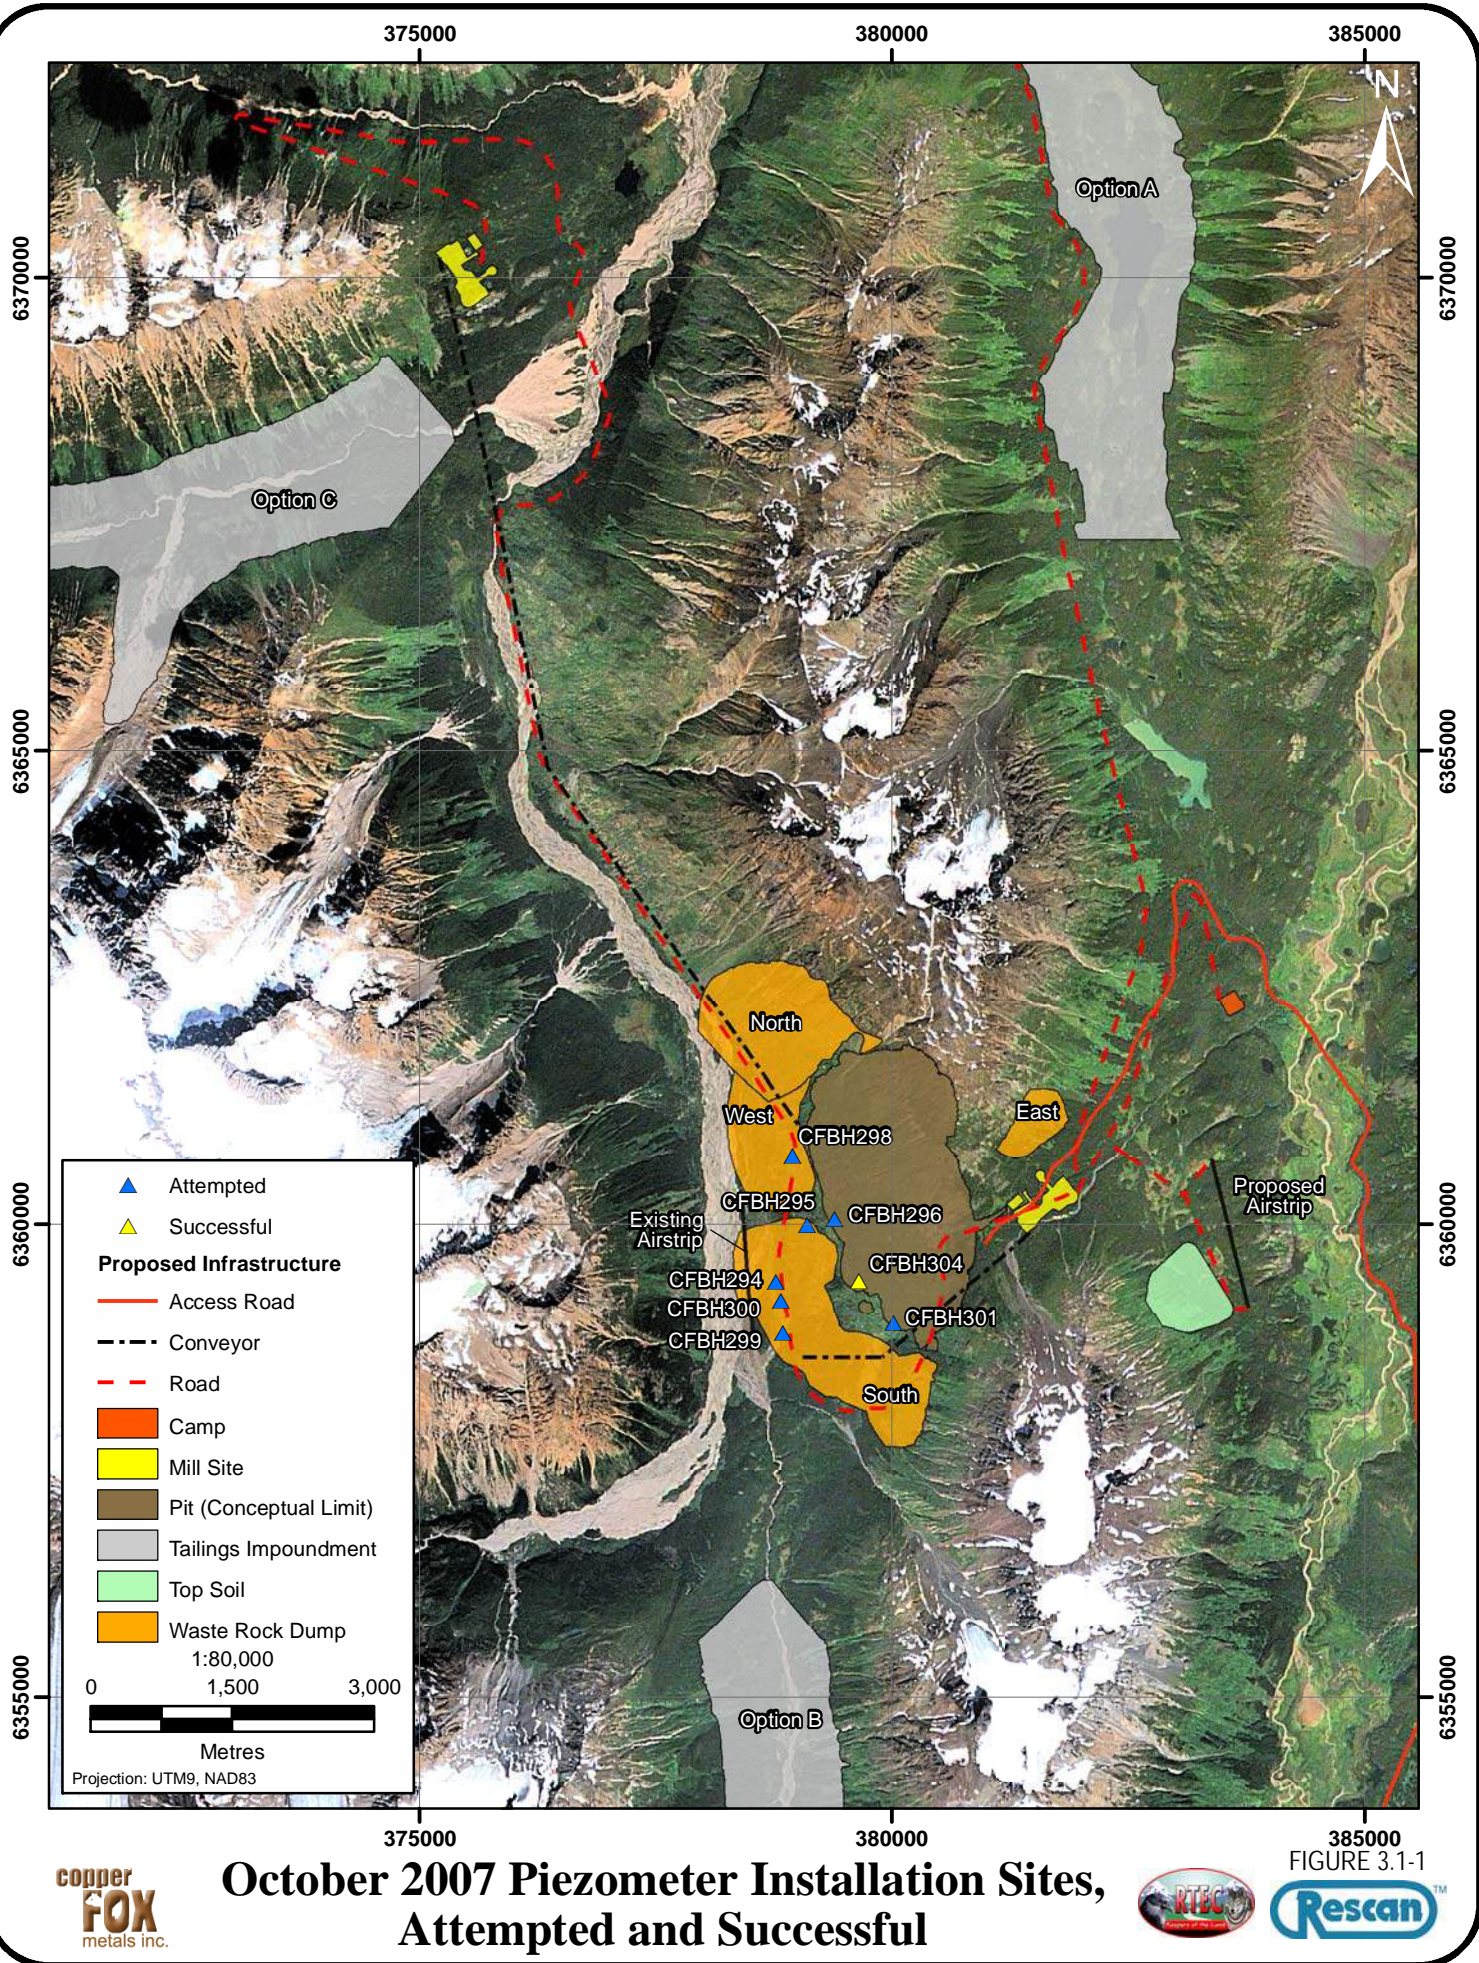
385000
FIGURE 3.1-1

**October 2007 Piezometer Installation Sites,
Attempted and Successful**

In October 2007, the installation of standpipe piezometers into eight previously drilled boreholes was attempted. One shallow and one deep standpipe piezometers were installed in borehole CFBH304. At all other sites, piezometers were not installed as hole integrity was compromised (*i.e.*, borehole wall caving). Specific problems encountered are detailed in Table 3.1-2. A map of the location of each site is presented in Figure 3.1-1. UTM Locations for all sites are presented in Appendix B-2.

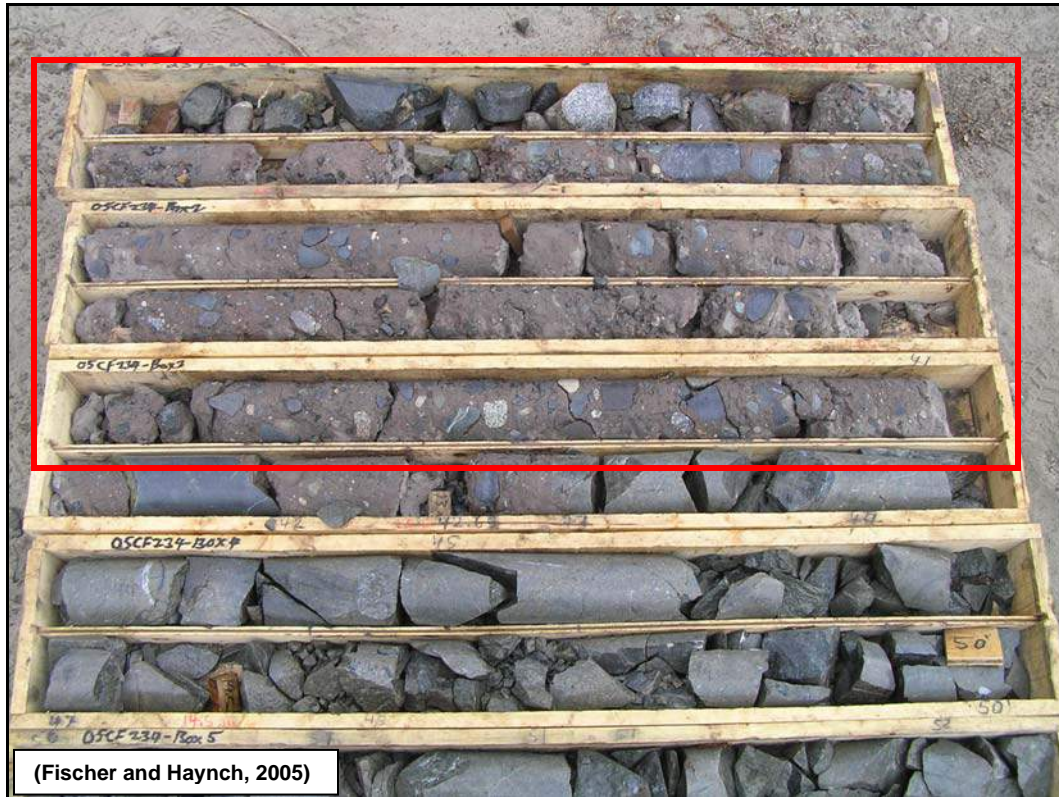
Plate 3.2-1. An example of overburden from a 2005 Diamond Drill core.

There is a general trend of decreasing overburden thickness as property elevation increases (Ewanchuk and Hanych, 2006). Overburden on the property is composed of glacial till, fluvio-glacial material, locally derived purple clay and local bedrock talus (Plate 3.2-1) (M^cCandlish, 2007). Scree and Talus cover the western-facing slopes of Schaft Creek. Material is derived from the bedrock below, and as a result is mineralized when derived from mineralized bedrock (Mann, 2006). Freeze and Cherry (1979), state that glacial tills range in hydraulic conductivities from 10^{-12} m/s to 10^{-6} m/s. Glacial till high in silt with some clay predominately comprises the overburden on the property. As a result, it is expected hydraulic conductivities of the overburden material lie within the mid to low estimates of this range ($\approx 10^{-8}$ m/s).

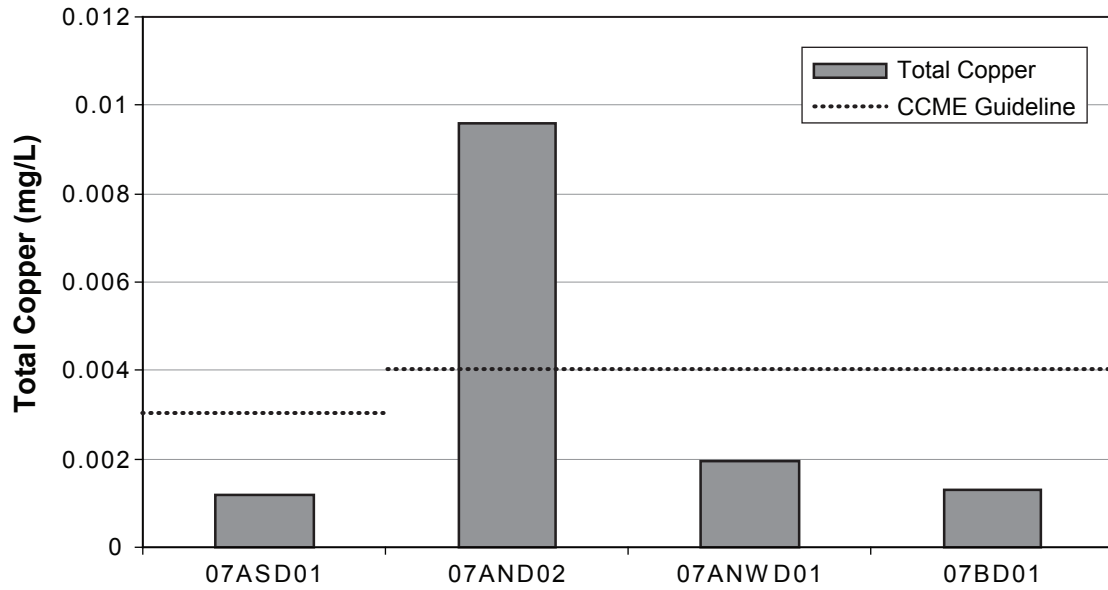
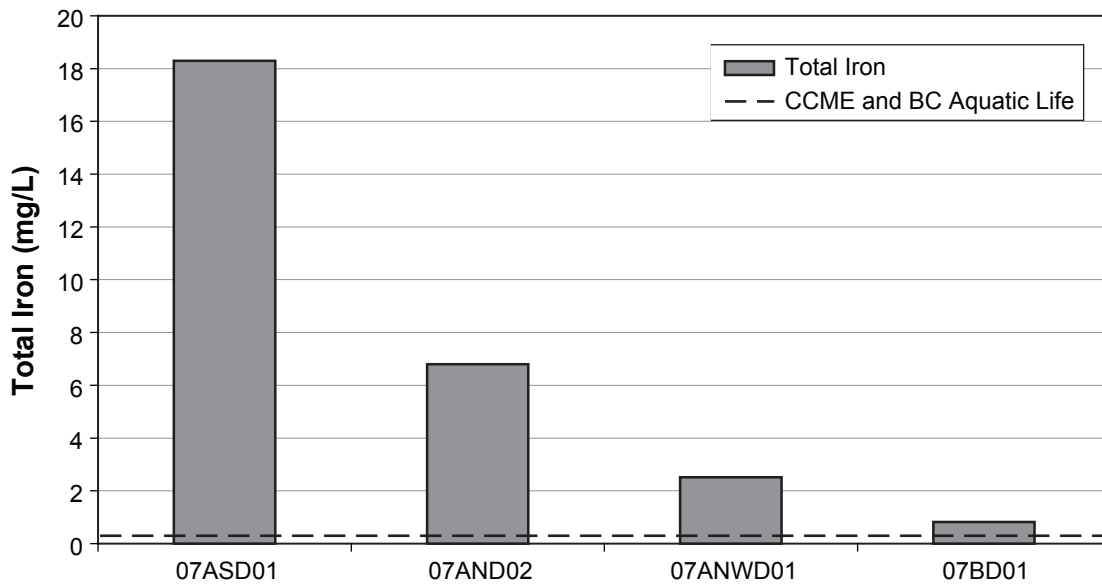
FIGURE 4.3-5

Total Copper and Total Iron Profiles in Groundwater
